WASTE MATERIAL REMOVAL COMPLETION REPORT FOR  
ARVINMERITOR

Former Moose Lodge Road Disposal Area  
Grenada, MS

January 12, 2006  
220T.11530.00.00016

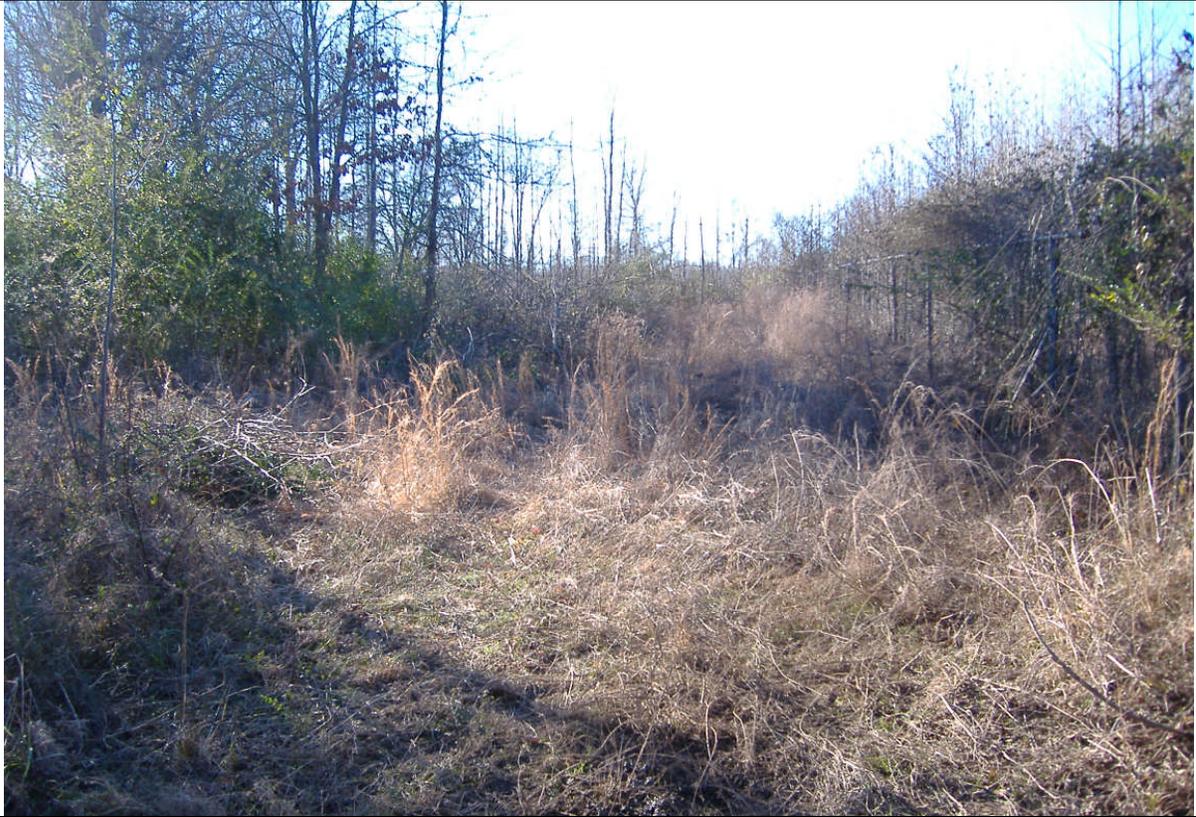
**PHOTO No. 1**

Entrance of Site prior to clearing and grubbing. (view from east to west)

During the week of January 30, 2006, clearing and grubbing was initiated to remove trees, snags, logs, stumps, rubbish and garbage from the area illustrated on Figure 2 and in Appendix B – Photographs 1 and 2. Clearing and grubbing was necessary to remove vegetation and allow access to the waste material. Trees and underbrush were cut above ground level and chipped on-site. The root systems were left in place until the Site was cleared. The root systems with visible waste material were removed and staged for disposal. Larger trees were cut above ground surface and staged for off site transportation. The clearing and grubbing concluded during the week of February 13, 2006.

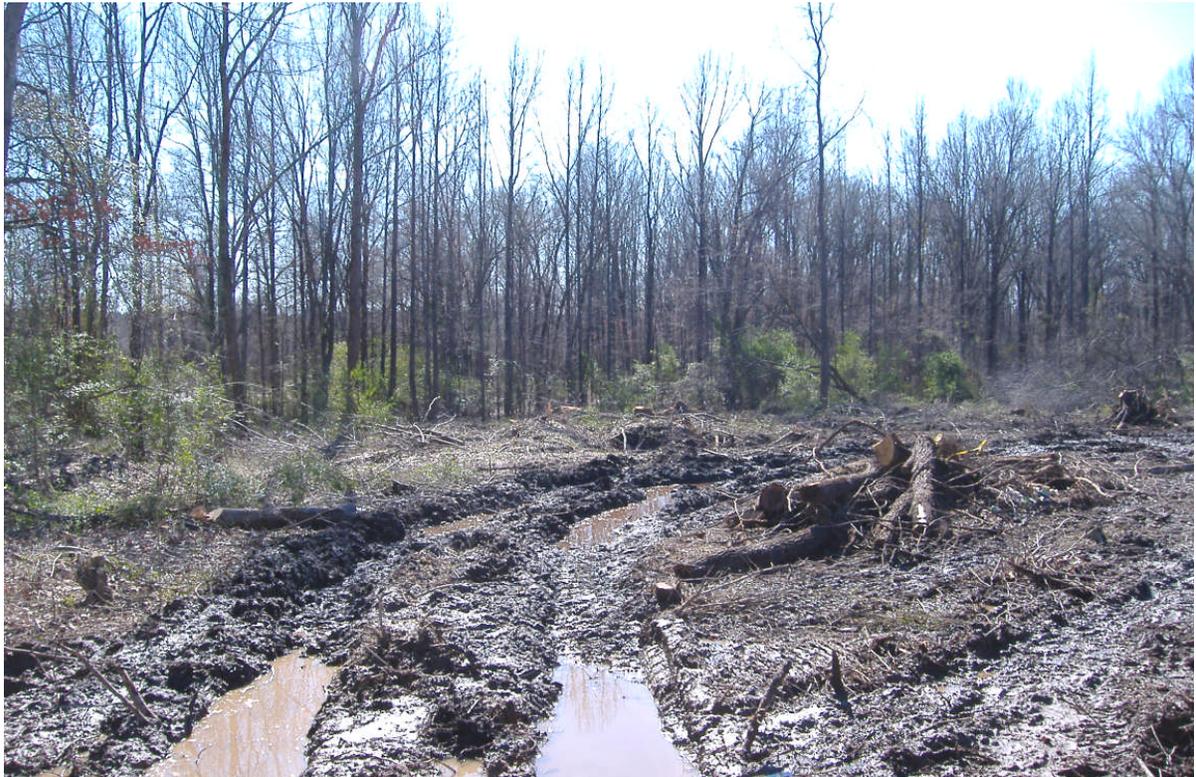
**PHOTO No. 2**

Site during clearing and grubbing. (View from north to south)

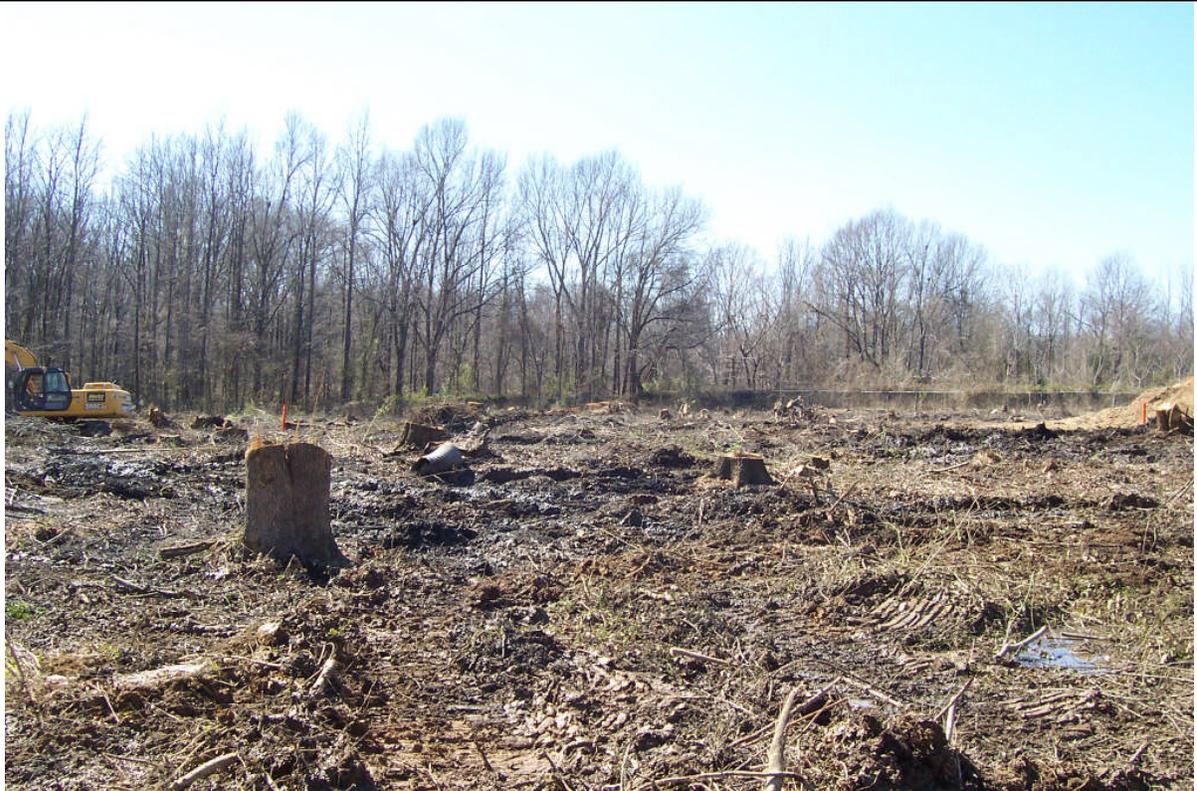
**PHOTO No. 3**

Site after trees and brush have been cleared. (View northeast to southwest)

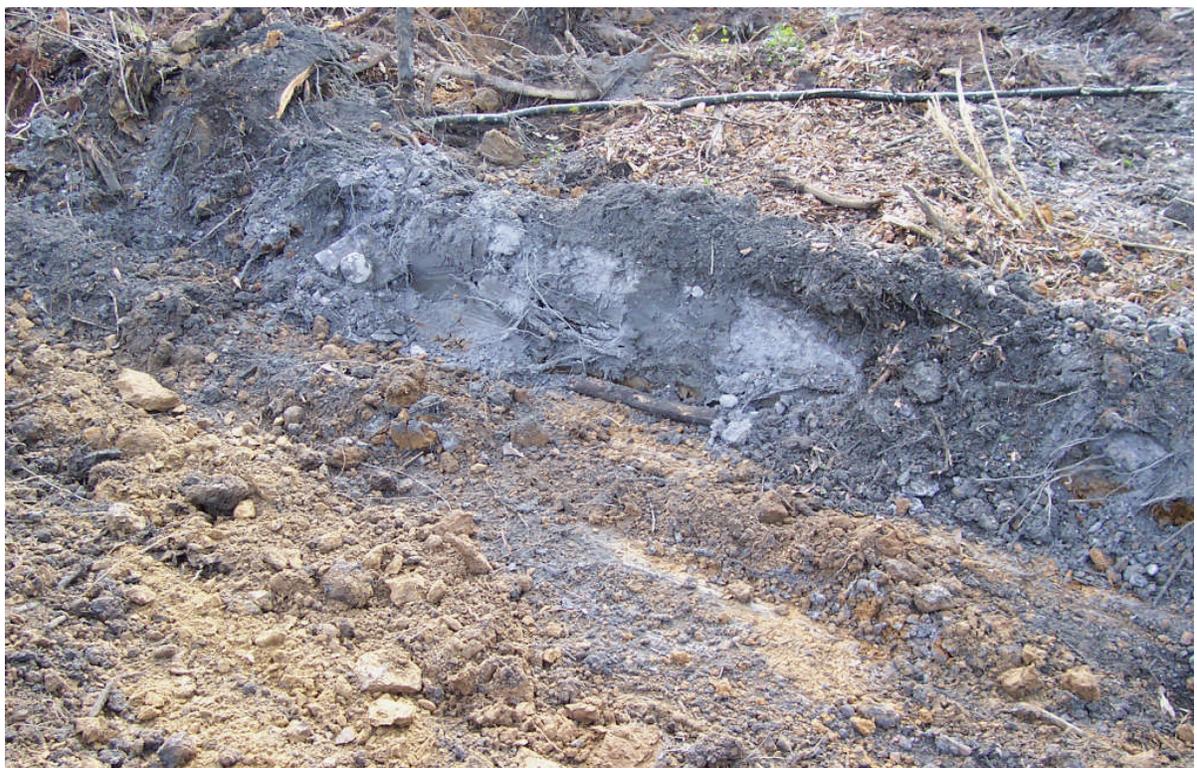
**PHOTO No. 4**

Removal of the buffing compound was initiated in the southwest corner of the Site. A toothless excavator bucket was used to remove surficial waste material (buffing compound) down to the native soil. The toothless bucket was used to allow for effective removal of the waste material and to minimize removal of the underlying native soil. The waste material is visibly distinct from the underlying native soil, it is primarily dark gray to black in color with the consistency of fine sand. The underlying native soil is silty sand and is tan to brown in color (reference Appendix B - Photograph 4).

View of buffing compound and native soil.

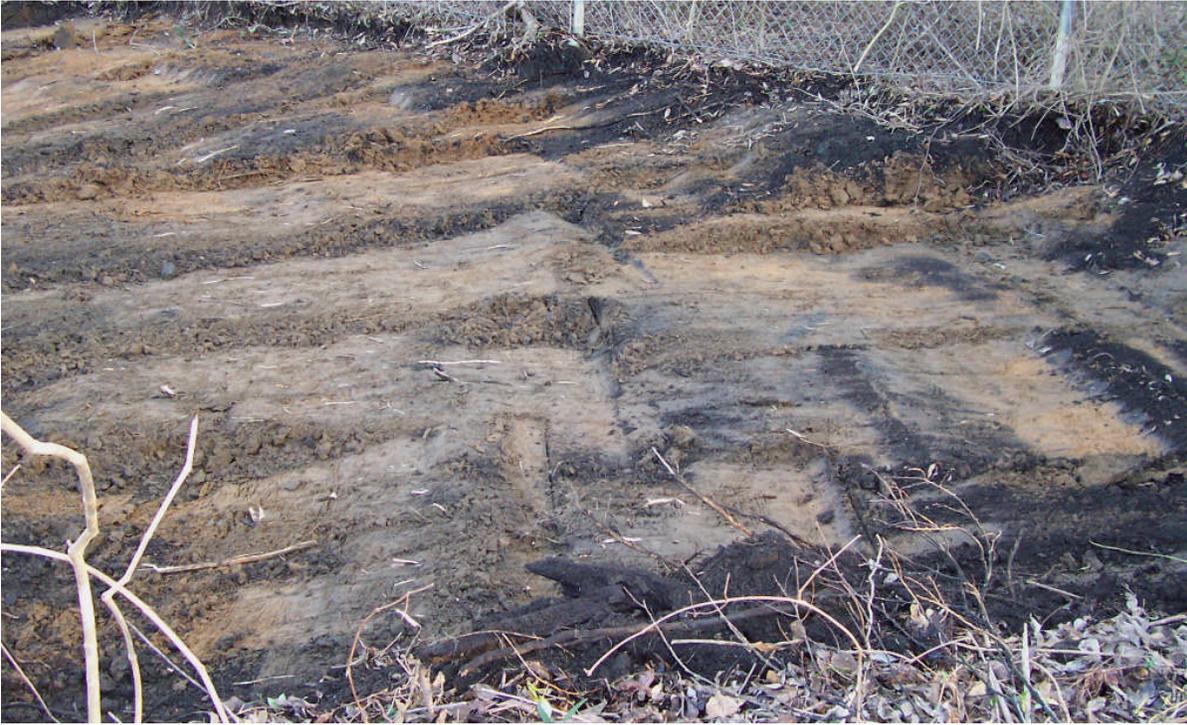
**PHOTO No. 5**

Southwest section of the Site during buffing compound removal. (View to southwest from the northeast)

In accordance with Section 2.5 of the MDEQ approved Waste material Removal Work Plan (September 14, 2004). Removal of the waste material was to confirmed by visual inspection. The waste material and underlying soil are visibly distinct and can be easily differentiated based on visual inspection (refer to Appendix B – Photograph 4). As the excavation progressed from the southwest to the northeast, the removal area would be inspected to confirm that any residual waste material had been removed. Photographs showing representative portions of the site before, during, and after removal of the waste material are presented in Appendix B – Photos 5 through 21. These photos clearly illustrate successful removal of the waste material.

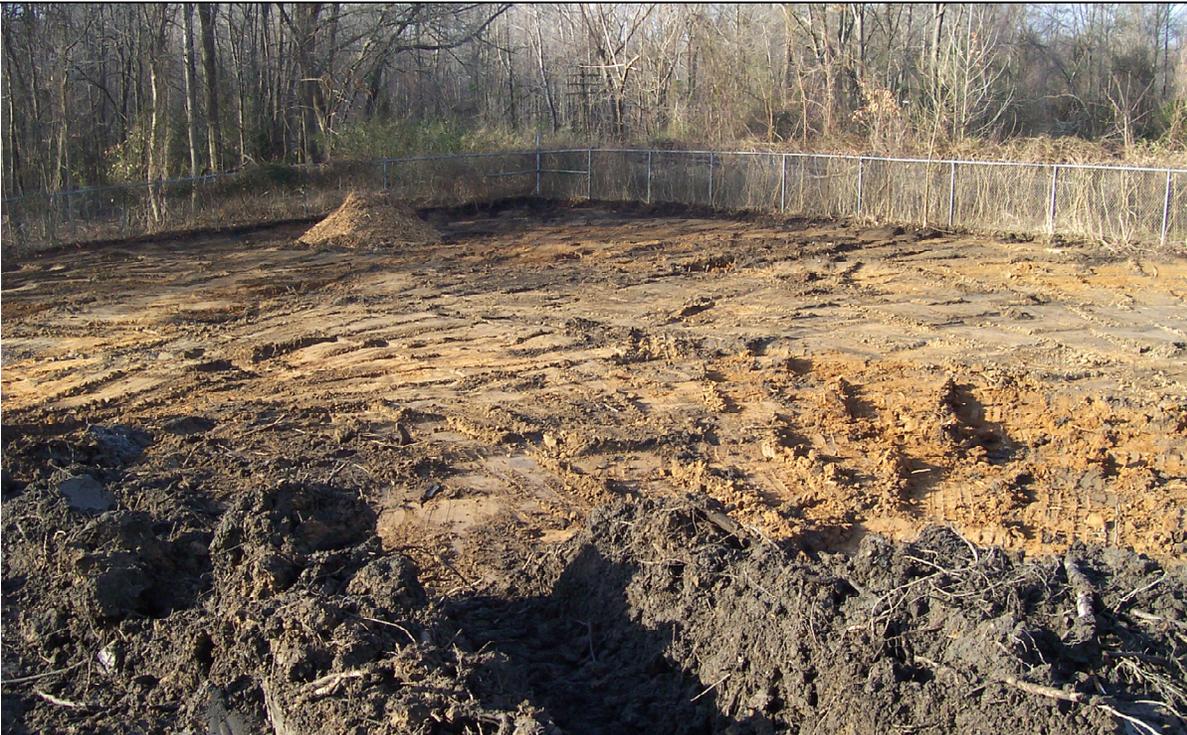
**PHOTO No. 6**

View of the southwest portion of the Site during removal of buffing compound. (View from the northeast)

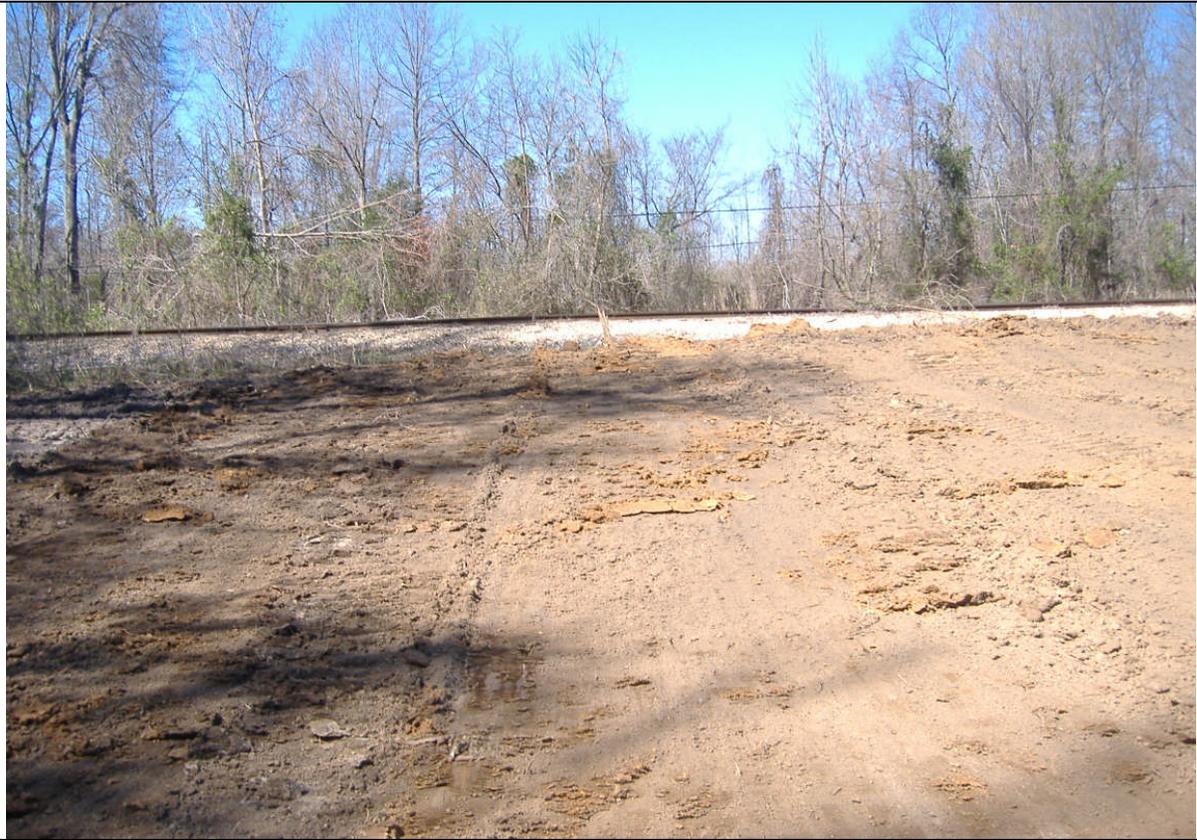
**PHOTO No. 7**

Southwest section of the Site after removal of buffing compound. (View from east)

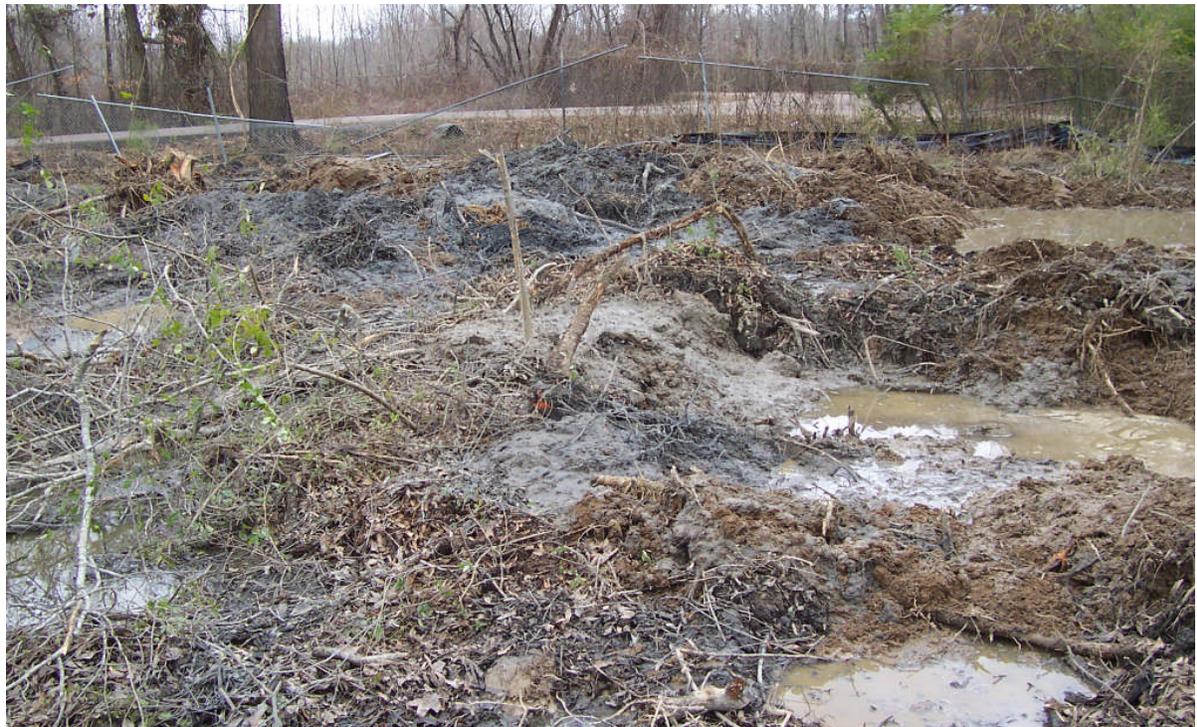
**PHOTO No. 8**

Southeast section of the Site prior to removal of buffing compound. (View from the northwest.)

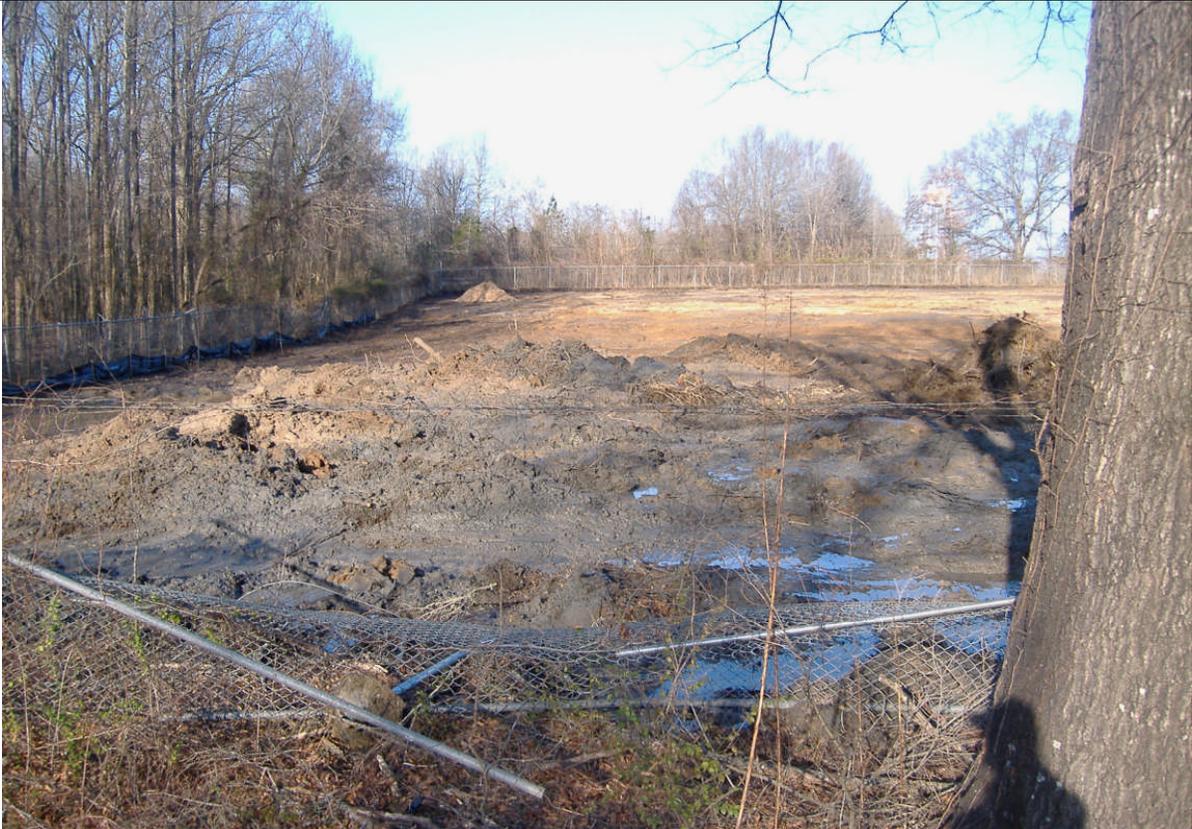
**PHOTO No. 9**

Southeast section of the Site prior to removal of buffering compound. (View from the east.)

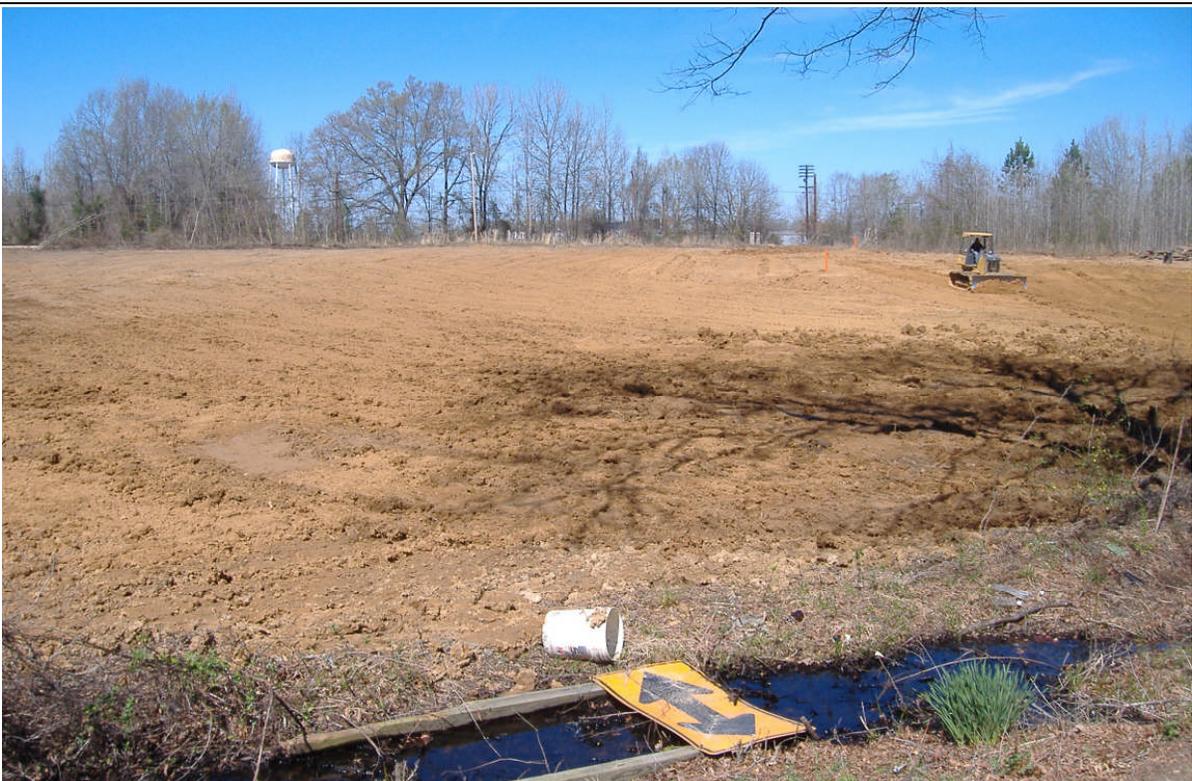
**PHOTO No. 10**

Southeast section of the Site after removal of buffering compound. (View from the east)

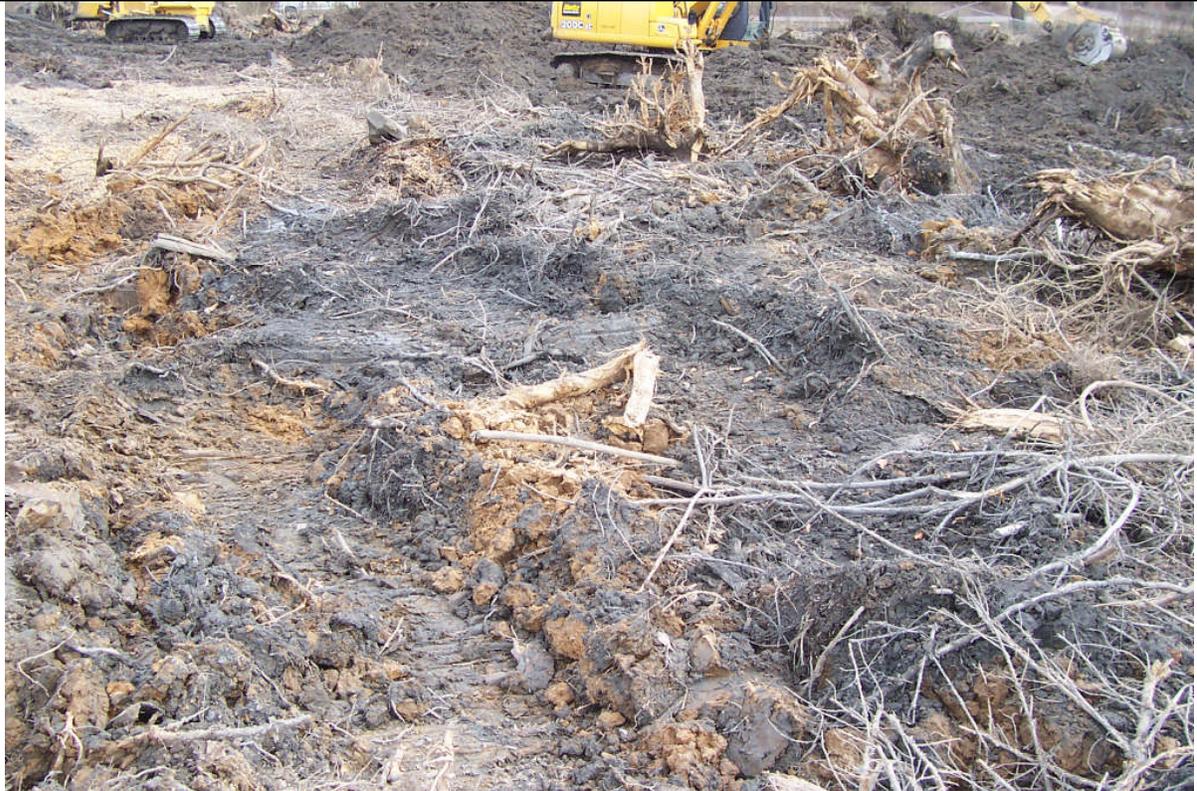
**PHOTO No. 11**

North central portion of the site prior to removal of buffering compound. (View from the northwest.)

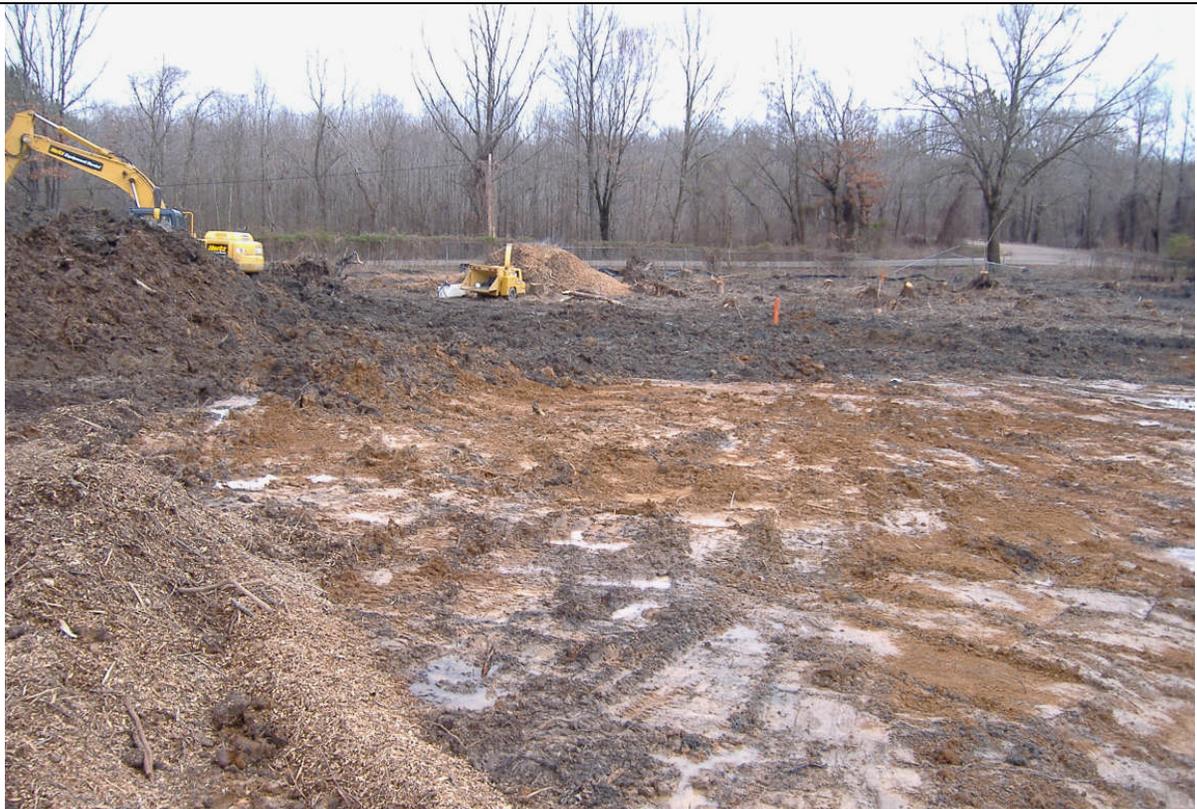
**PHOTO No. 12**

View from the northwest to the southeast during removal of the buffering compound.

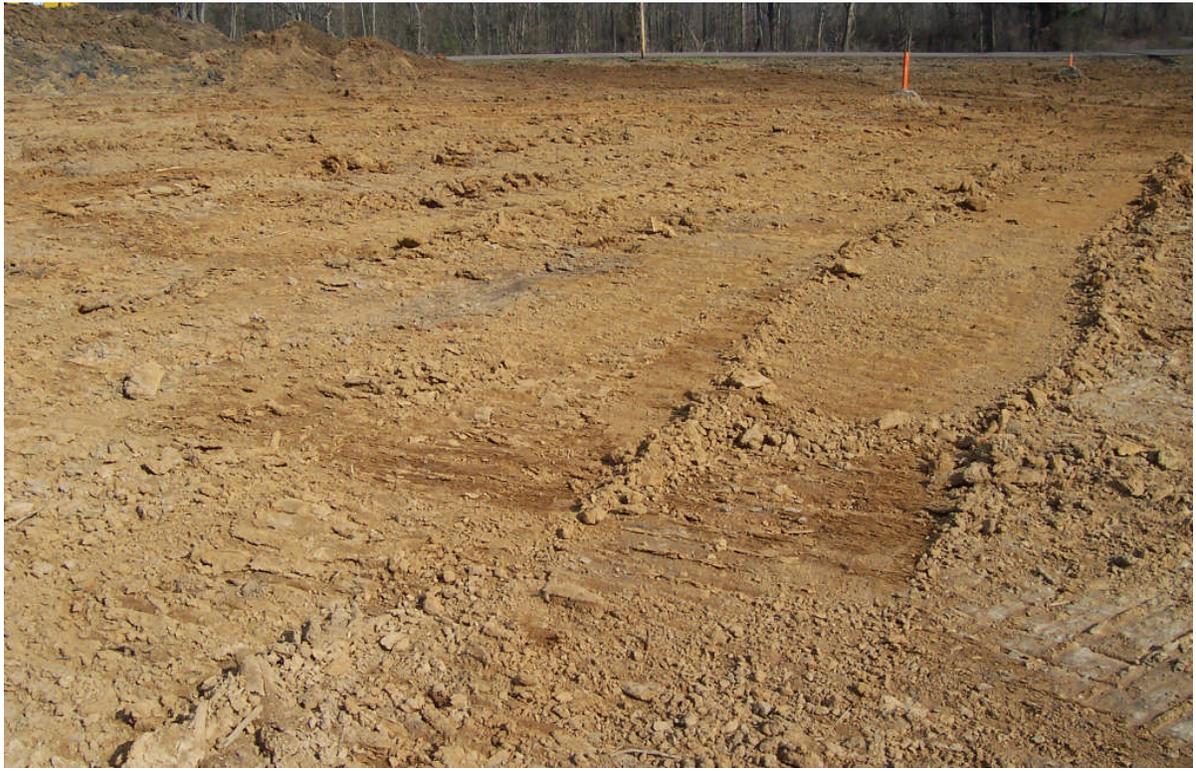
**PHOTO No. 13**

View for the northwest to the southeast after removal of the buffing compound.

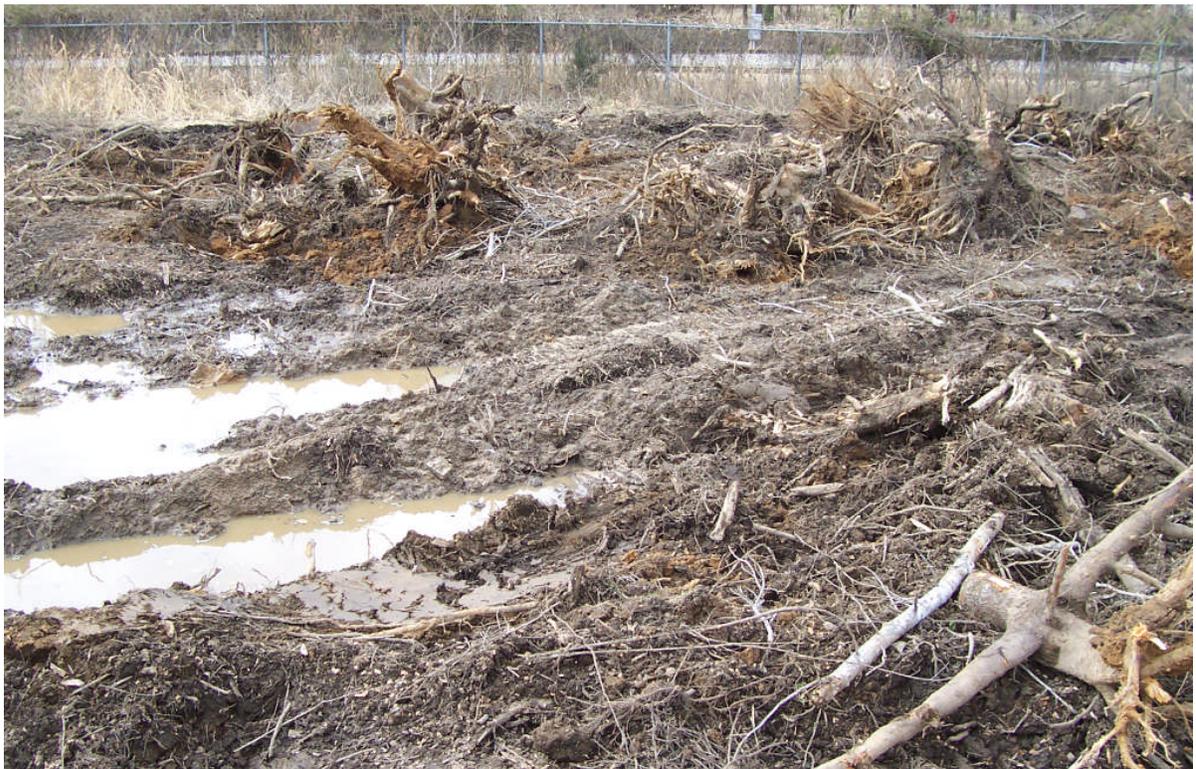
**PHOTO No. 14**

Root systems and buffing compound in the northwest corner of the site. (View from the southeast)

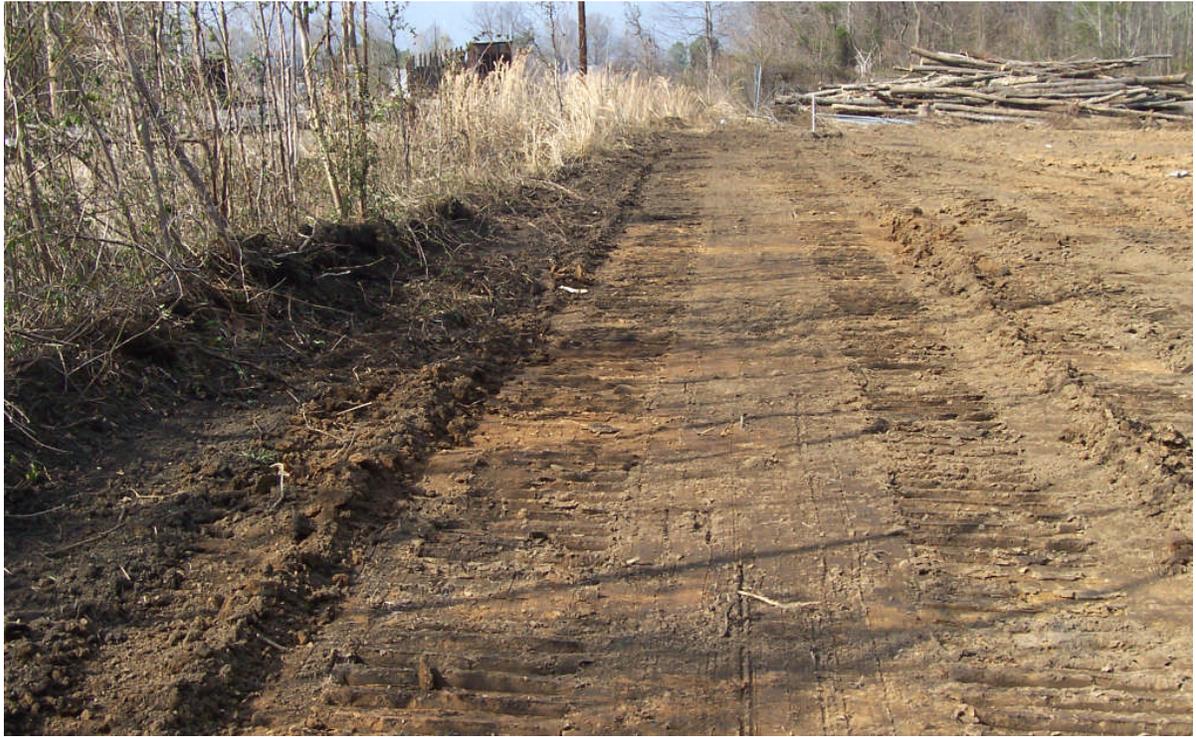
**PHOTO No. 15**

View of the northwest section of the site after removal of the root systems and buffing compound. (View from the south.)

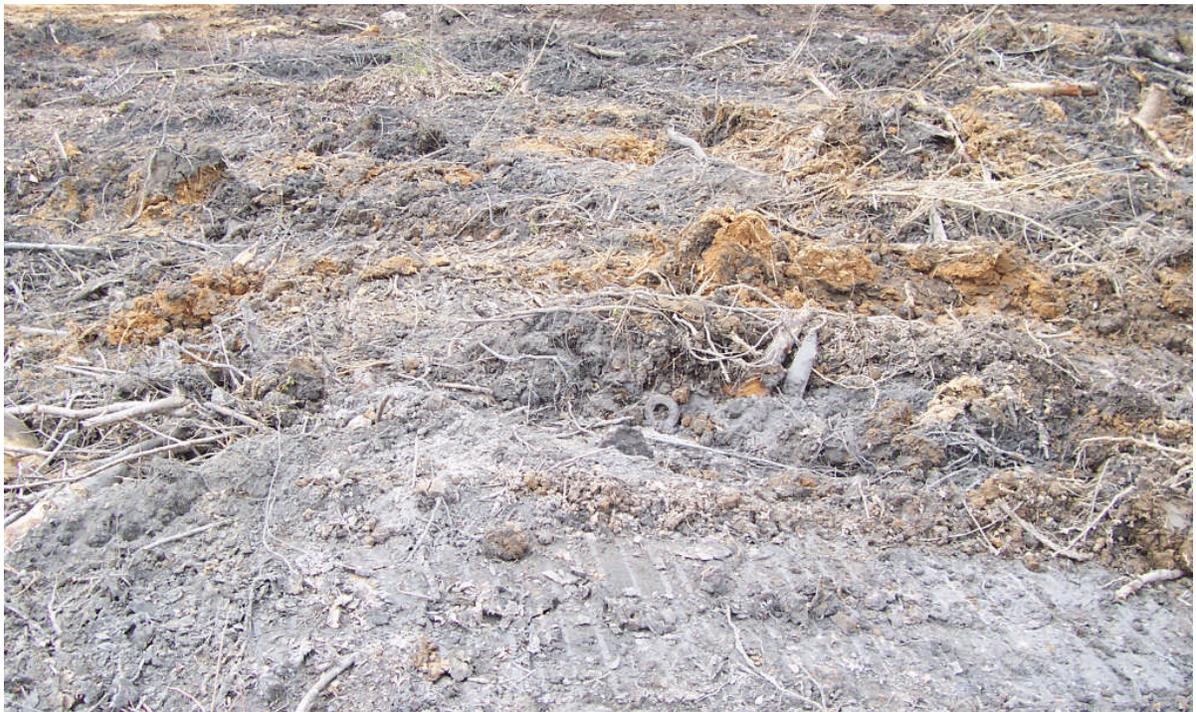
**PHOTO No. 16**

Buffing compound located in the central portion of the Site. (View from east to west.)

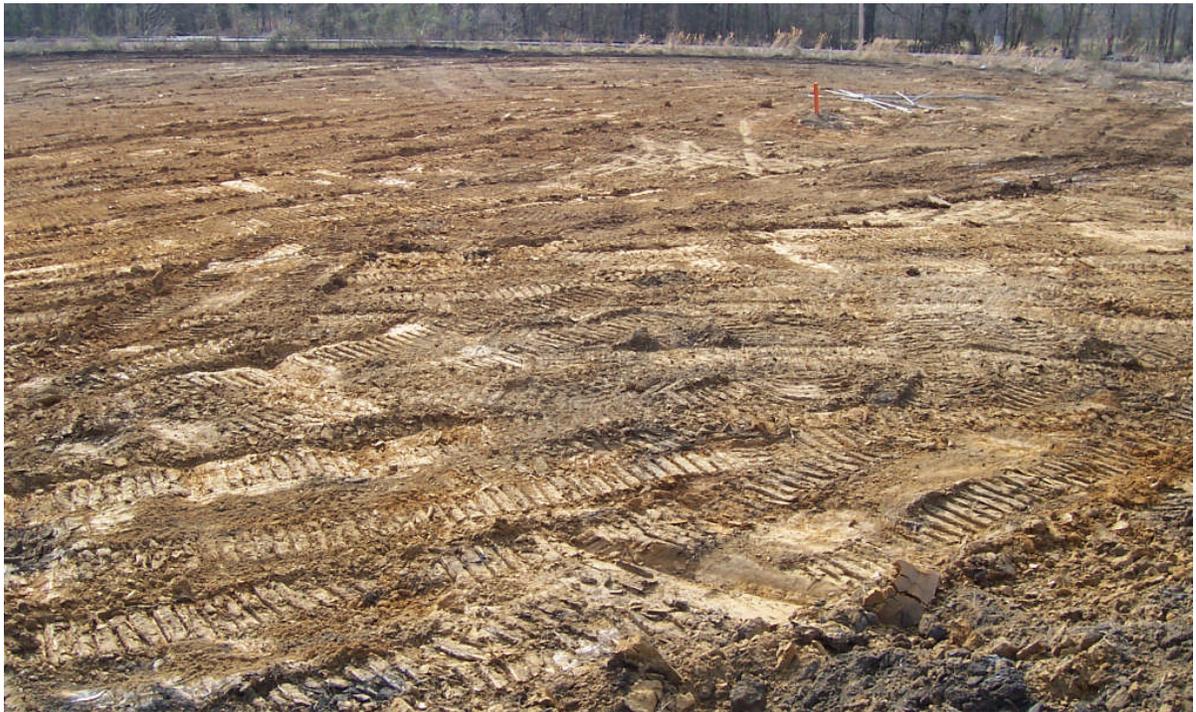
**PHOTO No. 17**

View of the central portion of the Site after removal of buffing compound.

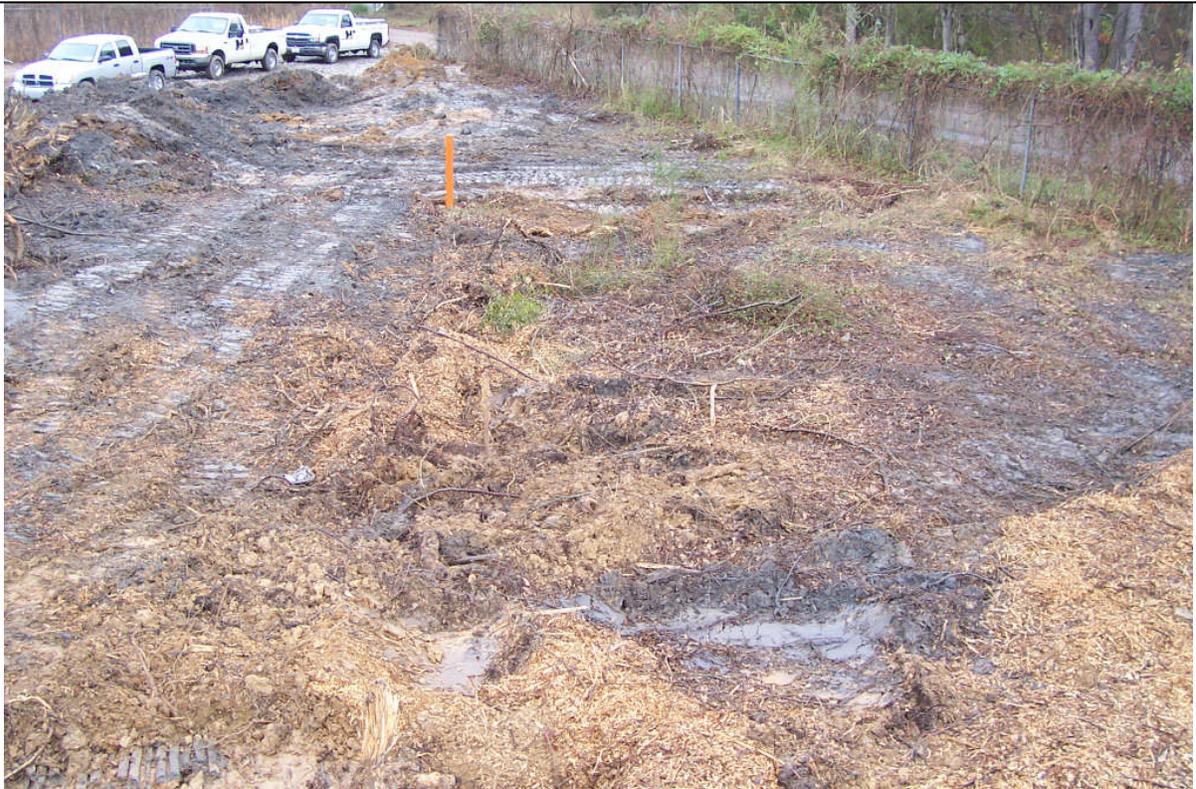
**PHOTO No. 18**

Northwest section of the Site near stock pile prior to removal of buffing compound.  
(View from excavator to the northeast.)

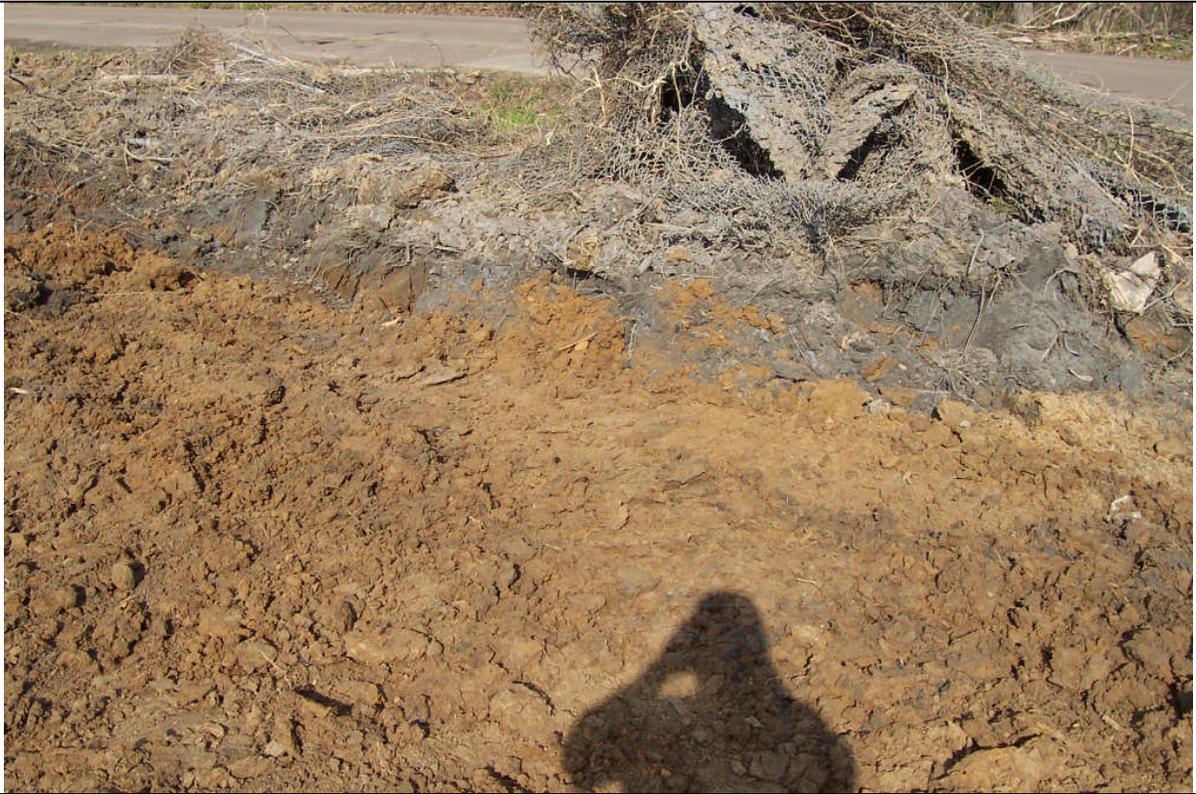
**PHOTO No. 19**

Buffing compound along the eastern margin of the Site. (View from the west.)

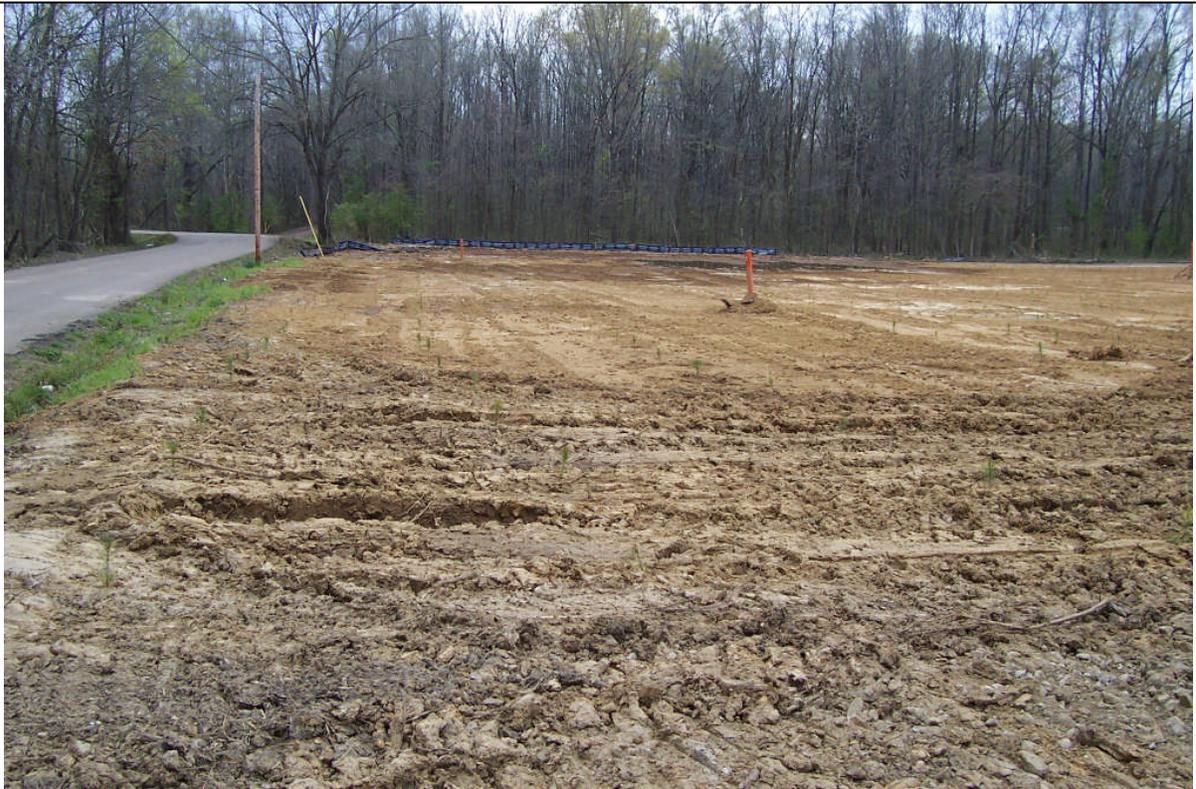
**PHOTO No. 20**

View of the eastern margin of the Site after buffing compound removal. (View from the north.)

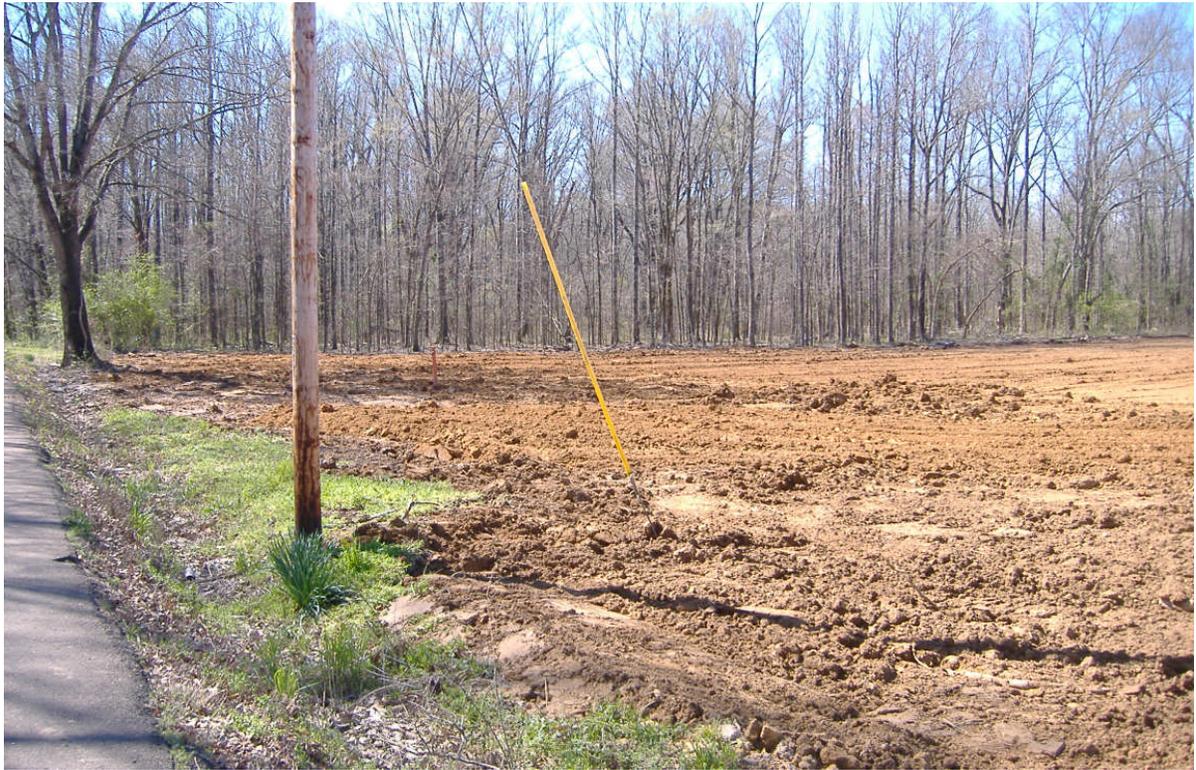
**PHOTO No. 21**

View of the eastern margin of the Site after removal of the buffing compound.  
(View from the northeast to the southwest.)

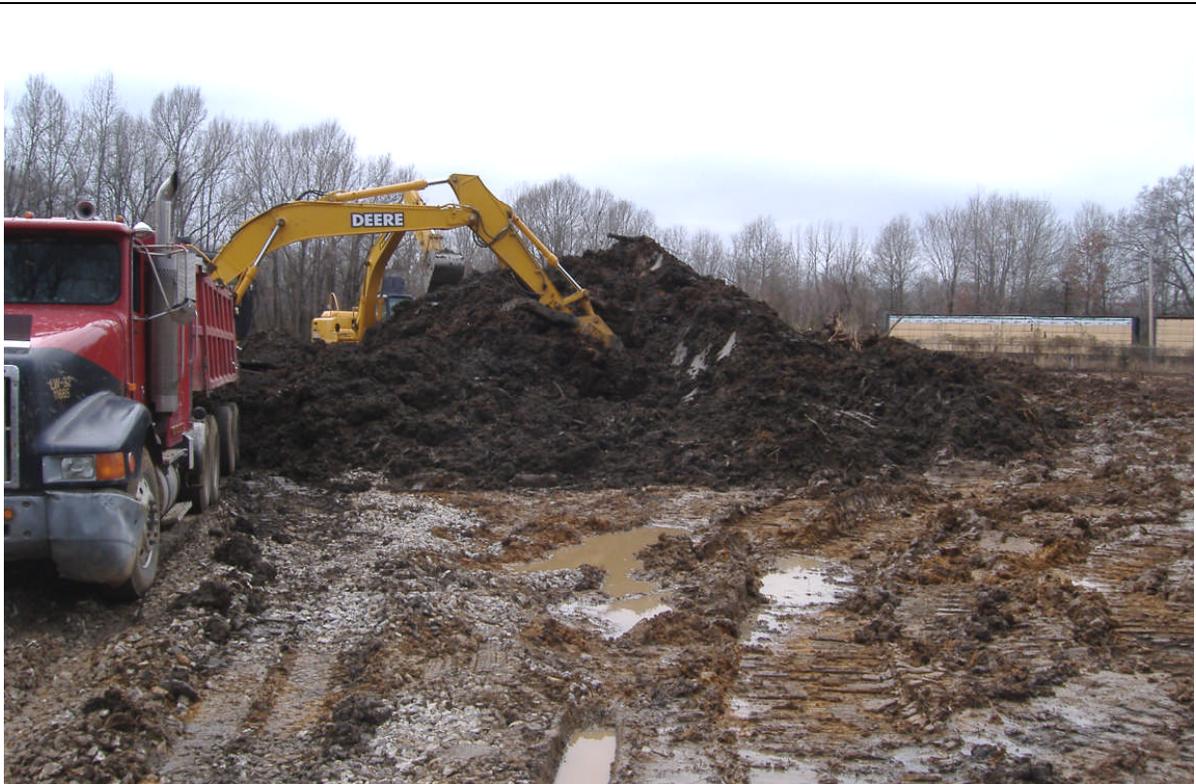
**PHOTO No. 22**

Semi-truck loading of buffing compound.
