WASTE MATERIAL REMOVAL COMPLETION REPORT FOR  
ARVINMERITOR

Former Moose Lodge Road Disposal Area  
Grenada, MS

January 12, 2006  
220T.11530.00.00016

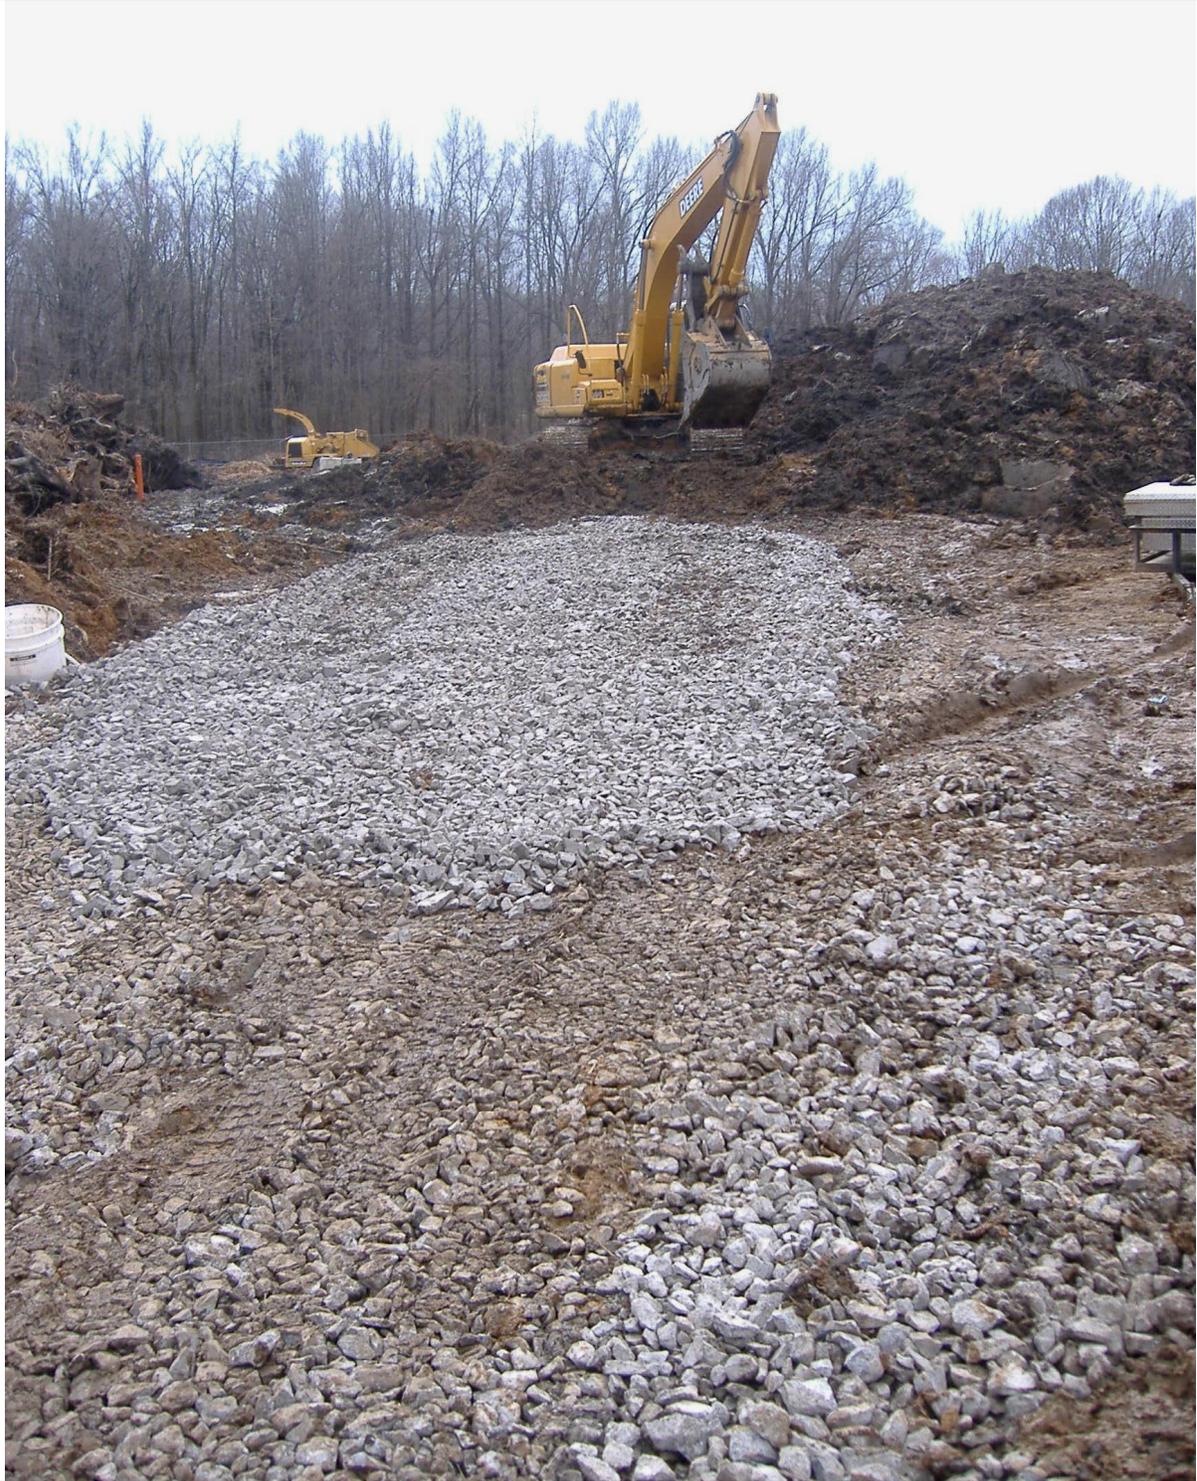
**PHOTO No. 23**

Semi-Truck loading area.

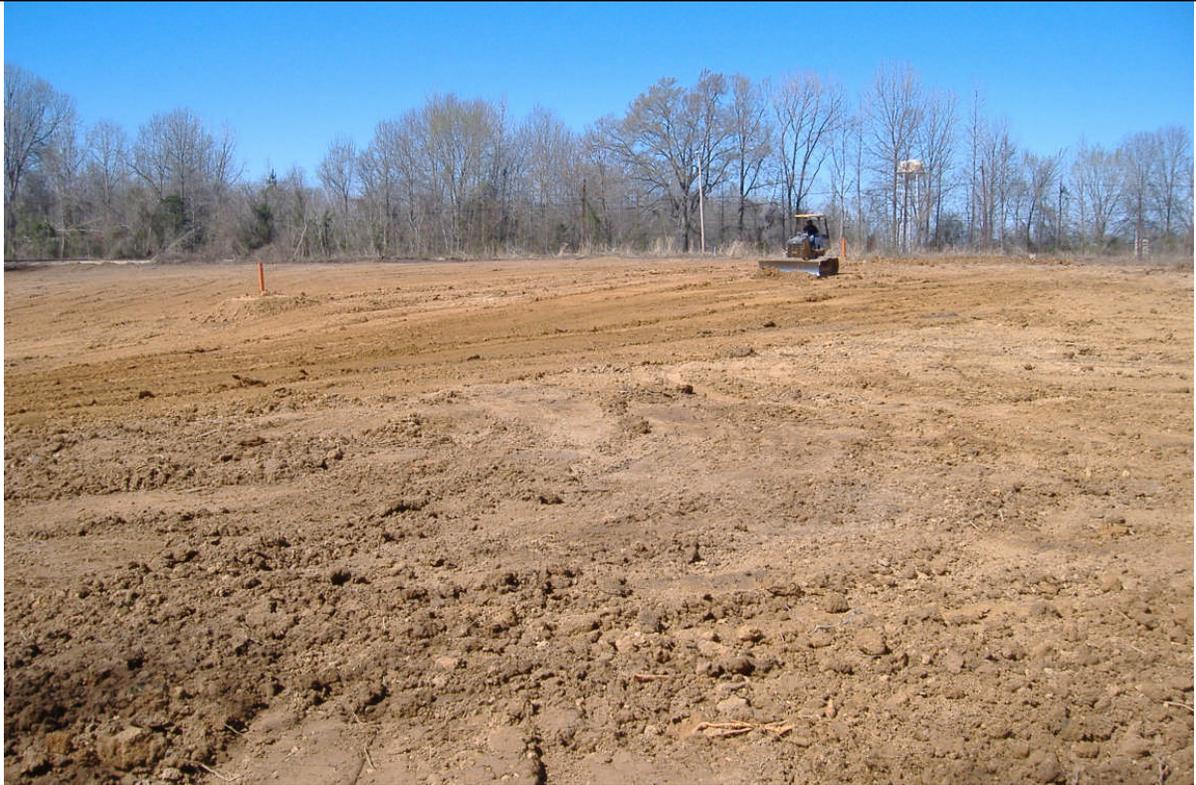
**PHOTO No. 24**

View of Site grading after removal of buffing compound. (View from the east to west.)

Following removal of the waste material and decontamination of the equipment, the Site was re-graded to match the natural grade using a bulldozer (Appendix B – photographs 24 and 25). Earth moving was conducted as necessary to remove low spots and facilitate run-off toward the southeast corner of the site. The waste material had historically been placed on the natural ground surface and not used to fill in any depressions. Therefore, additional soil was not necessary to achieve the final grade.

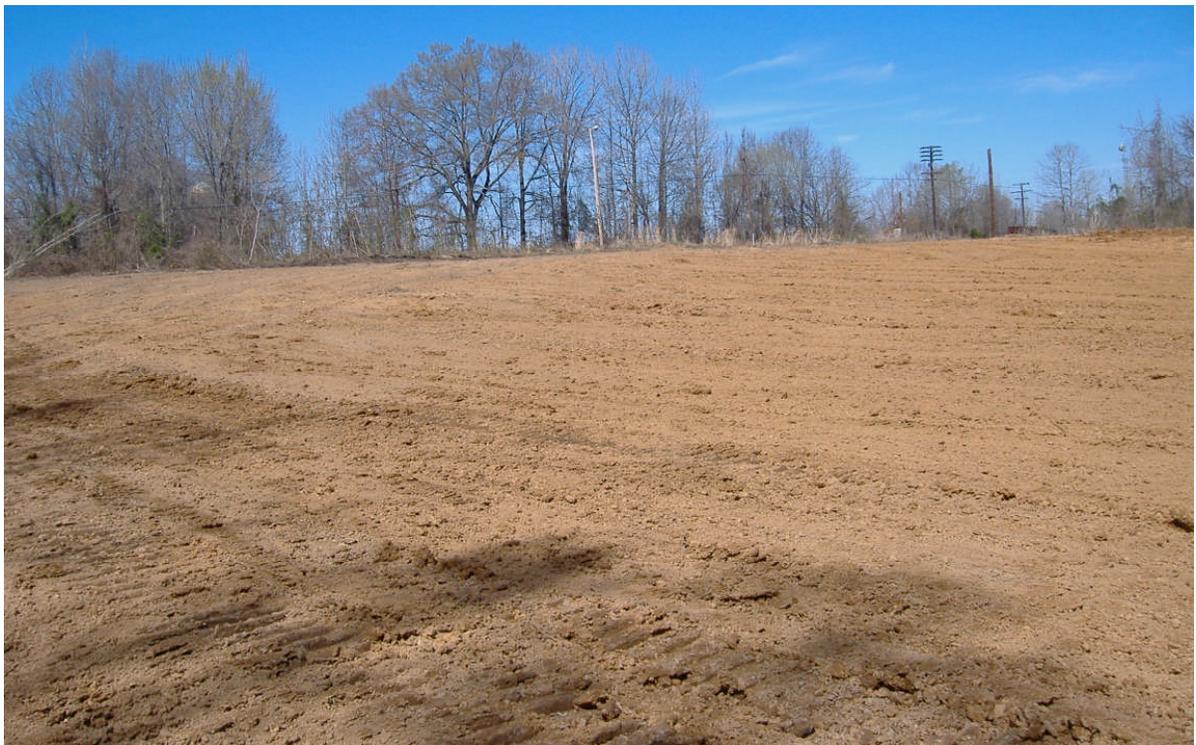
**PHOTO No. 25**

View of Site after completion of grading. (View from the southwest to the northeast.)

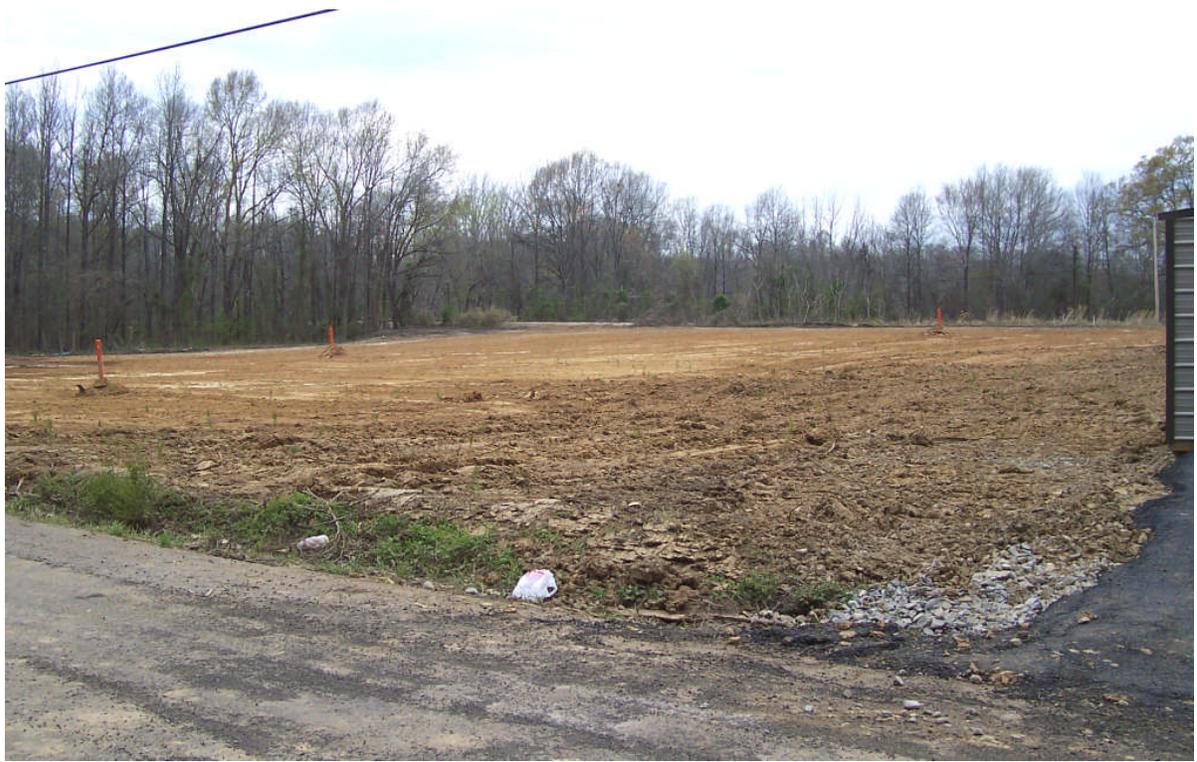
**PHOTO No. 26**

View of Site and loading area after the removal of buffing compound was completed. (View from the northeast.)

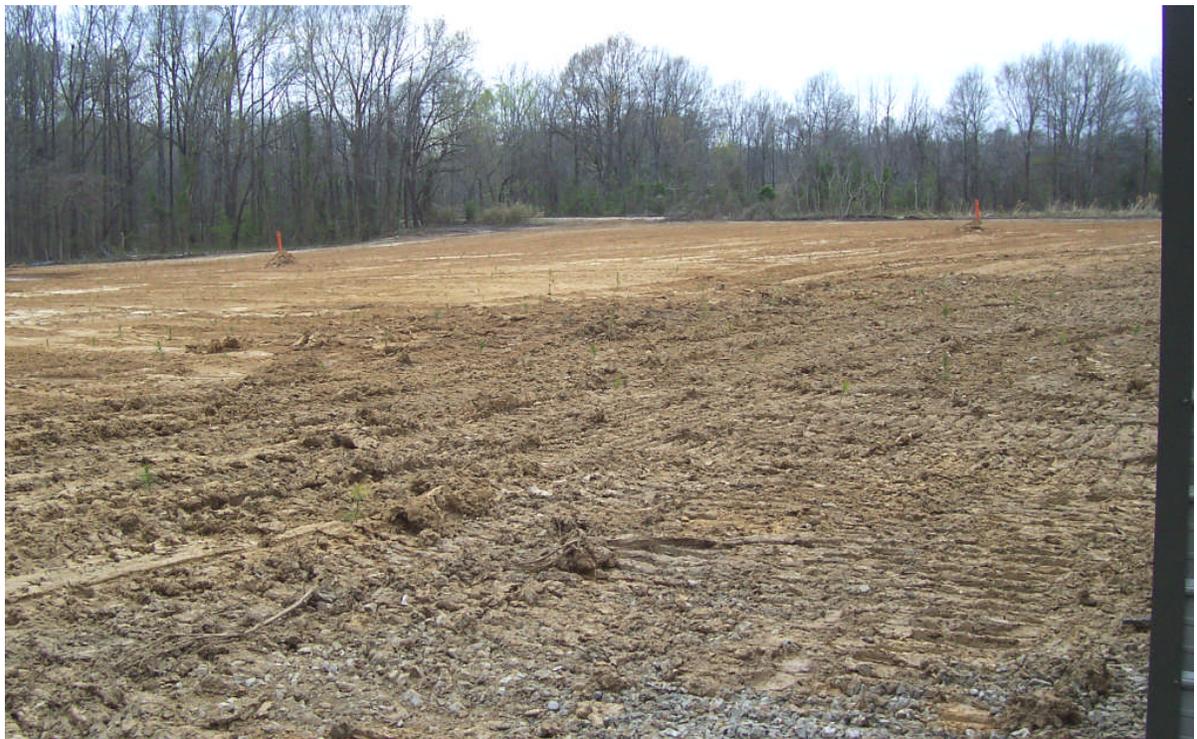
**PHOTO No. 27**

View of Site from the northeast after pine tree planting. (View from the northeast.)

The MDEQ approved Waste Removal Work Plan (September 17, 2004) specified that Site would be seeded and mulched to re-establish vegetative cover. Inspection of the surface soils remaining after waste removal indicated that it may be difficult to establish an effective grass cover. A representative of the Mississippi Forestry Commission visited the Site, based on soil conditions; he suggested re-vegetation of the Site using pine trees. The MDEQ was contacted and verbal approval was granted to substitute pine trees as the vegetative cover. Approximately 1,800 pine trees were planted to minimize erosion and establish a vegetative cover. Refer to photographs 27 through 30 in Appendix B.

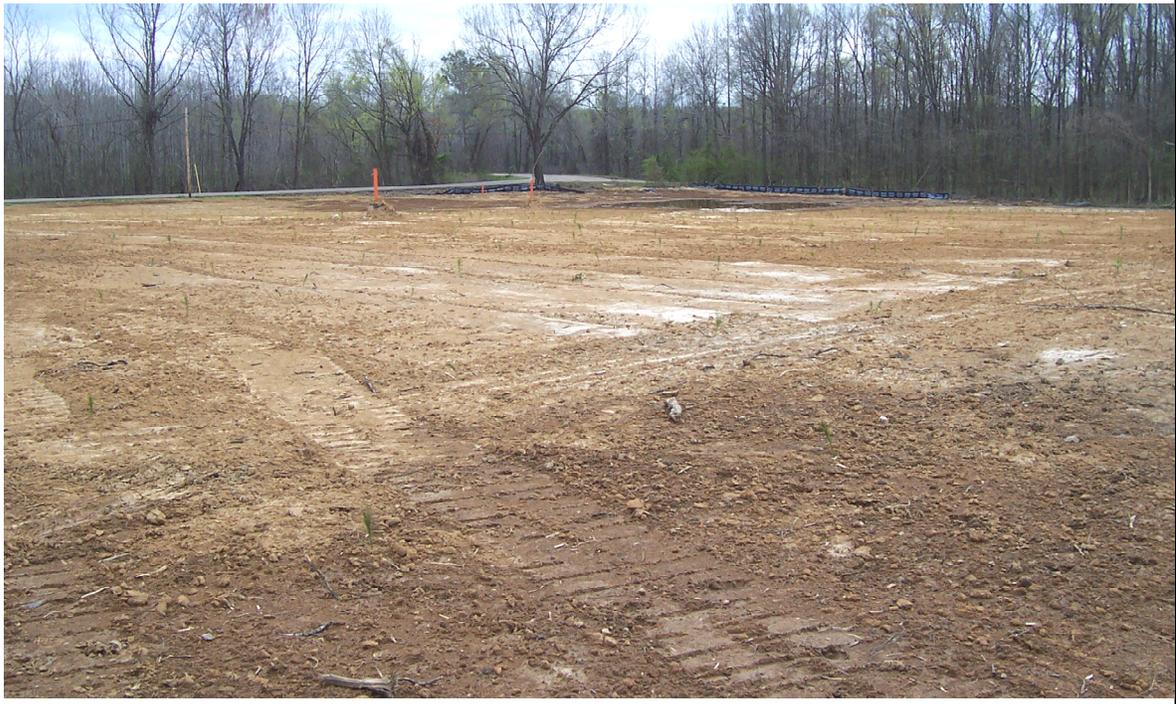
**PHOTO No. 28**

View of Site from the northwest after pine tree planting

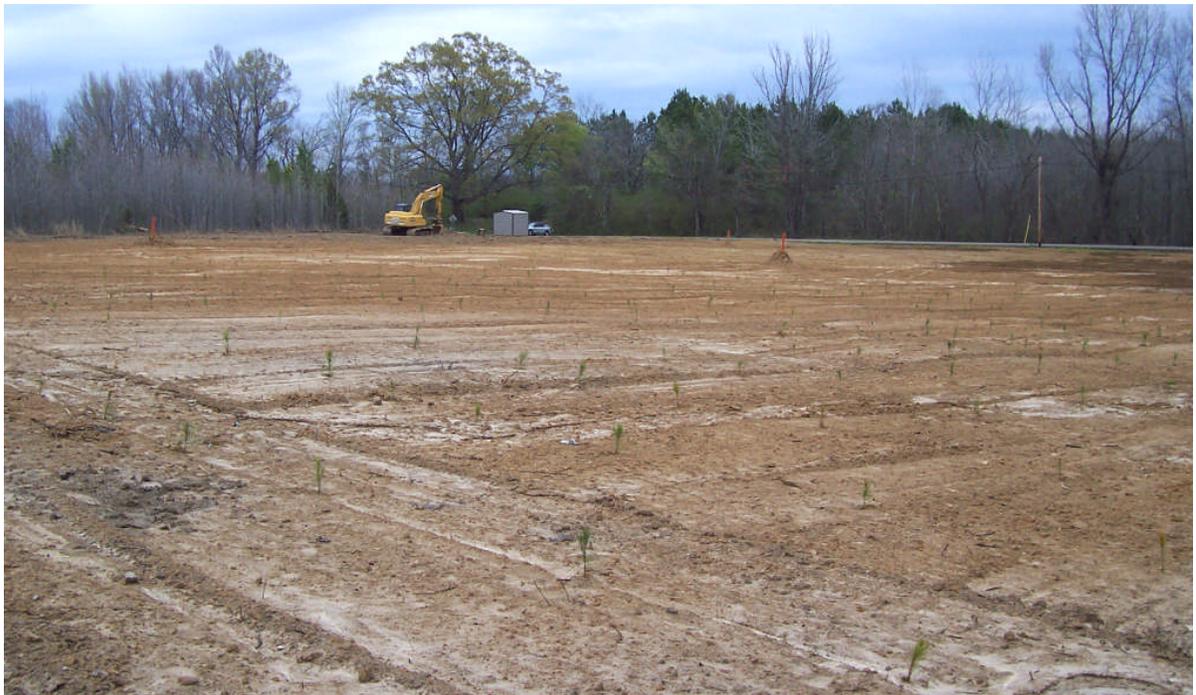
**PHOTO No. 29**

View of Site from the southwest after pine tree planting

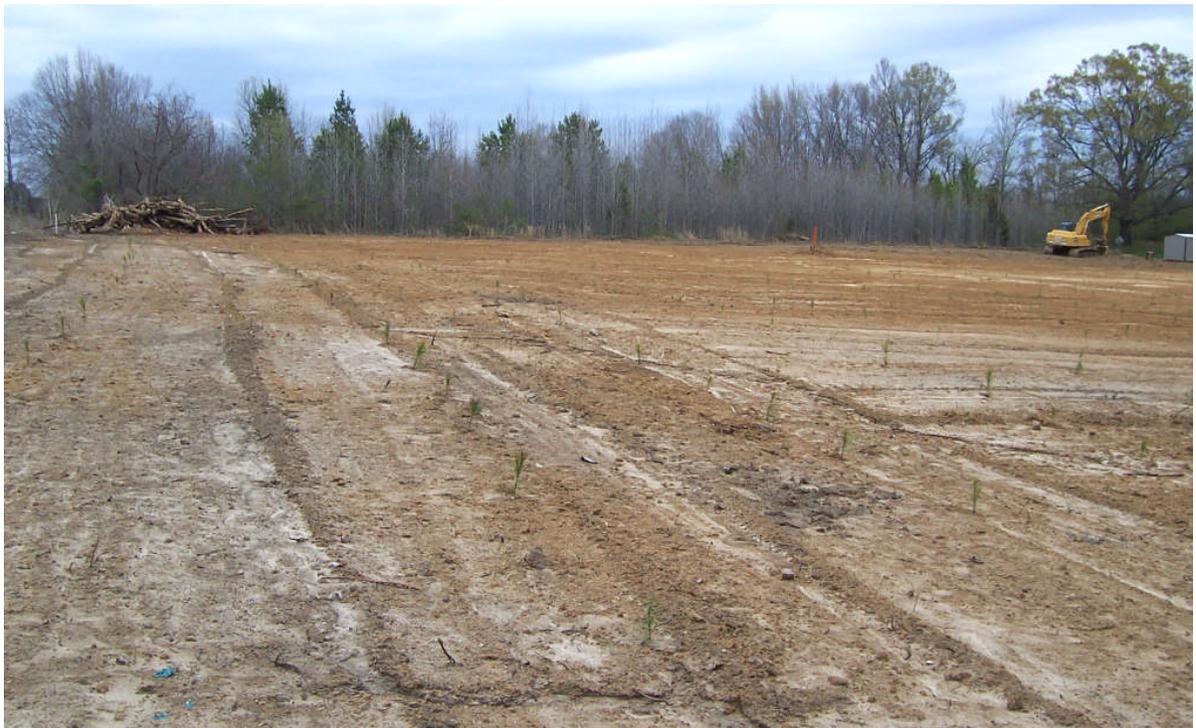
**PHOTO No. 30**

View of the Site from the south to the north after removal of buffering compound and pine tree planting.
