Appendix B

Selected Photographs of Remedial Construction Activities

Remedial Action Report

**Former Gulf States Creosoting Site
Hattiesburg, Mississippi**

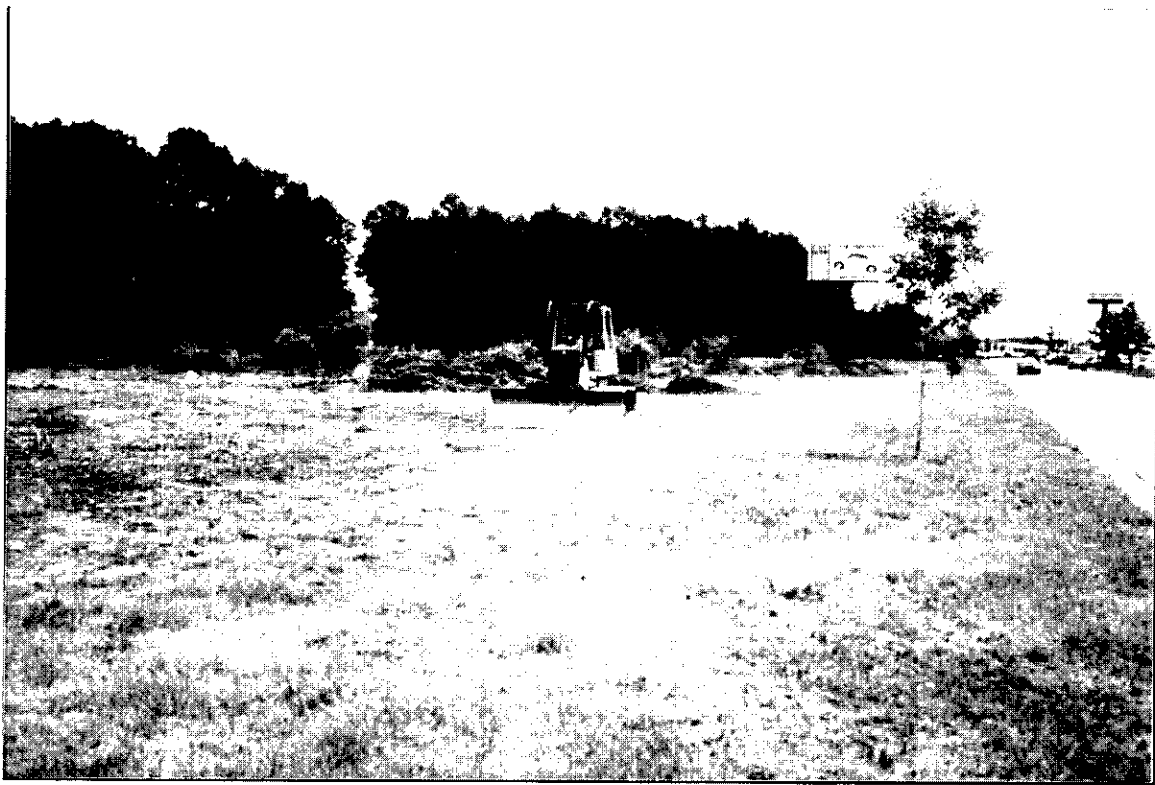
Gordon's Creek Fill Area during clearing and grubbing

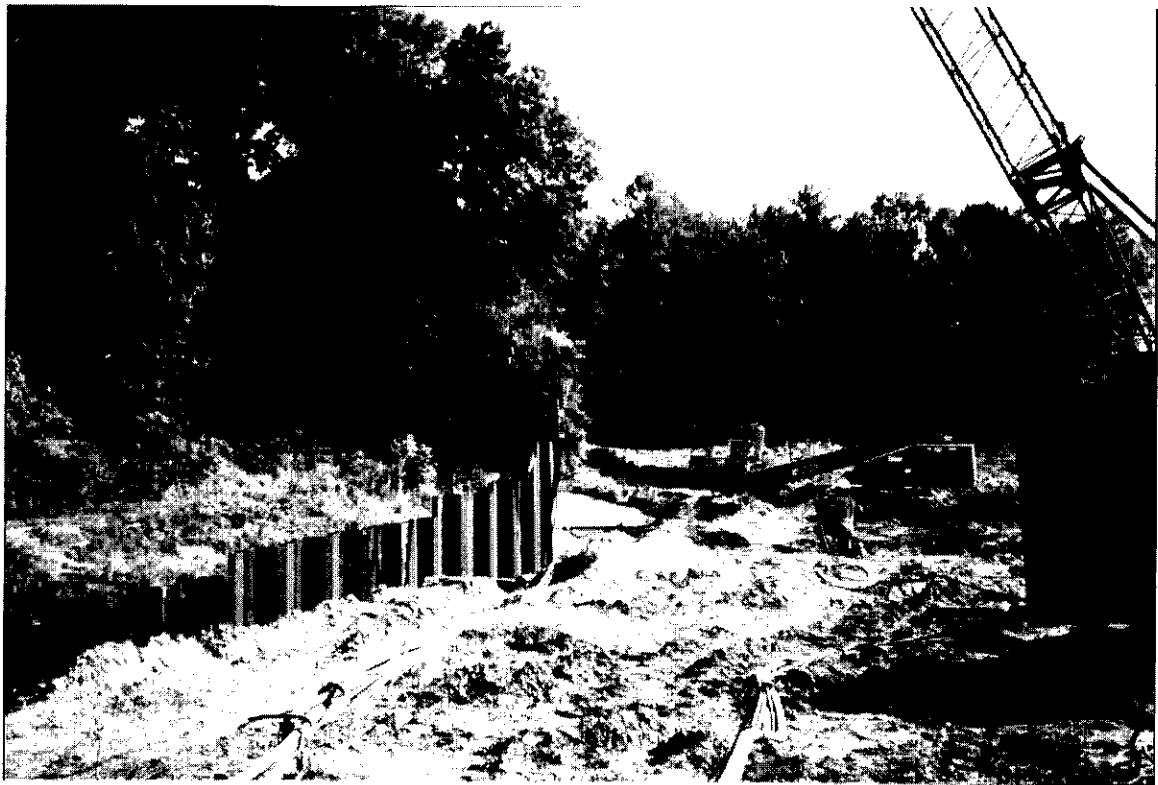
Driving piles along Gordon's Creek (facing north)

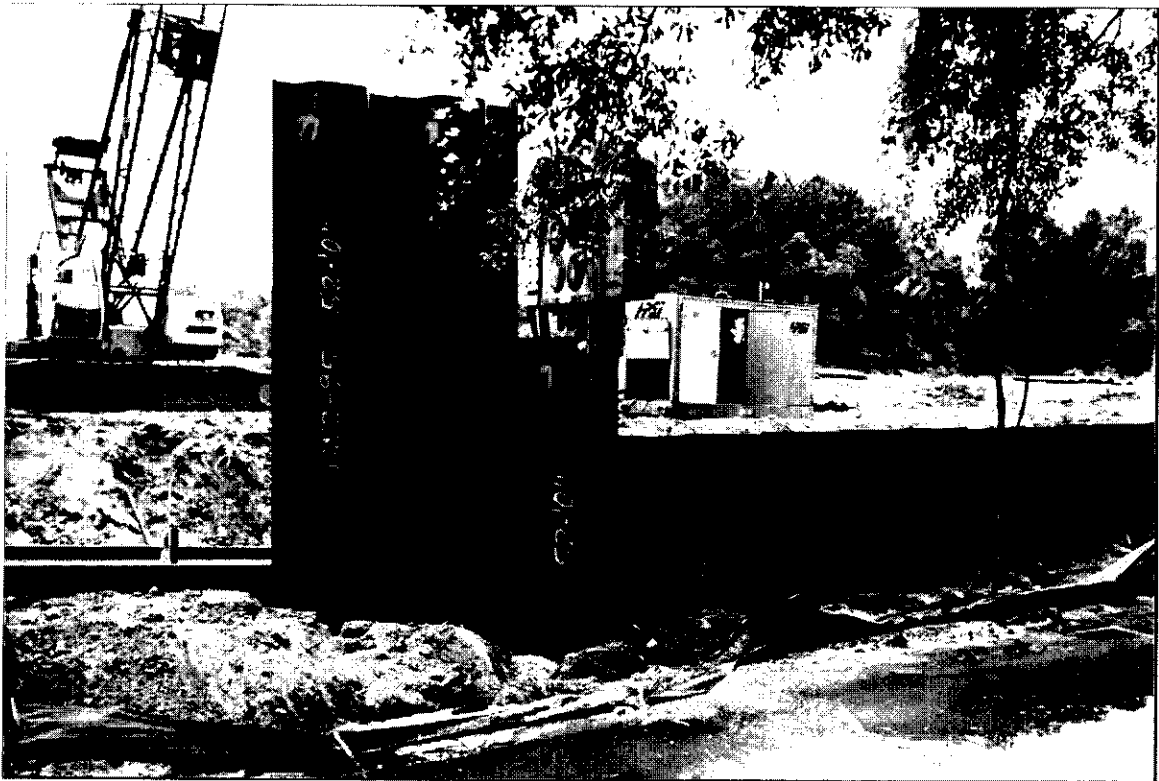
Driving piles along Gordon's Creek (facing east)

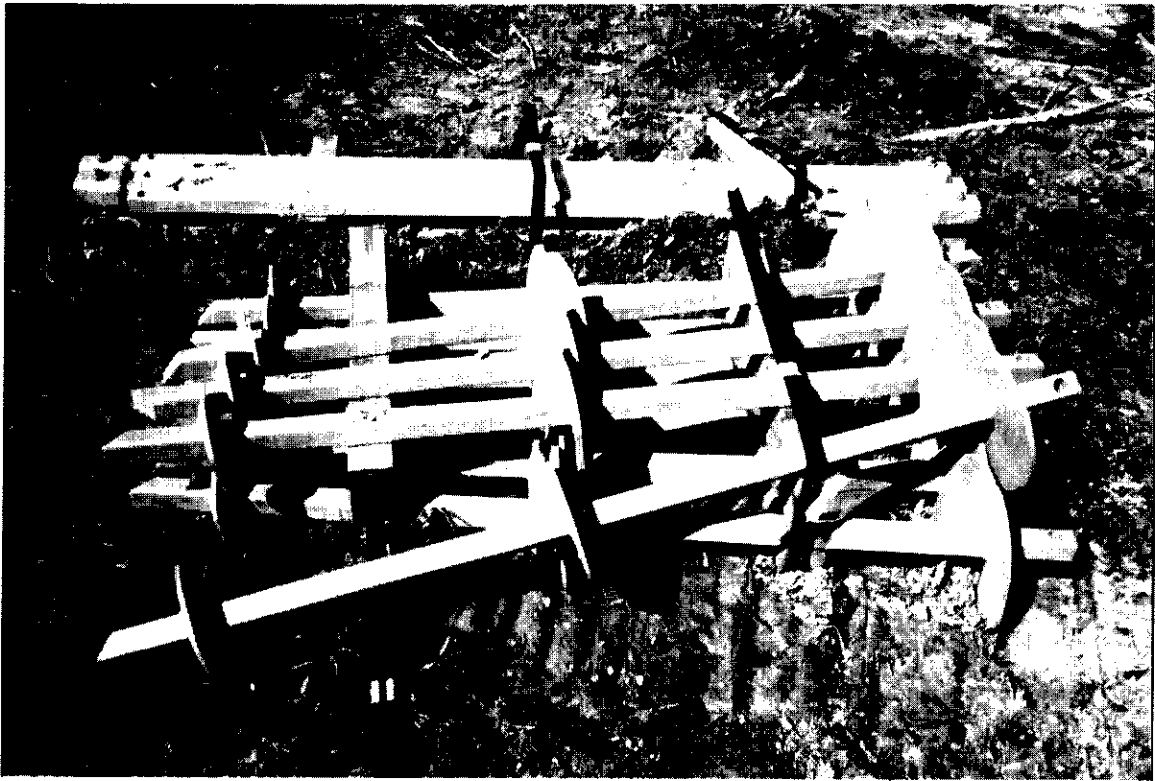
Helical piers for Waterloo Barrier tieback system

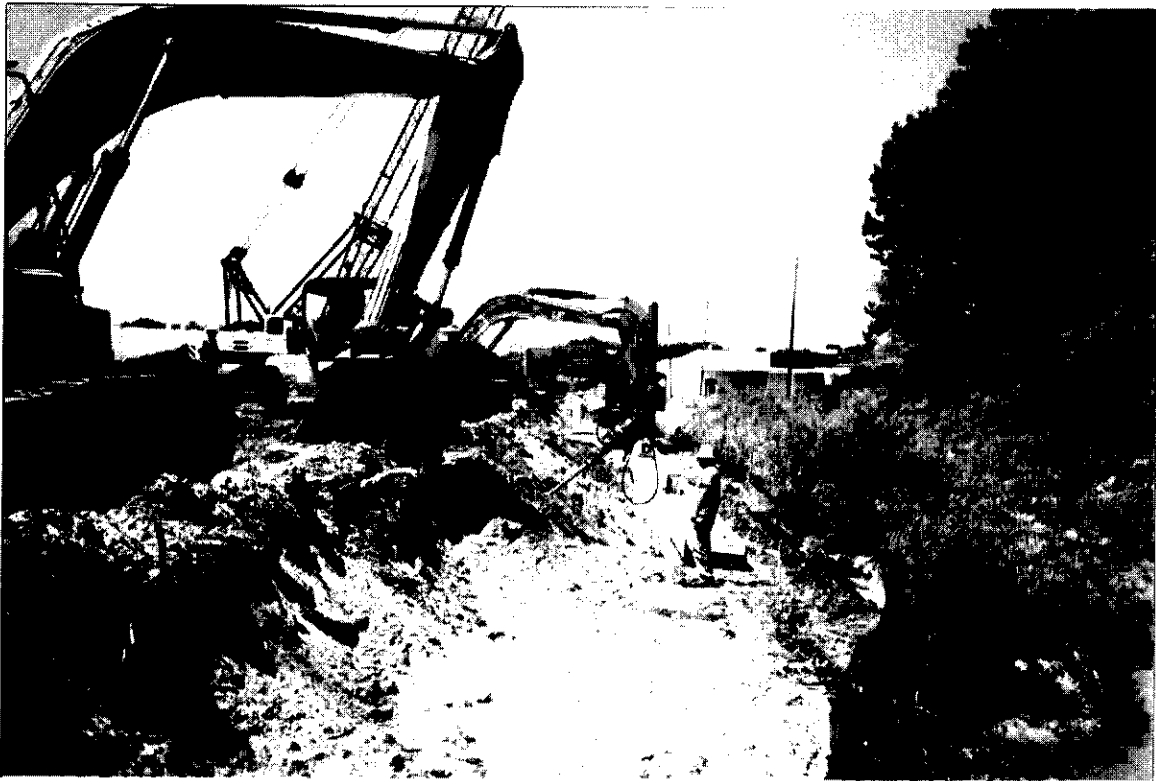
Installation of helical piers

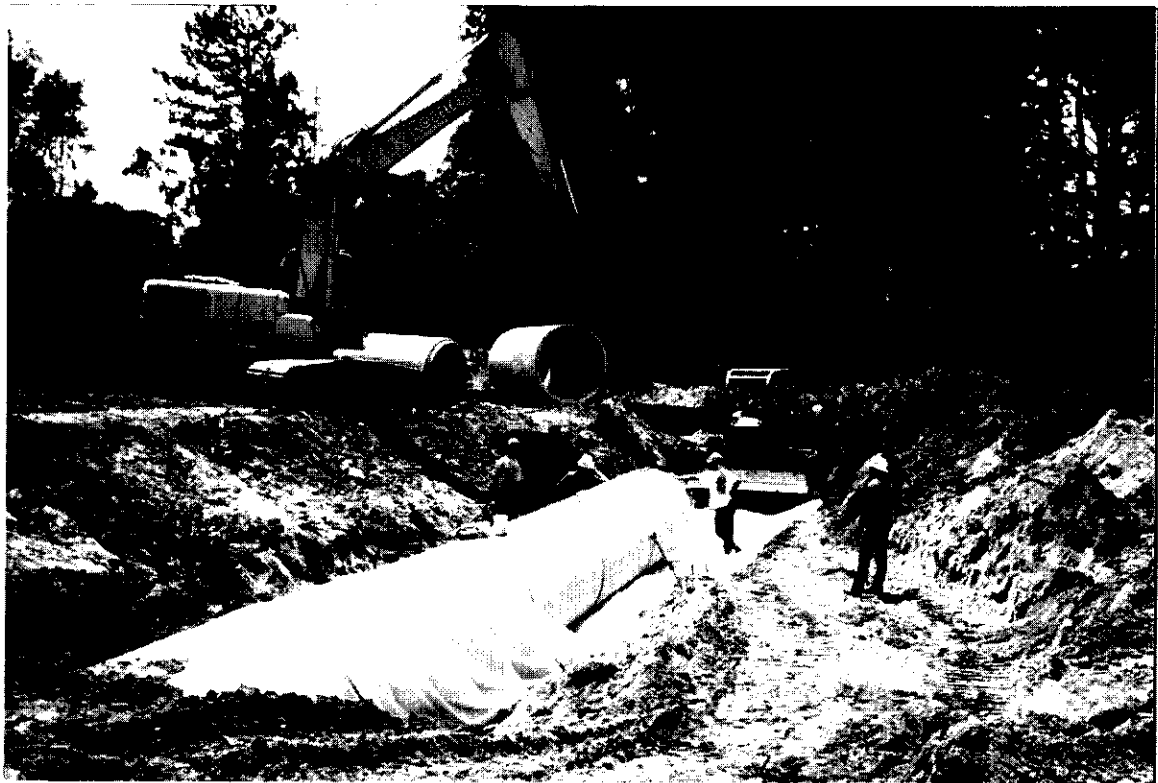
Fill Area culvert installation

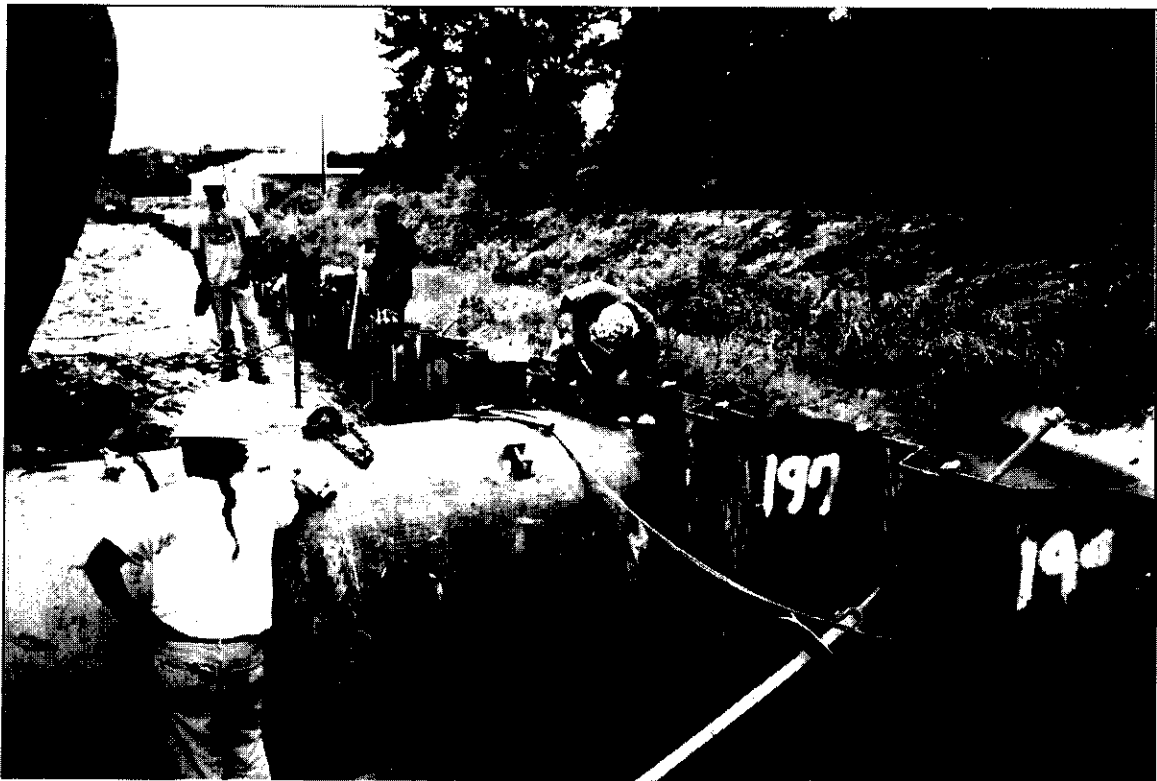
Welding culvert to Waterloo Barrier

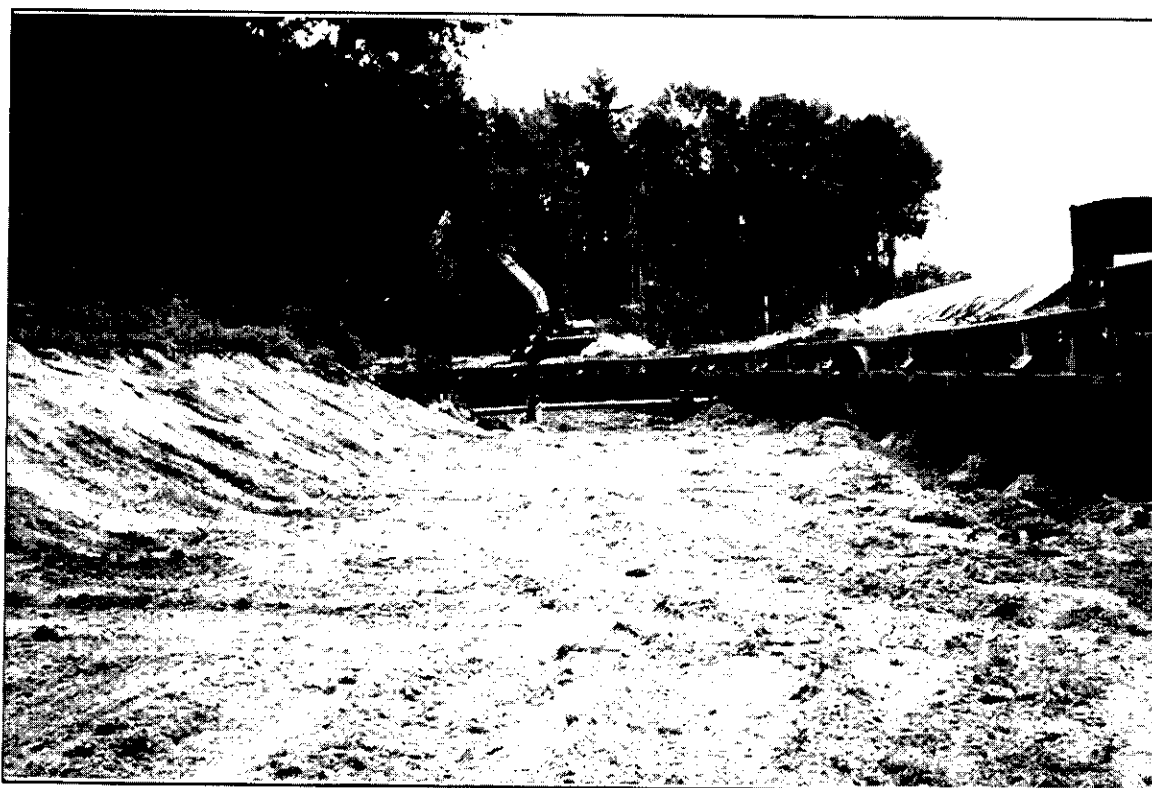
Cleaned and re-graded channel of Gordon's Creek

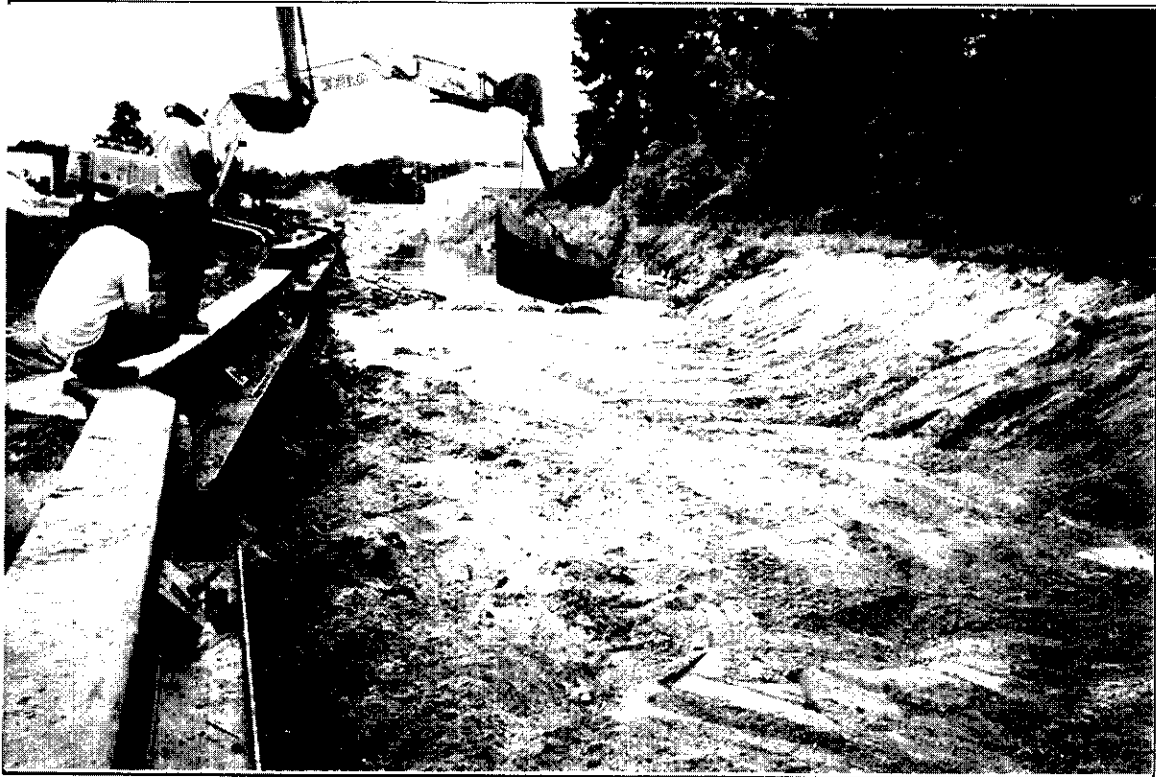
Removal of dam at upstream end of Gordon's Creek
sediment removal area

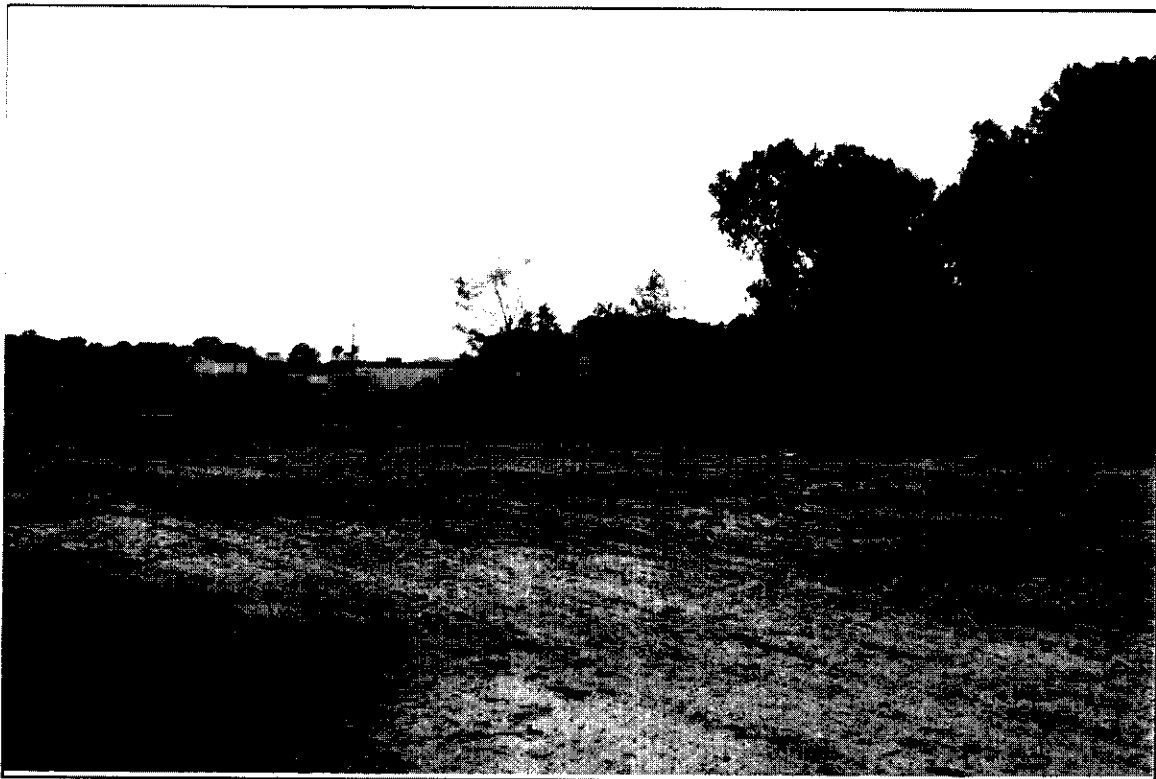
Fill area after placement of geosynthetic clay liner
(GCL) and topsoil

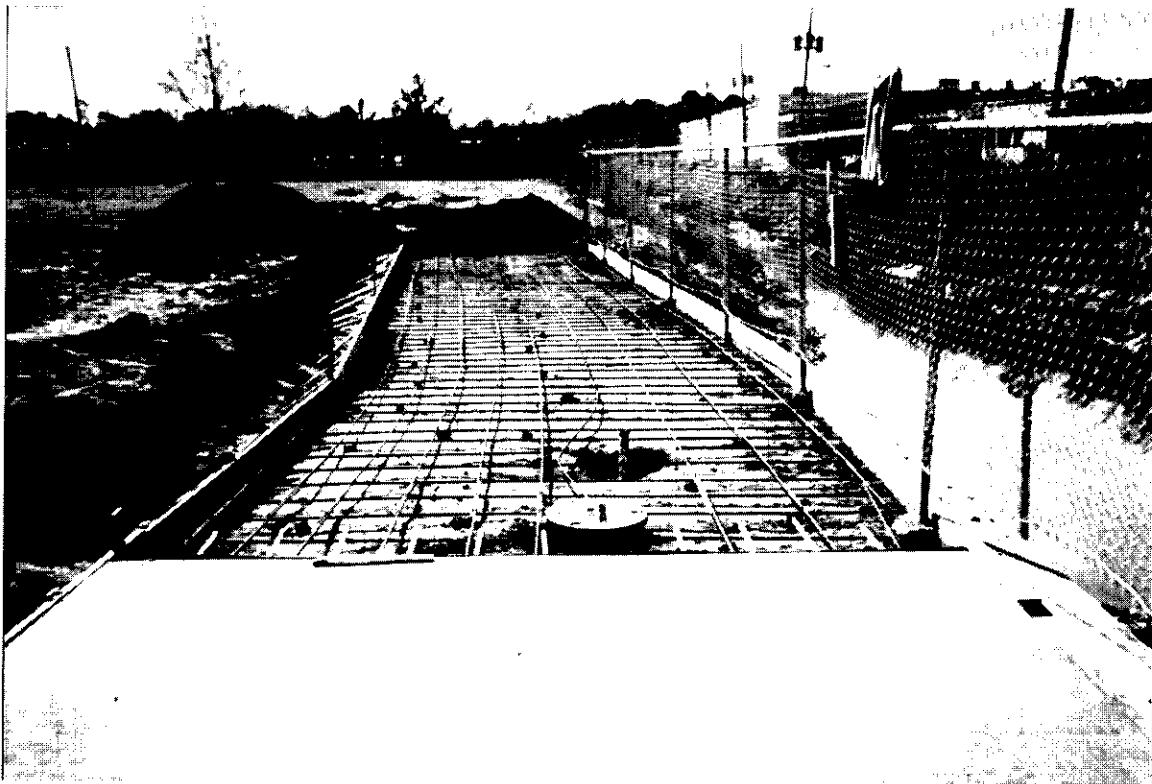
Construction of concrete driveway at top of Waterloo Barrier for recovery and monitoring well access

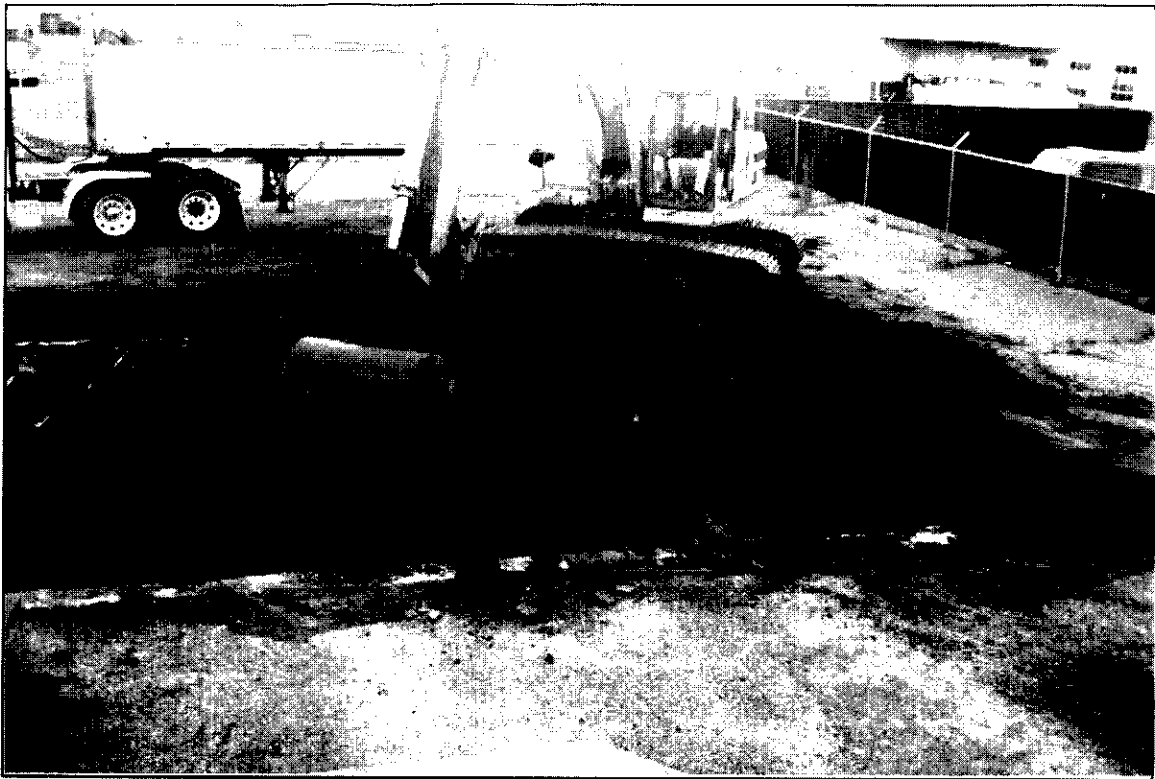
Removal of material from concrete sump in former
Process Area

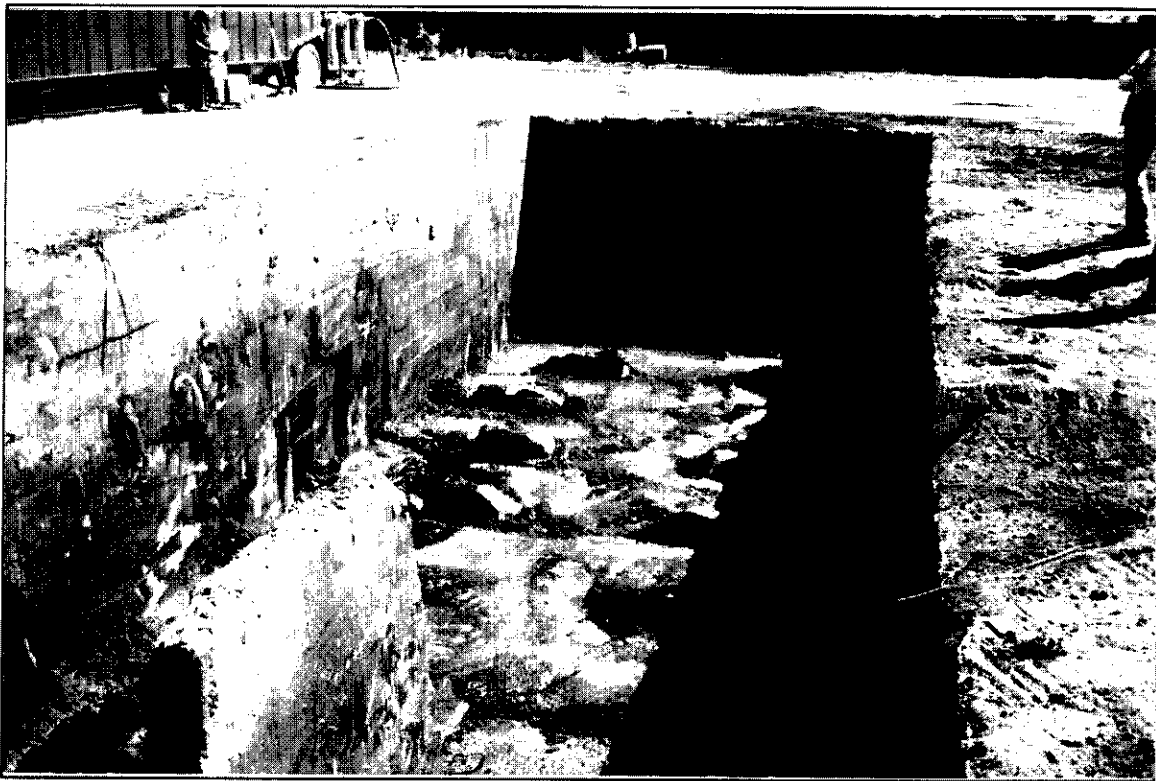
Cleaned out sump with concrete saddles at base

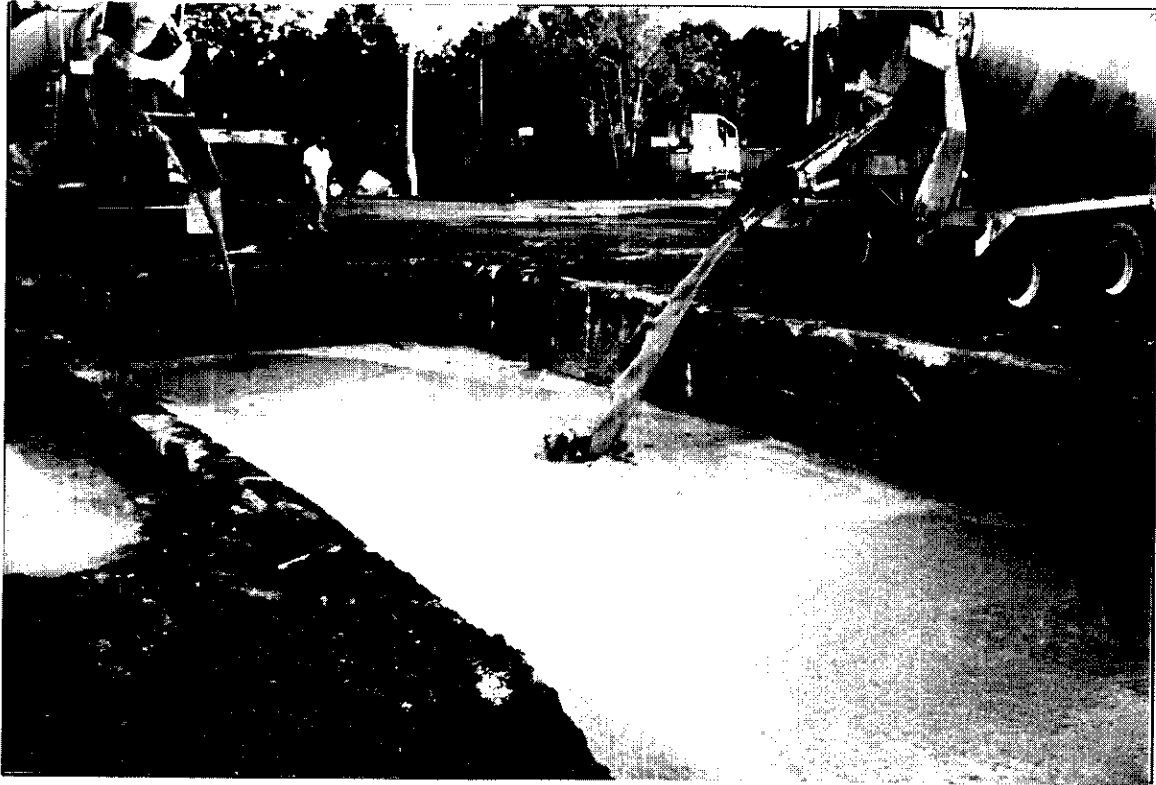
Filling concrete sump with flowable fill

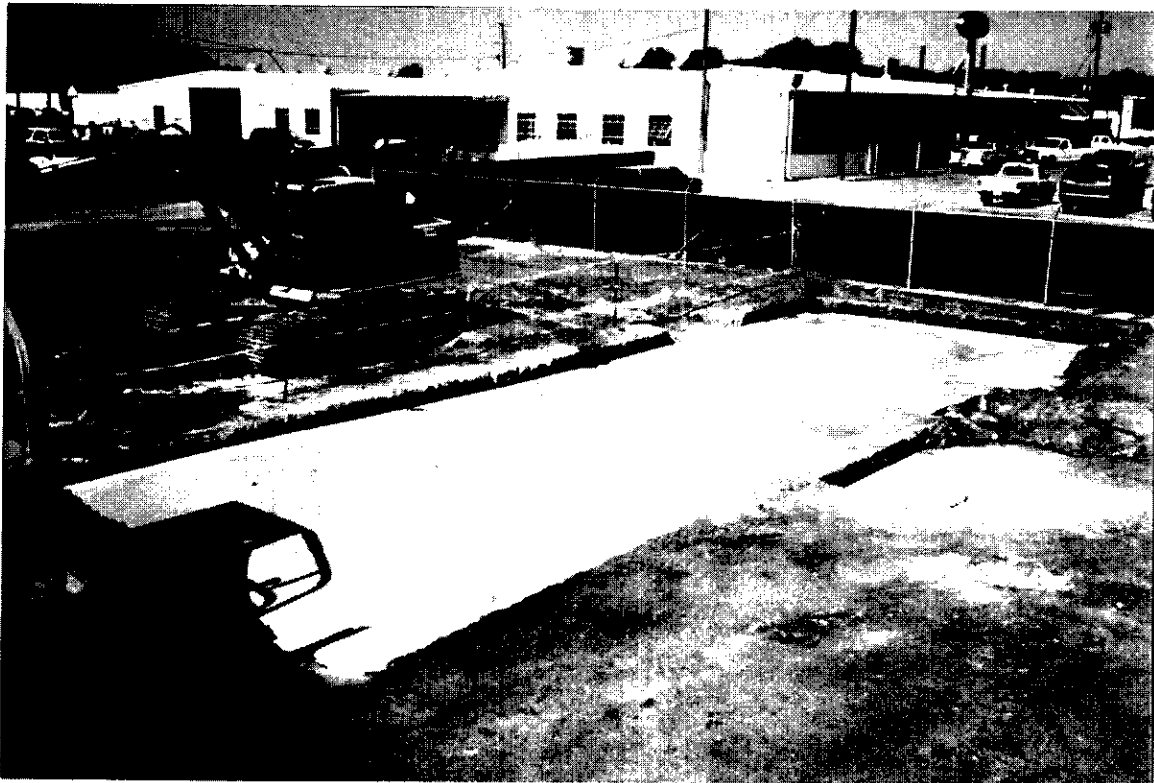
Concrete sump filled with flowable fill

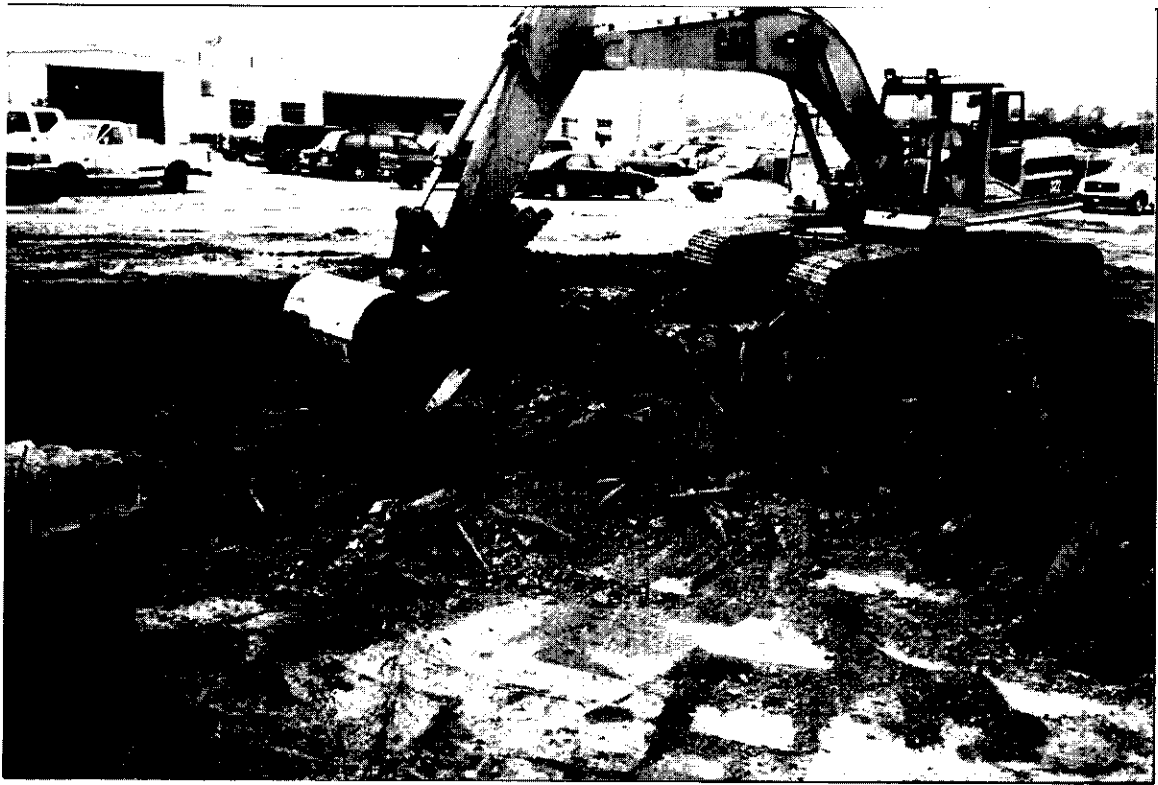
Excavation of wooden substructure

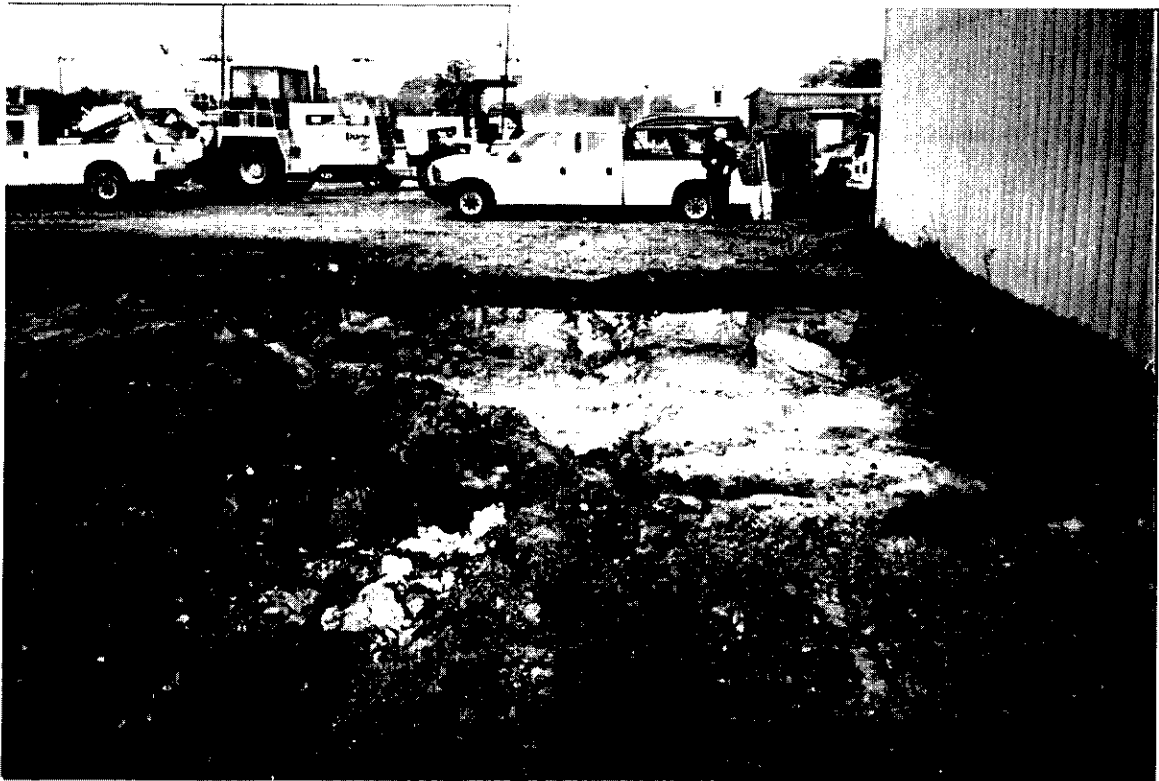
Removal of structurally incompetent material beneath
base failures in former Process Area

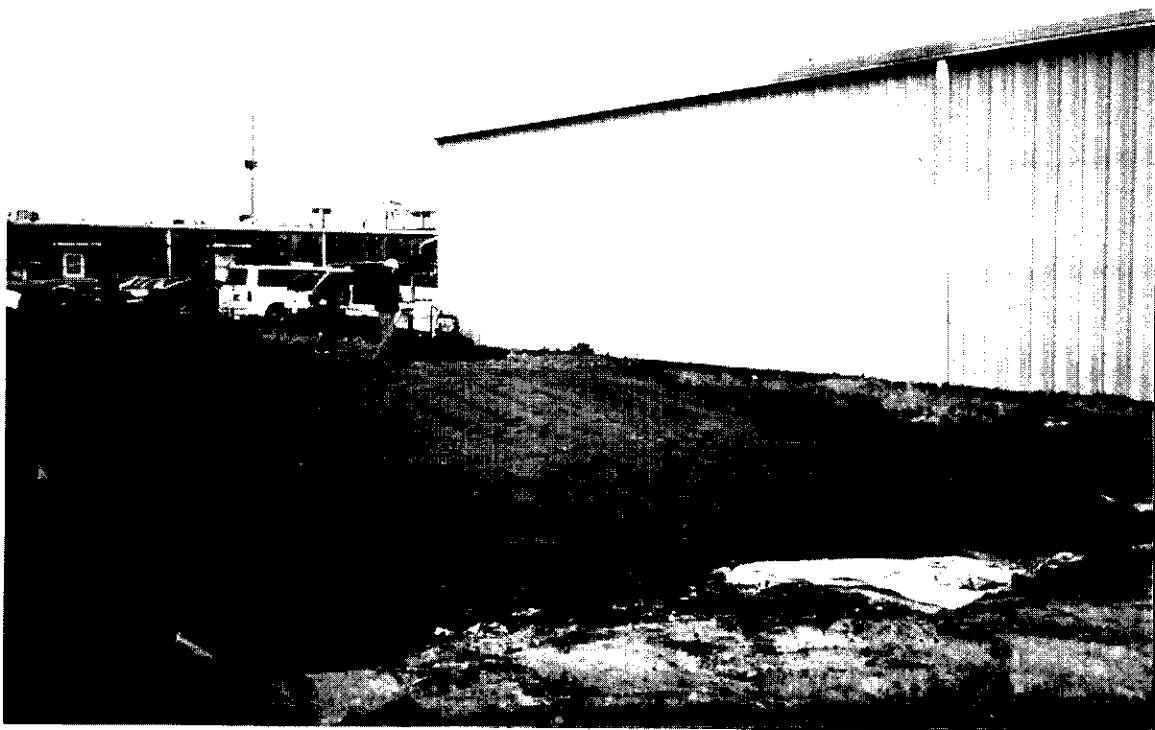
Backfilling and compaction of fill in base failure excavations

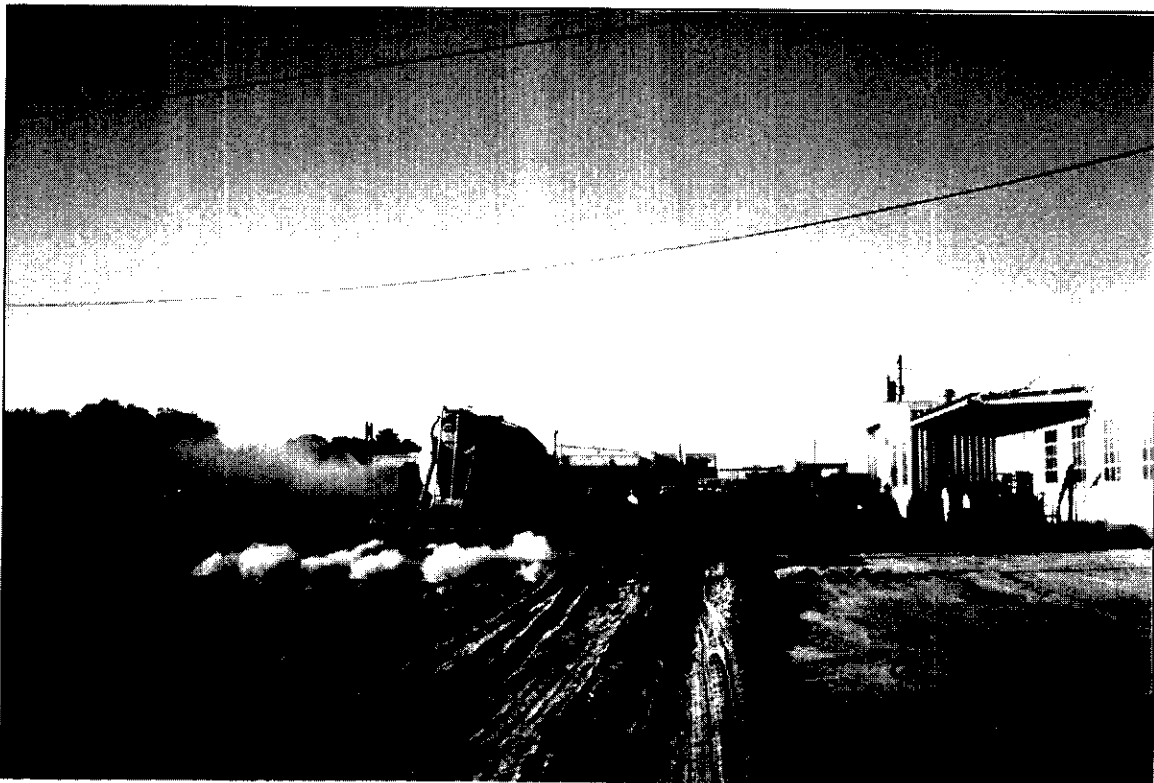
Application and mixing of stabilizing agent (soil cement)

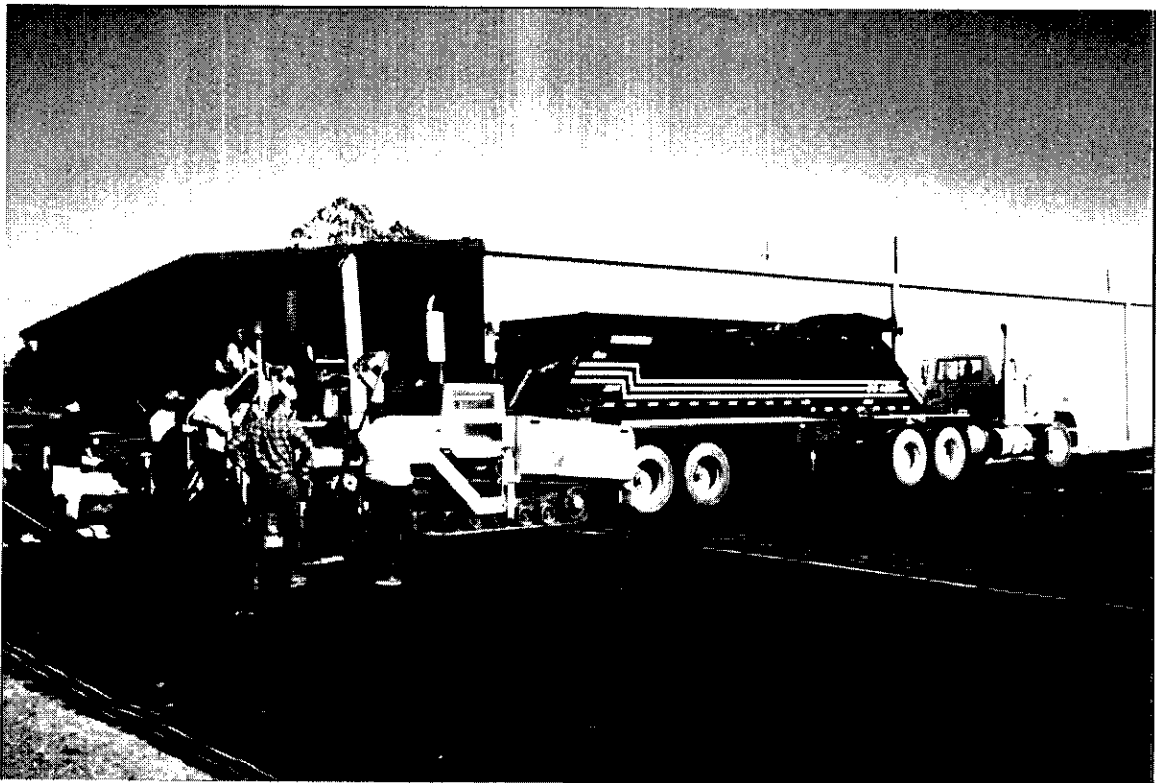
Installation of composite liner and application of tack coat

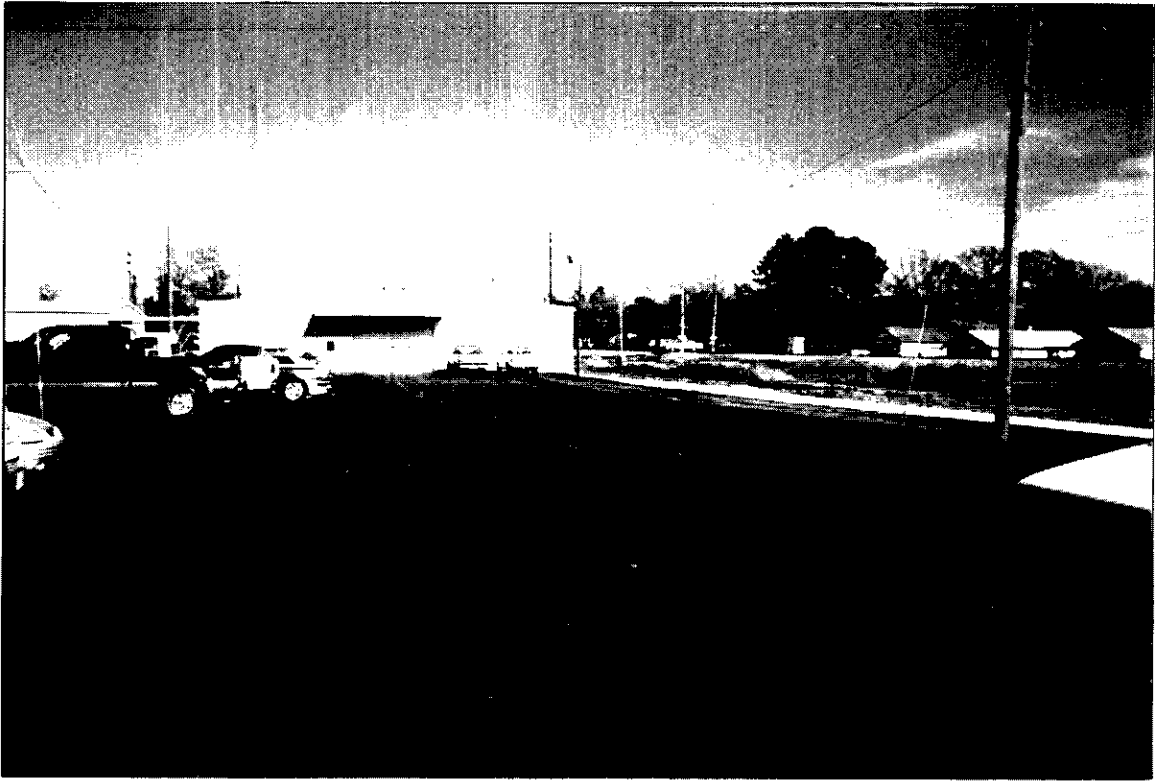
Freshly-paved asphalt Courtesy Ford parking lot

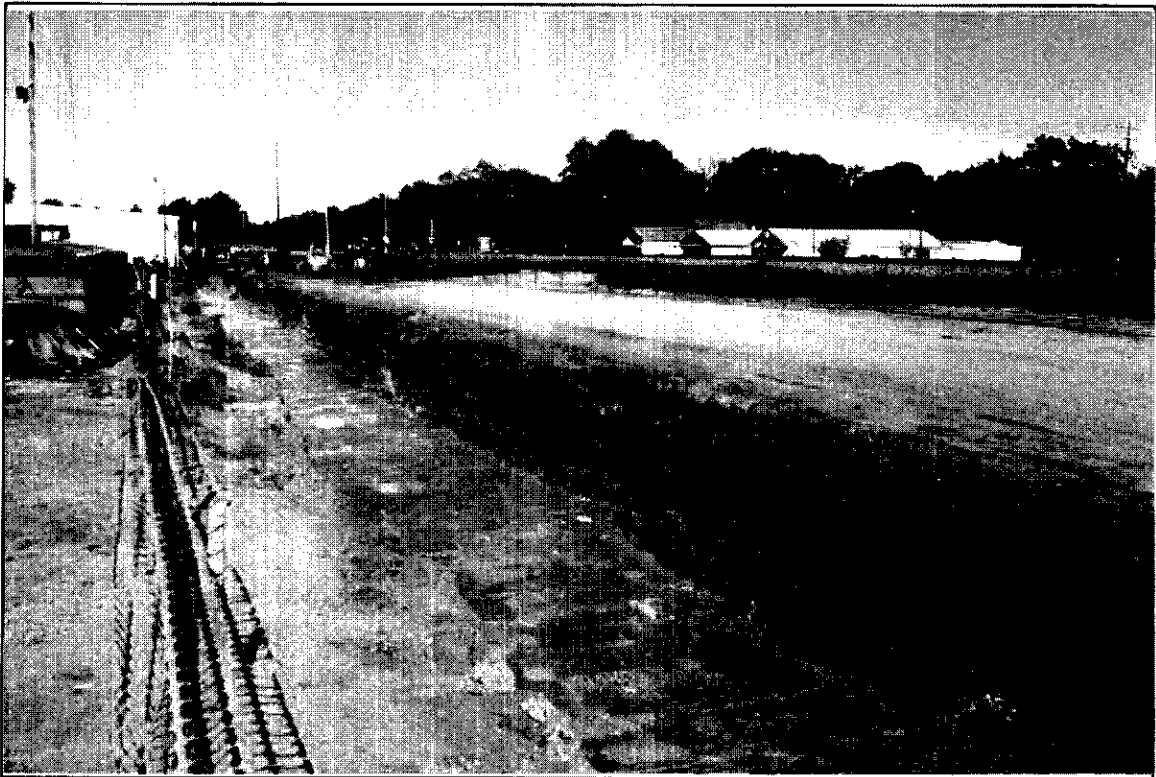
Over-excavation of Courtesy Ford ditch

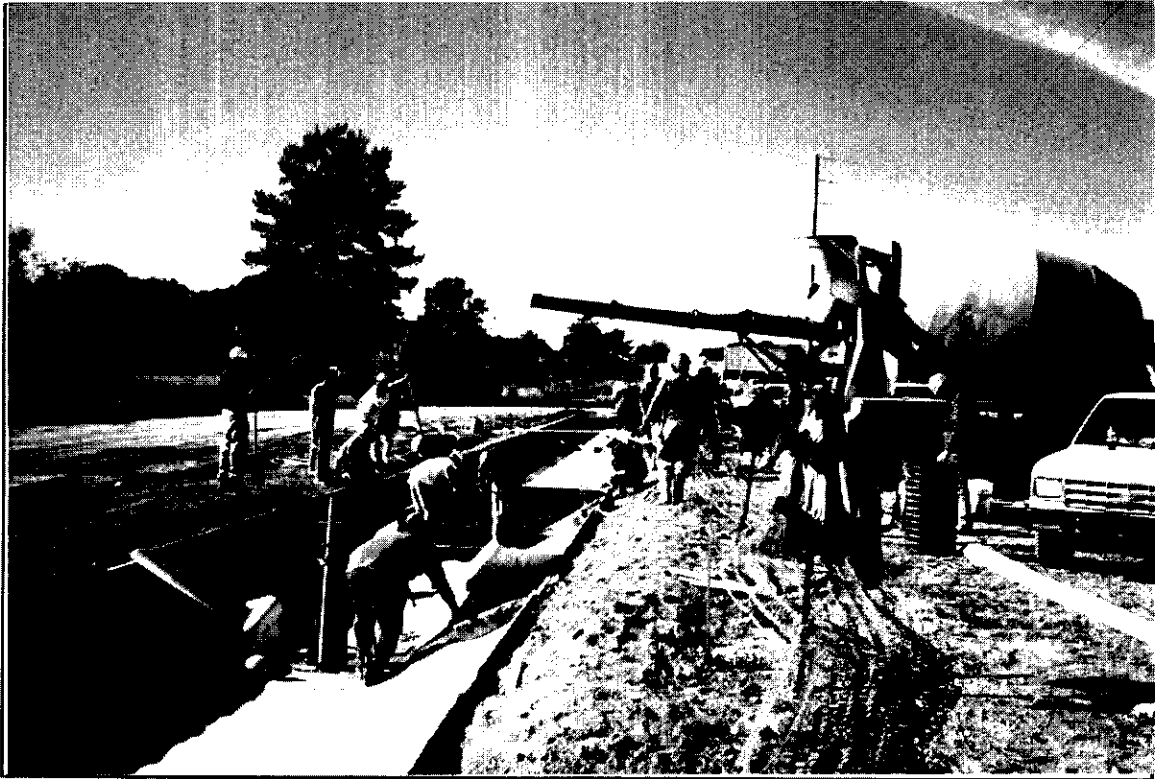
Construction of concrete-lined ditch on top of composite liner

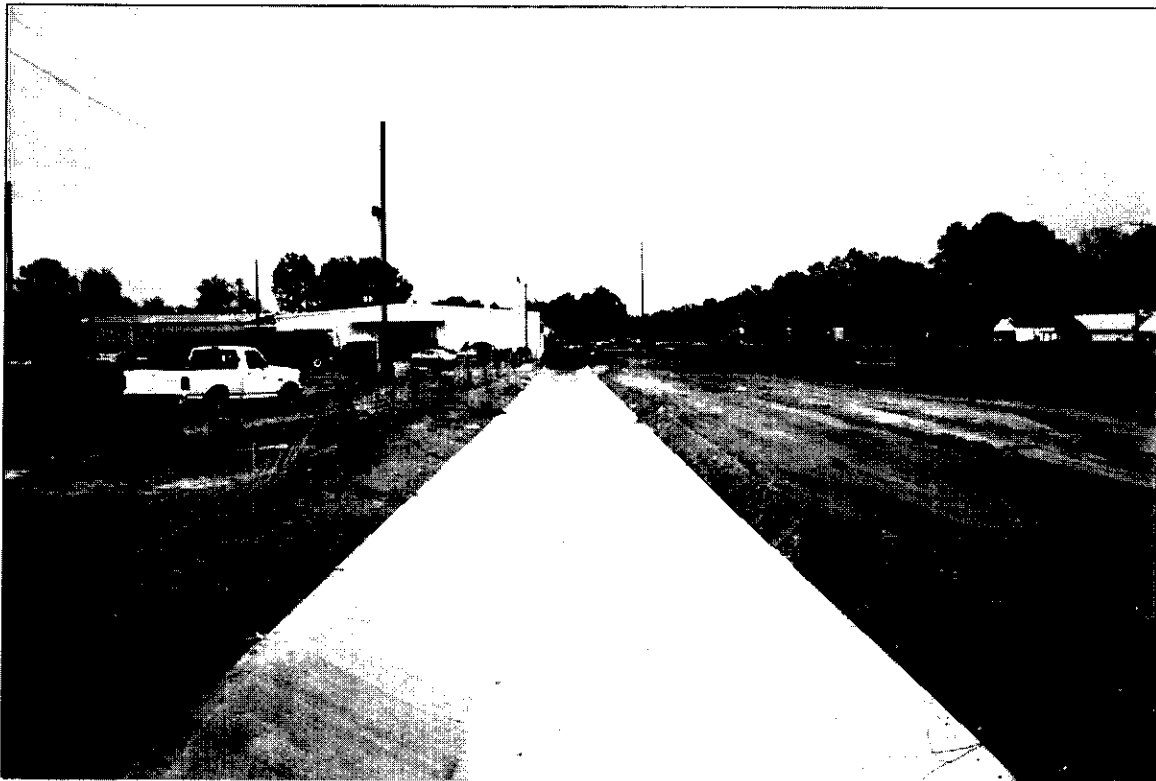
Completed concrete-lined ditch

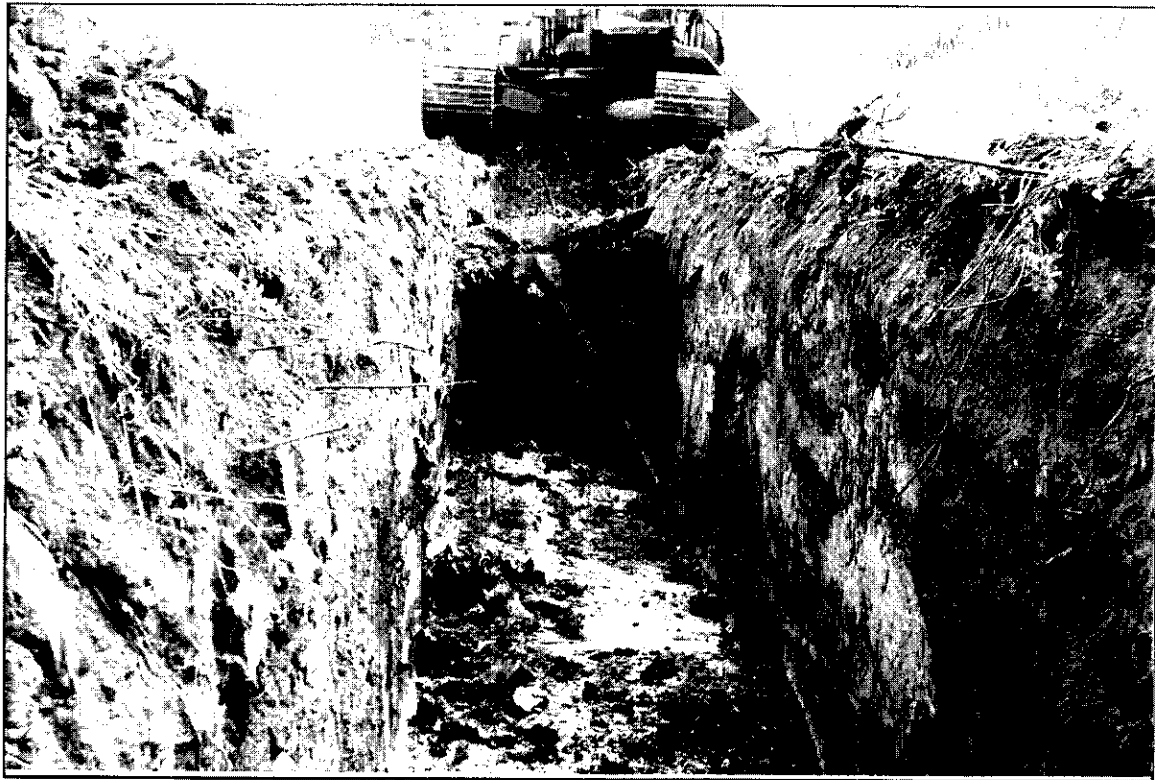
Excavation and removal of wooden trough
