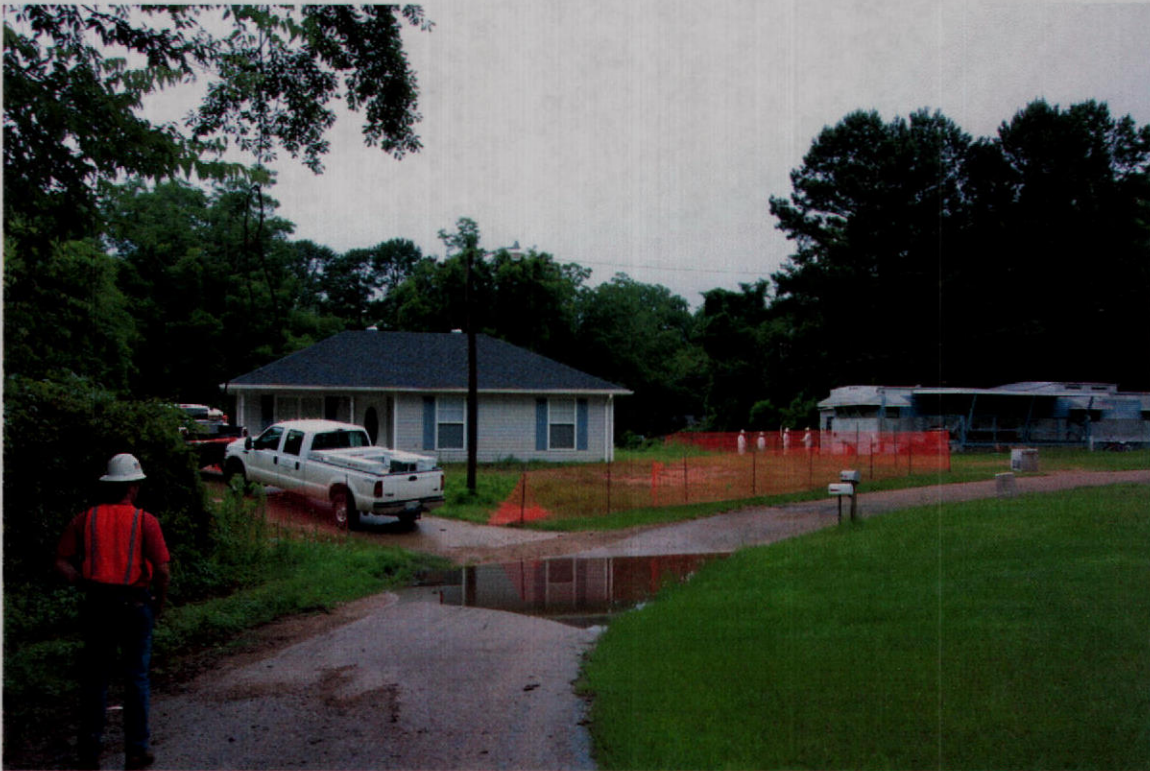
PHOTO 1 – View of the 112 and 114 Brent Street MSL properties looking from the southeast. Photo was taken prior to the installation of the protective liner.

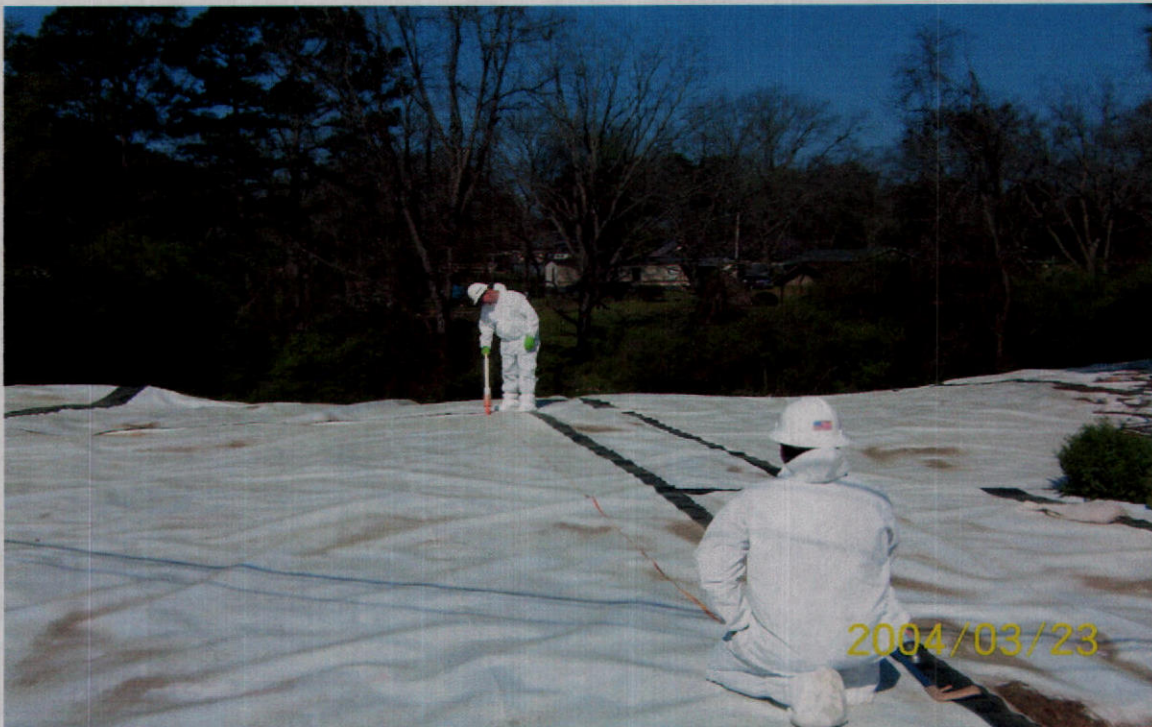
PHOTO 3 – Schnabel Engineering personnel laying out the X-Y survey grid for the geophysical study. Photo was taken looking east to west on the 114 Brent Street MSL property.

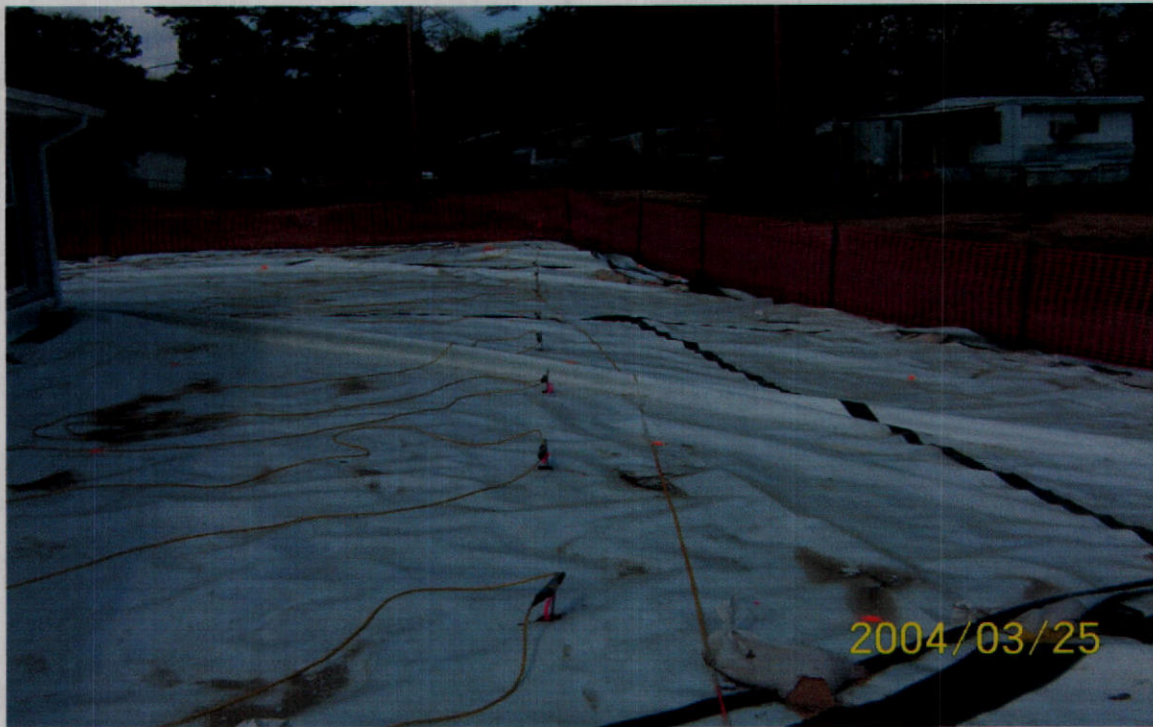
PHOTO 5 – Linear electrode array for the resistivity study portion of the geophysical survey. Photo was taken from the driveway to the house looking south to north.

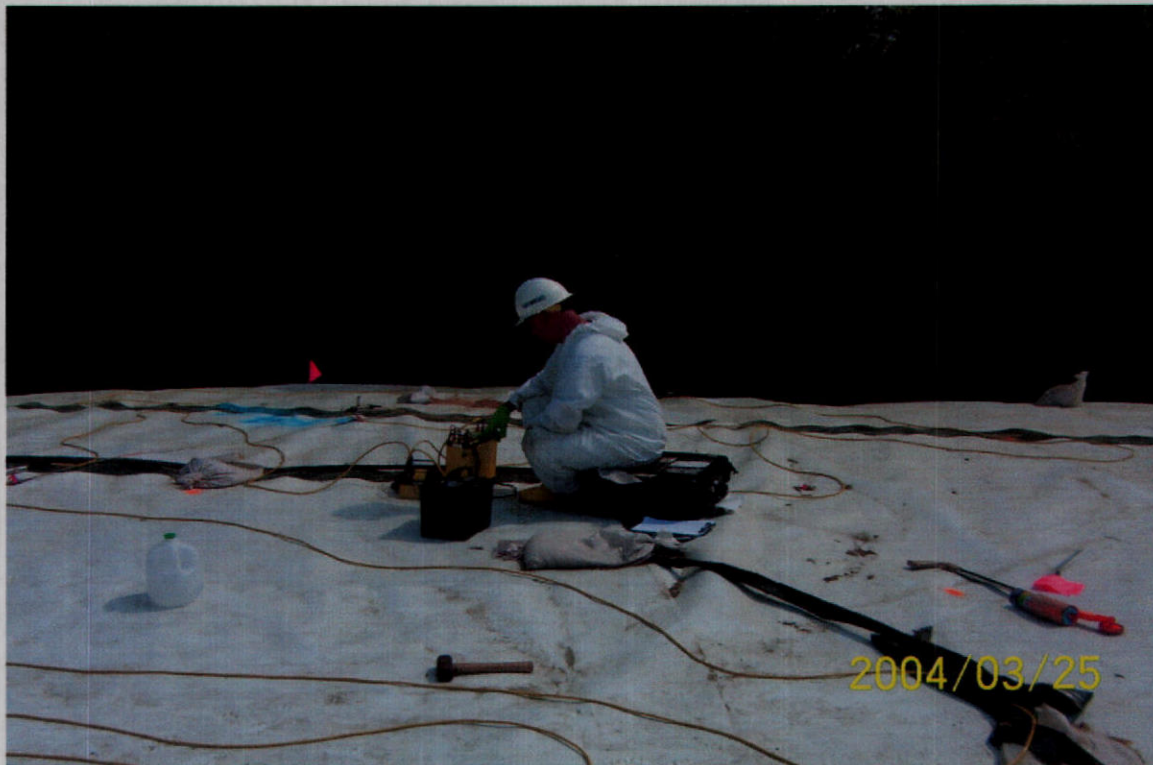
PHOTO 6 – Data gathering for the resistivity study. Photo was taken looking north to south at the southern slope of the fill area at 114 Brent Street.

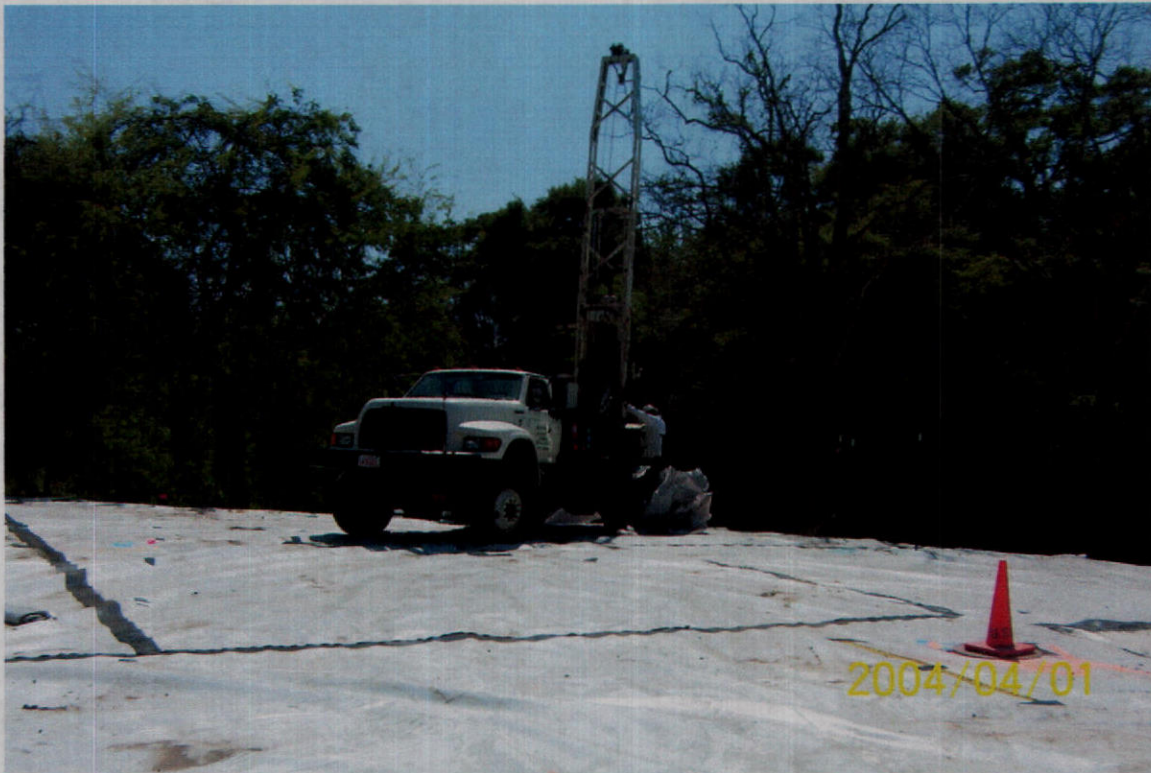
PHOTO 7 – Drillers positioning hollow stem auger drill rig on the western slope of the fill material on the 114 Brent Street MSL property.

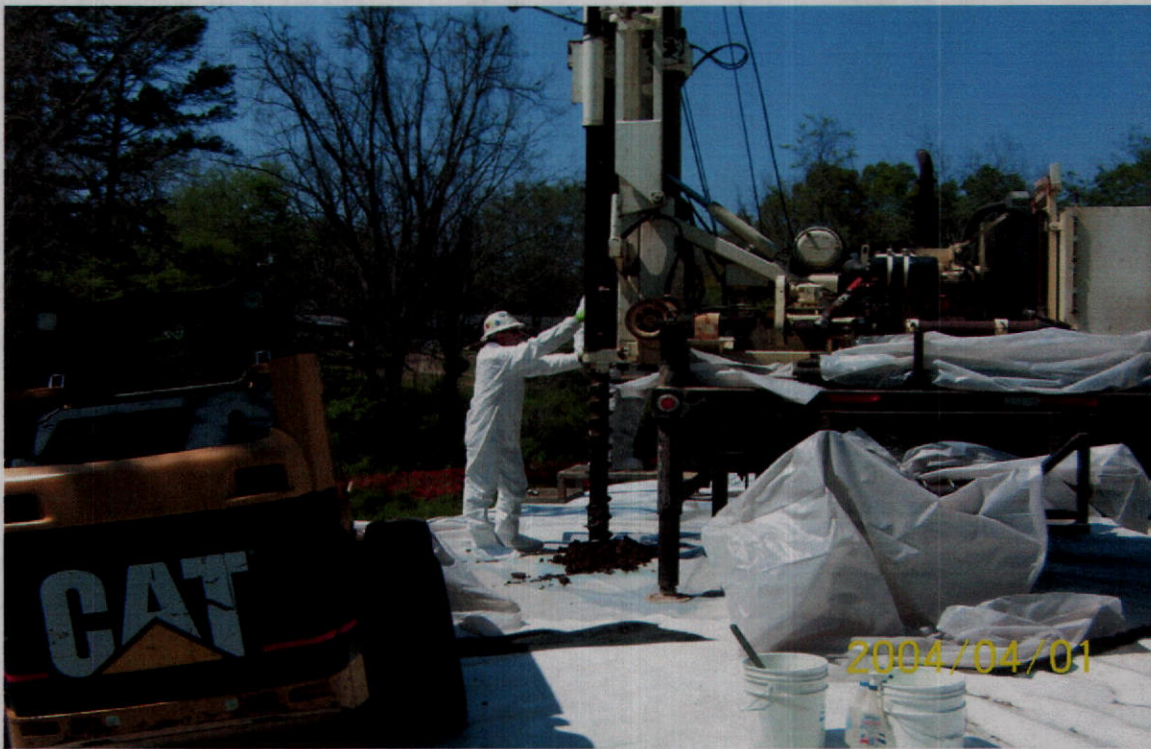
PHOTO 8 – Installation of hollow stem auger boring on the western slope of the fill area at 114 Brent Street. Boring locations were selected based on results of the geophysical survey and were placed in areas identified as containing minimal quantities of subsurface debris.

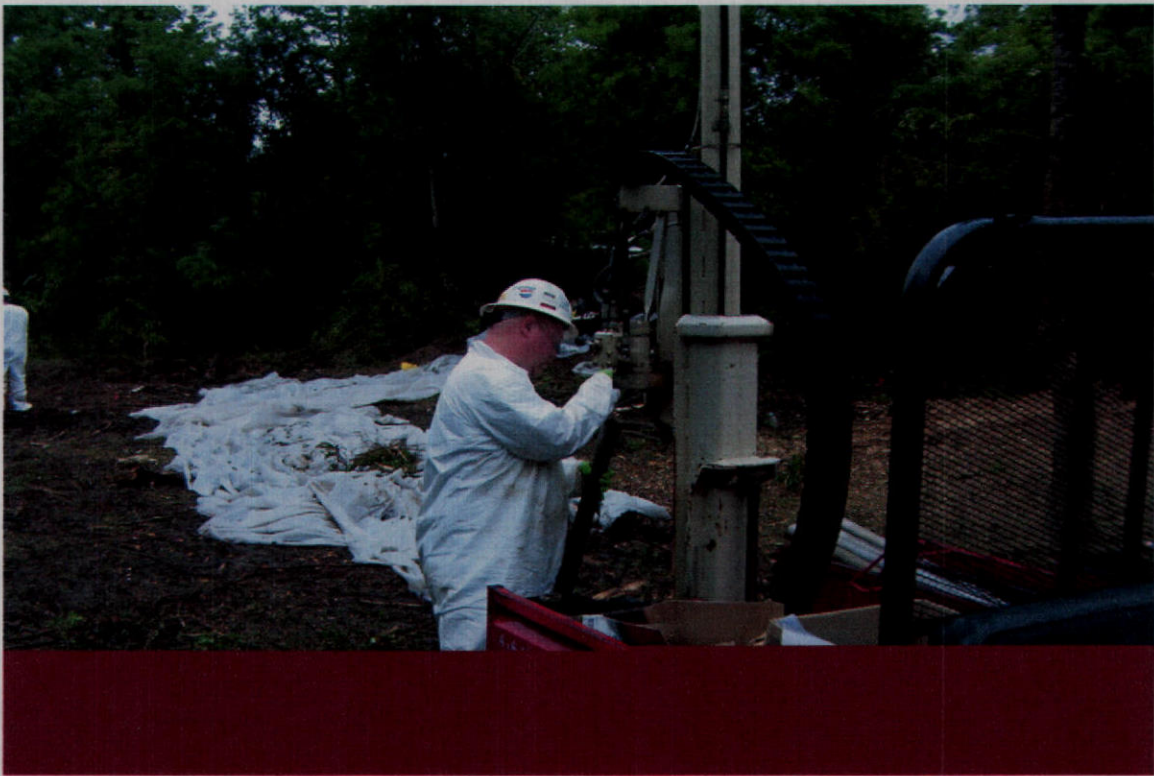
PHOTO 9 – Collection of soil samples in the drainage channel to the west of the fill area on the MSL properties using direct push methodology. Photo was taken in the drainage ditch near the toe of the western slope of the fill area at 114 Brent Street.

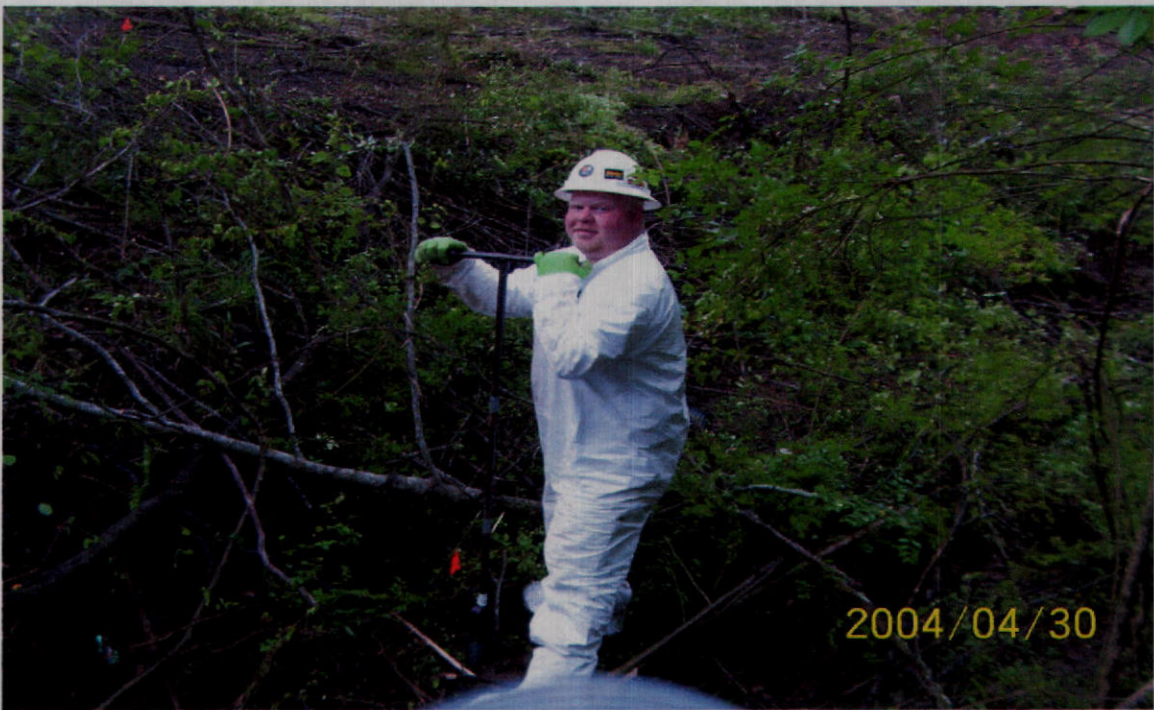
PHOTO 10 – Collection of soil samples using a hand auger. This sample was collected in the drainage channel on the Raymond Lamar, Sr. property at the mouth of the drainage ditch in an area immediately upgradient of the channel outfall into Turkey Creek.

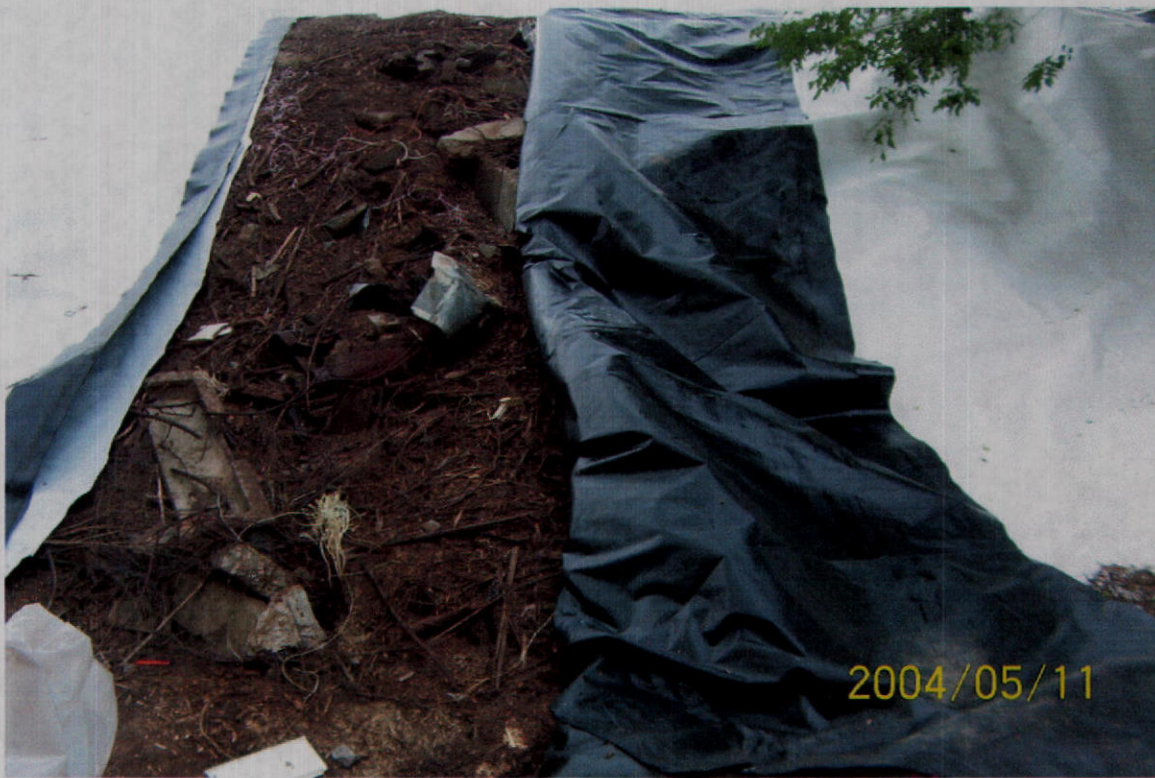
PHOTO 11 – A view of Test Pit #2 on the west side of the fill area prior to excavation. Test pits were placed in areas containing significant quantities of metallic and non-metallic debris. Photo was taken from the toe of the slope.

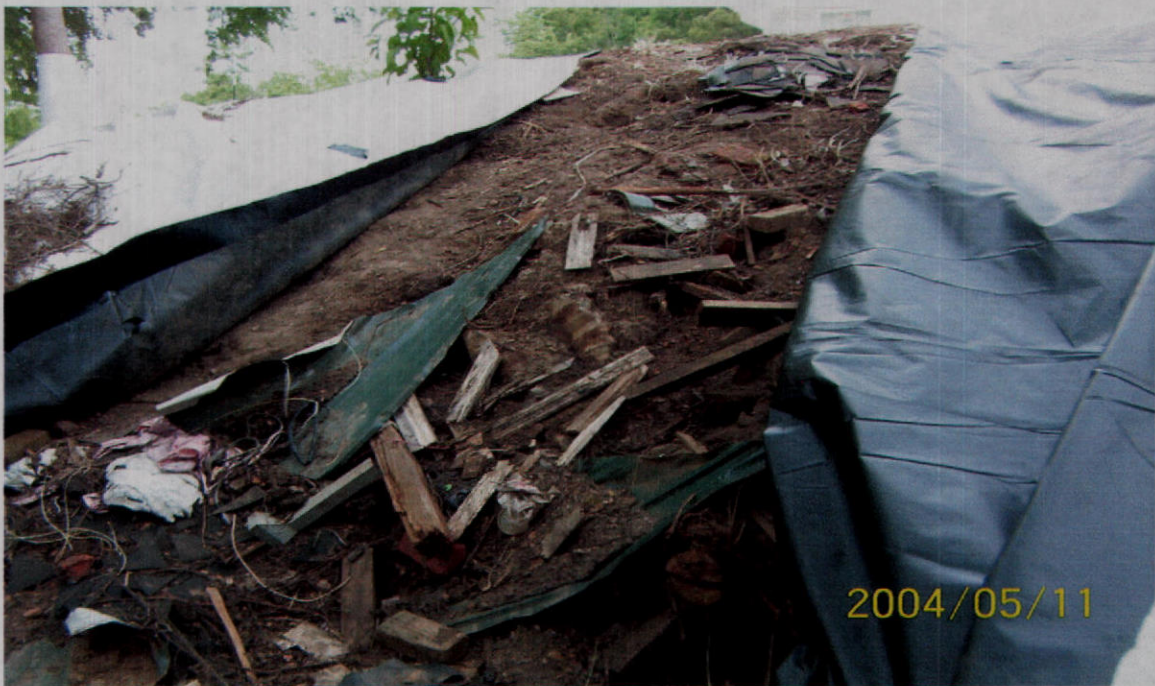
PHOTO 12 – View of Test Pit #4 on the southern slope of the fill area prior to excavation. Photo was taken at the toe of the slope.

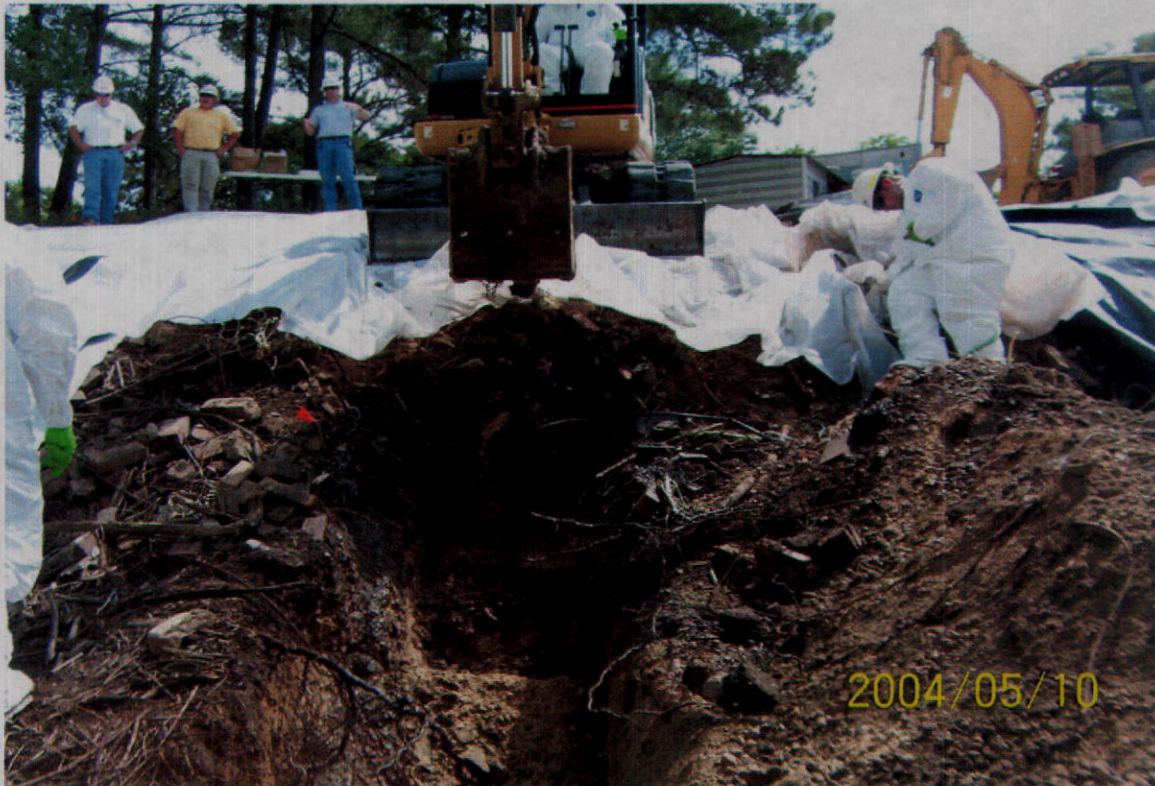
PHOTO 13 – Excavation of Test Pit #2 on the northwestern slope of the fill area. Photo was taken at the toe of the slope looking west to east.

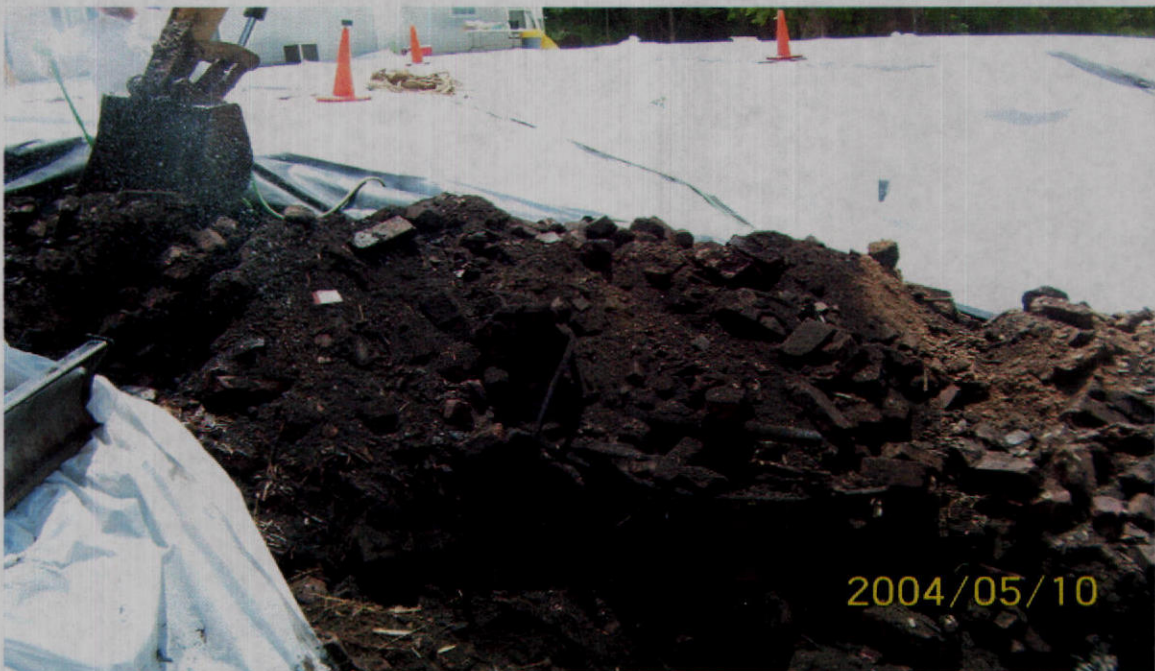
PHOTO 14 – View of the stockpile of typical metallic and non-metallic debris encountered during this phase of the assessment. This material was excavated from Test Pit #5 on the southeastern slope of the fill area. Photo was taken prior to backfilling the test pit.

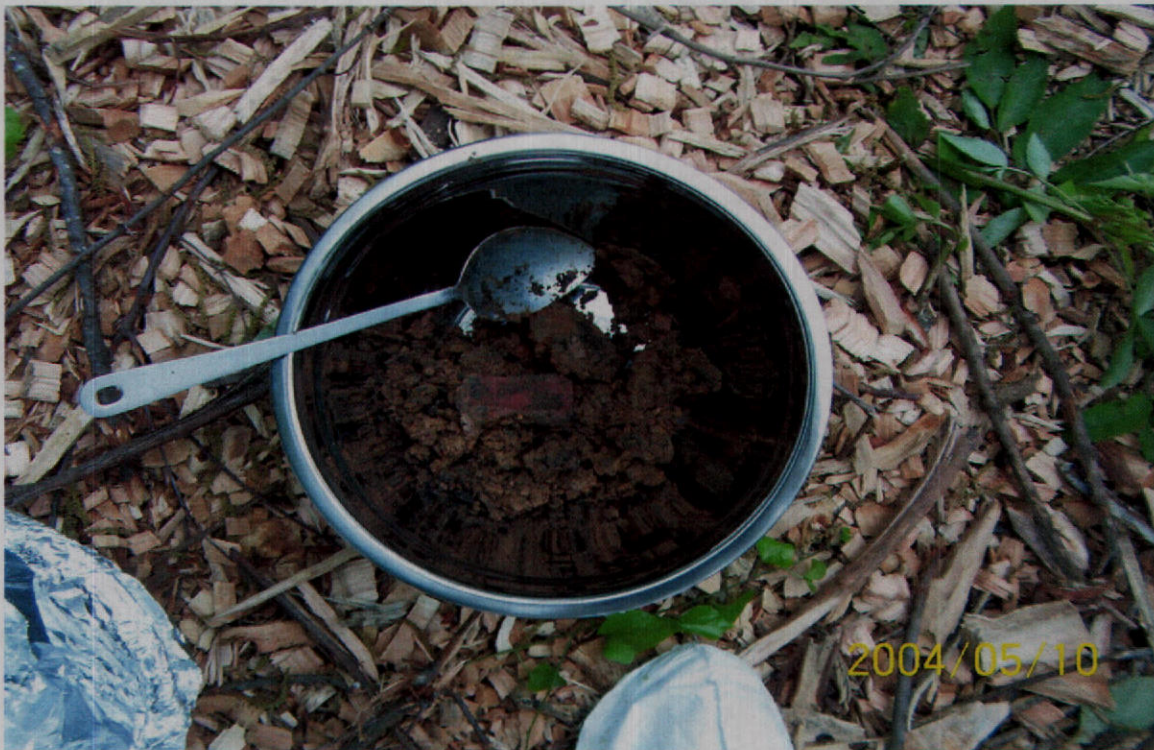
PHOTO 15 – A view of a typical sample taken from the trackhoe bucket during installation of the test pits. Note brick debris and discolored soil.

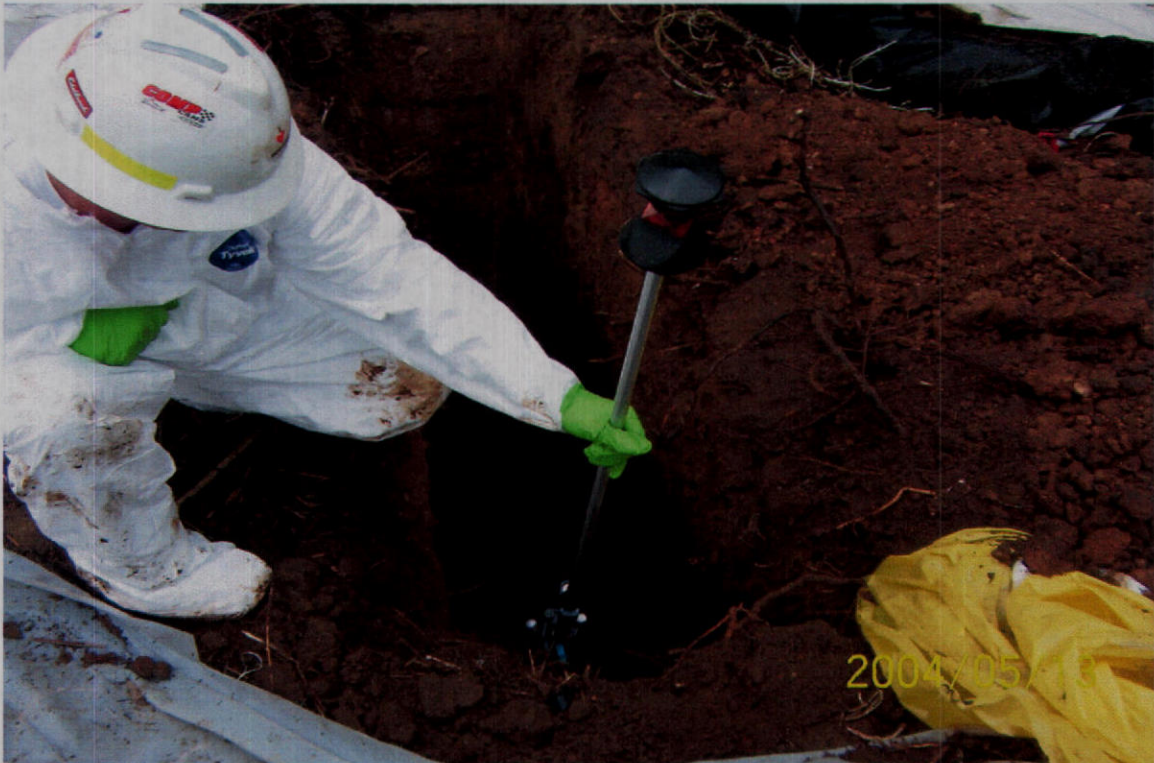
PHOTO 16 – A view of the surveyor gathering sample point coordinate data during installation of Test Pit #5. Test Pit #5 was located on the southeastern slope of the fill area.

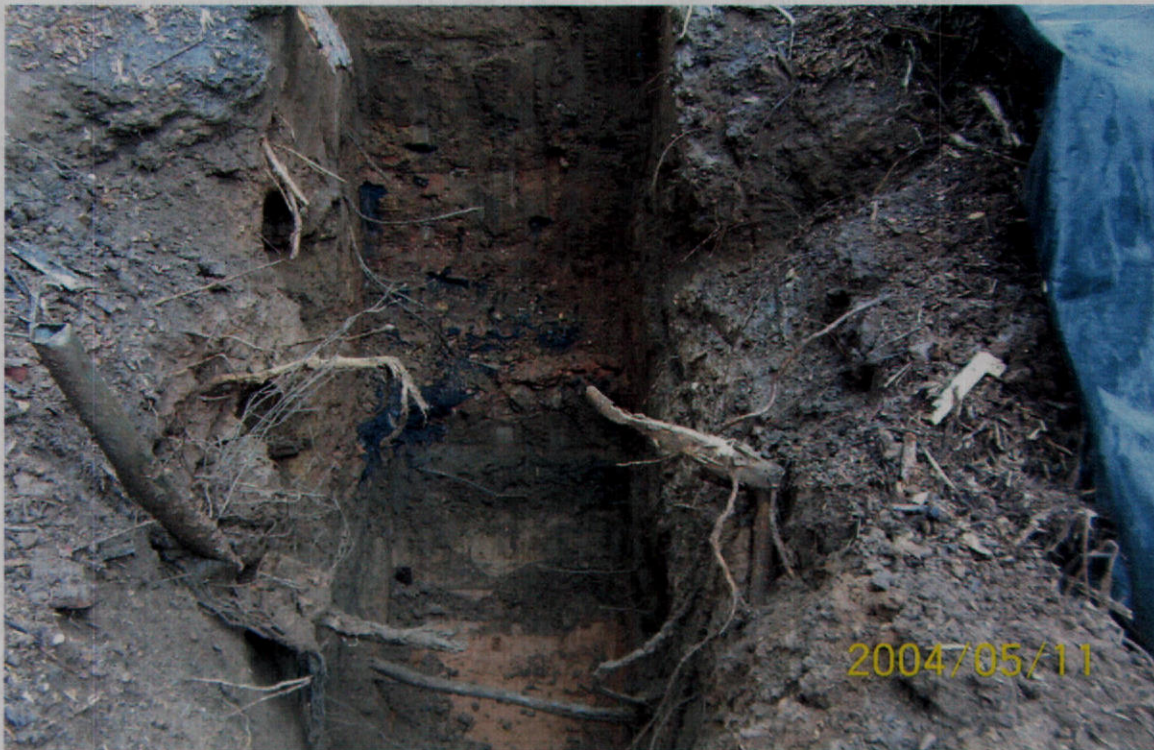
PHOTO 17 – A view of a completed test pit. Note transition zone between fill material and native red, sandy soils at the bottom of the pit.

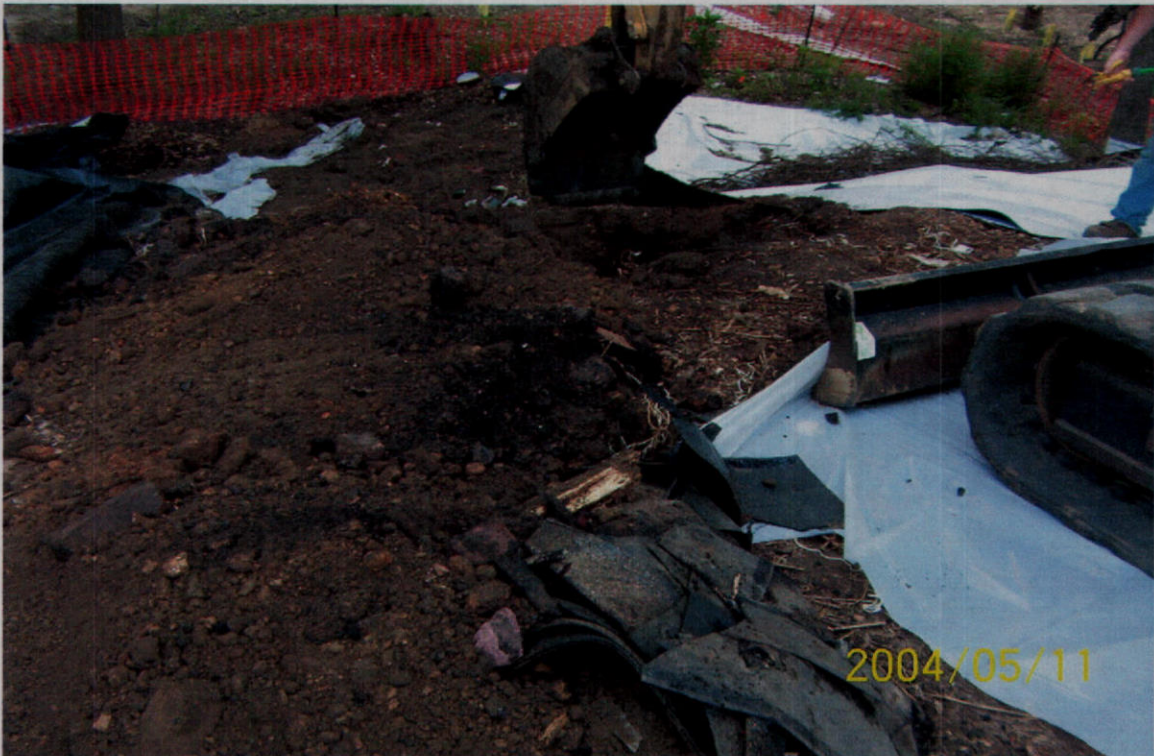
PHOTO 18 – A view of Test Pit #4 from the top of the southern slope after backfilling. After backfilling activities were completed, the HDPE liner was placed back over the excavated area and thermally sealed.
