SITE REMEDIATION REPORT

**Frazier Property
405 Lee Avenue
Crystal Springs, Mississippi**

BorgWarner Inc.

February 2002

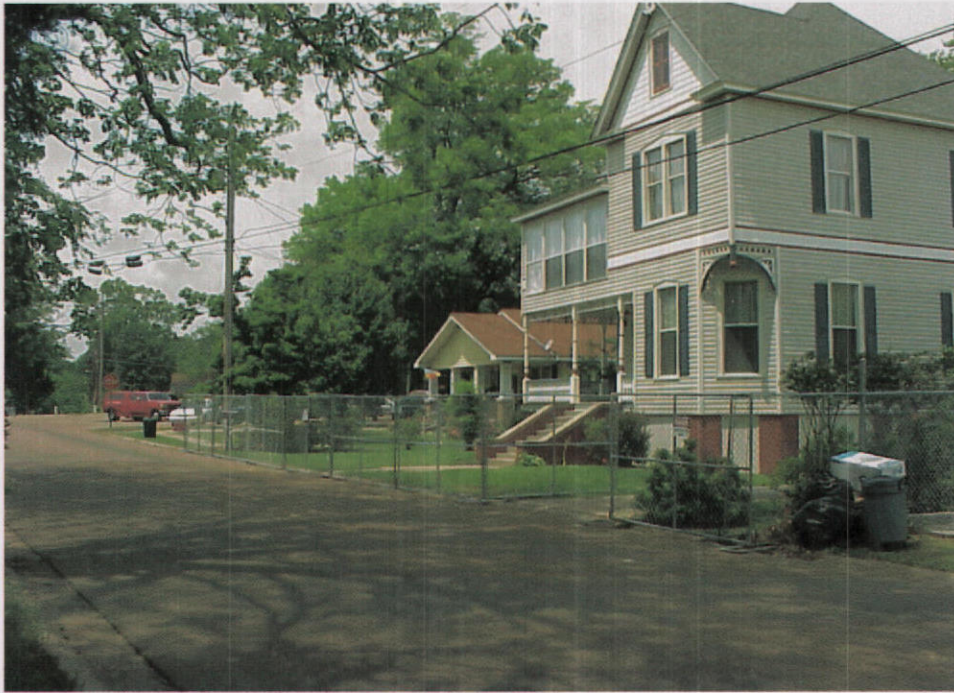
Photo 1 – View of the front of the Frazier property showing conditions prior to remediation activities. The fence is a temporary installation for public access control.

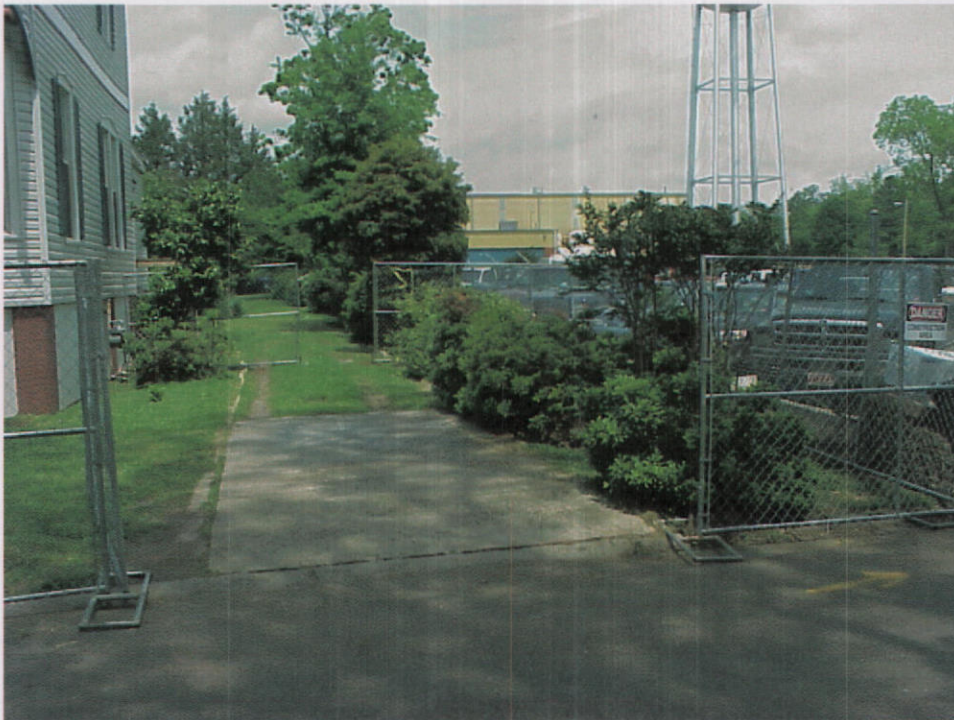
Photo 2 – The Frazier driveway prior to remedial activities. The temporary fence is shown in this view. This view is looking north from Lee Avenue.

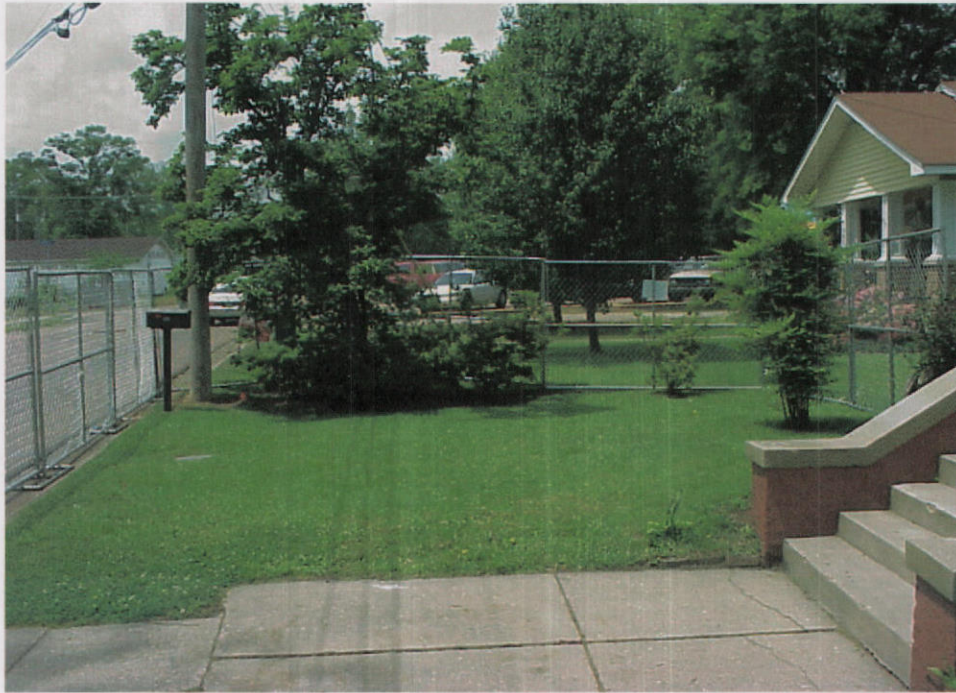
Photo 3 – View of the Frazier front yard prior to remediation. This view is looking west with Lee Avenue to the left side of the photo.

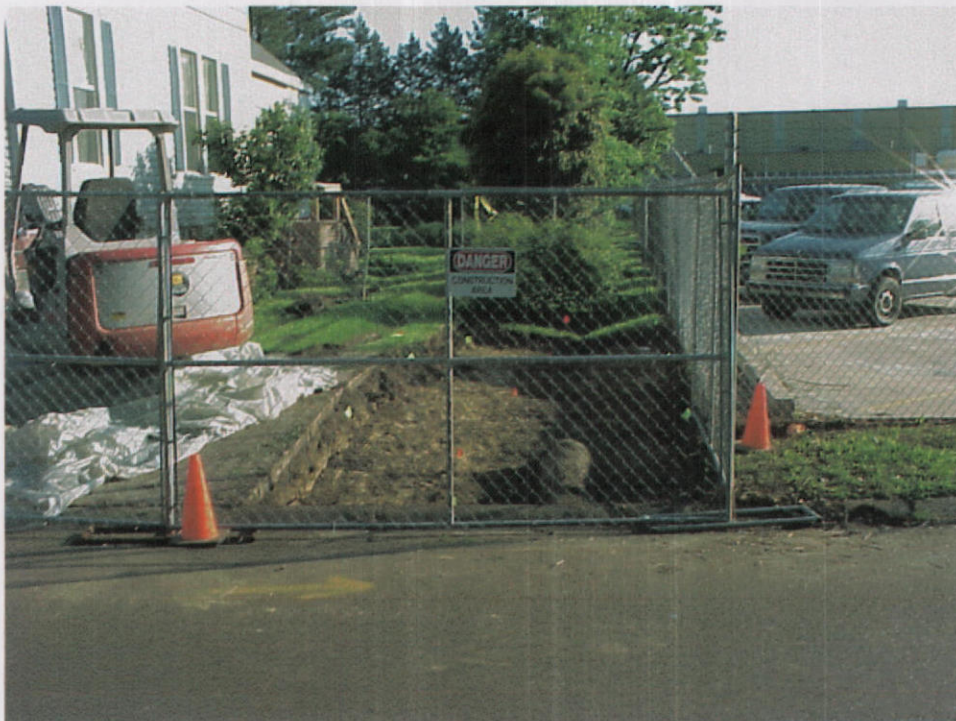
Photo 4 – Excavation of the hedgerow east of the Frazier driveway.

Some of the soil containing concentrations of PCBs in excess of 1.0 mg/kg was located around the roots of a bush located east of the house near the Frazier-Kuhlman property line. Impacted soil was removed from around bush's roots using an "Air-Shovel™" pressure washer/vacuum system. Contaminated soil removed by the pressure washer was vacuumed into a tank and transferred to a roll-off box located on the KEC property. Soil removal continued until on-site laboratory analytical results confirmed that all soil containing concentrations of PCBs exceeding the residential cleanup criteria established by MDEQ was removed.

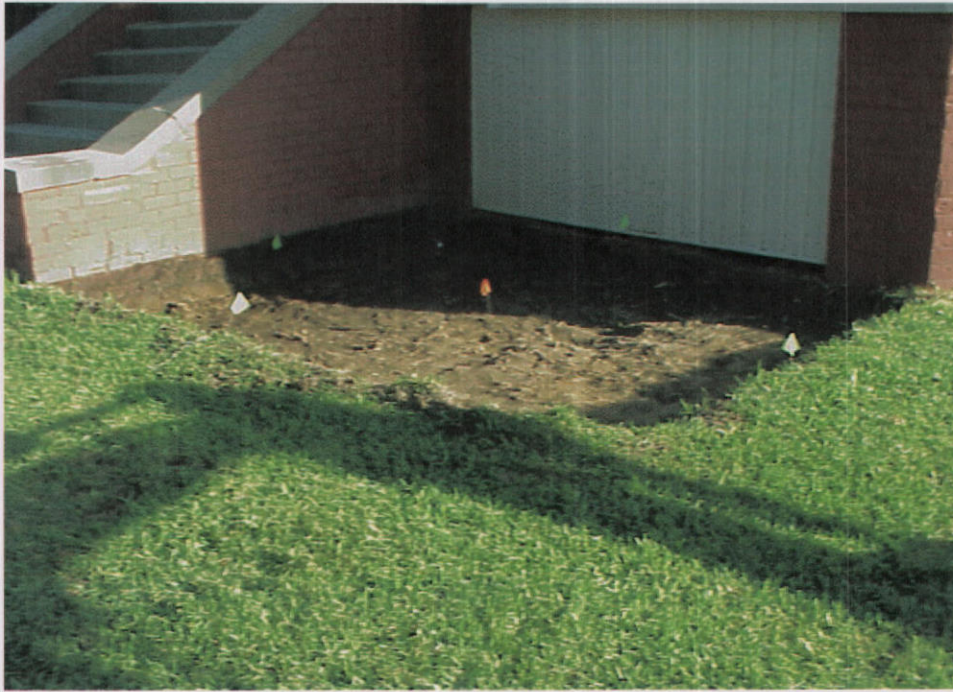
Photo 5 – Completed excavation on the northeast side of the Frazier's front porch. Flags marking confirmation sampling locations are visible in the excavation.

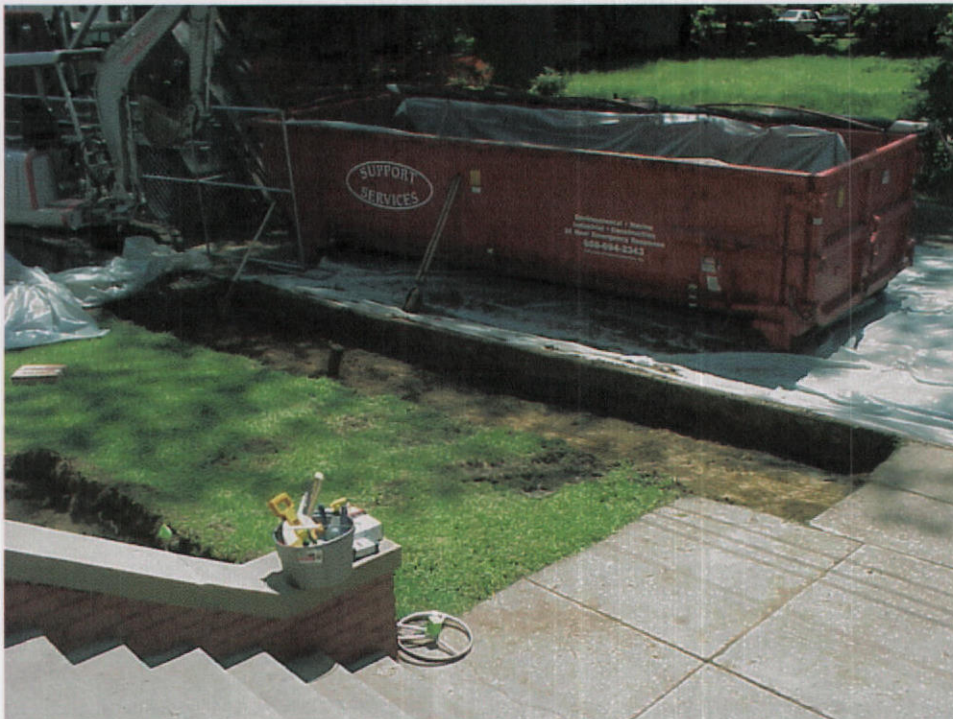
Photo 6 – View looking southeast showing completed excavation along Lee Avenue.

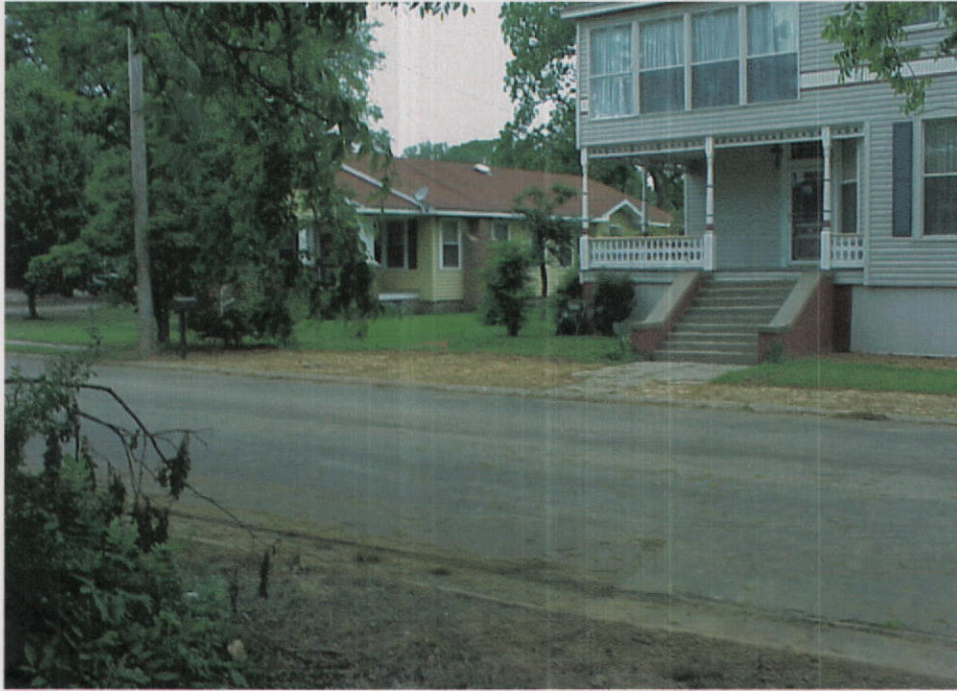
Photo 7 – Completed excavation along Lee Avenue with backfill in-place. View is looking northwest across Lee Avenue.

After confirmation results indicated that the remediation objective was met, the excavation was backfilled with analytically confirmed clean soil. The surface of the remediation area was covered with fresh sod and ornamental plants were replaced. Photographs showing details of remediation are included in Appendix 4.

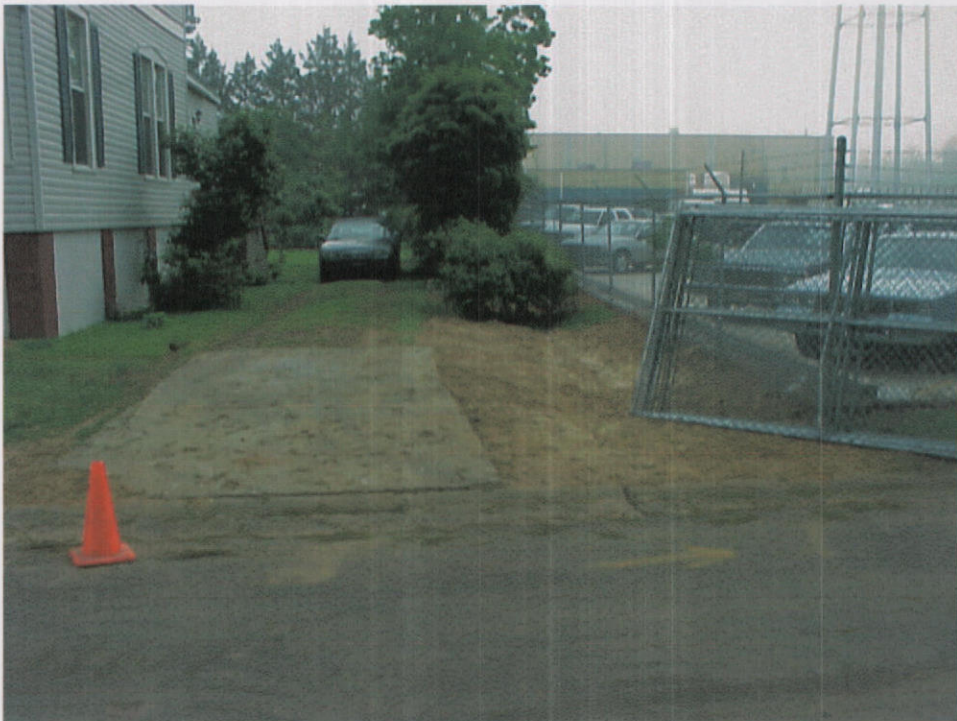
Photo 8 – Completed excavation between the driveway and Kuhlman Electric's parking lot with clean backfill in-place and graded. This view is toward the north across Lee Avenue.

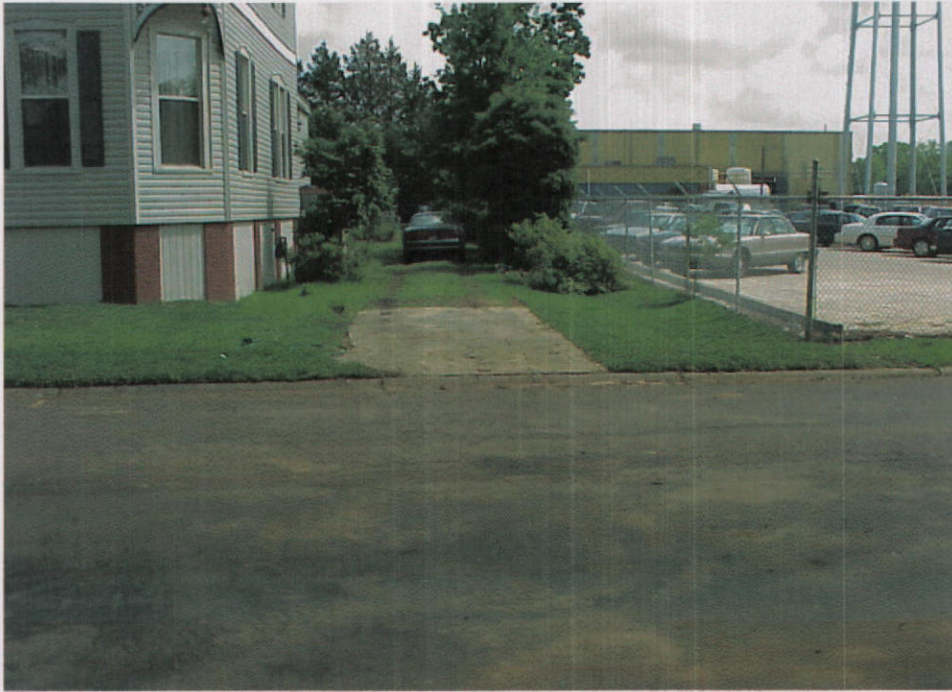
Photo 9 – Area east of the Frazier house with finished sod in place.

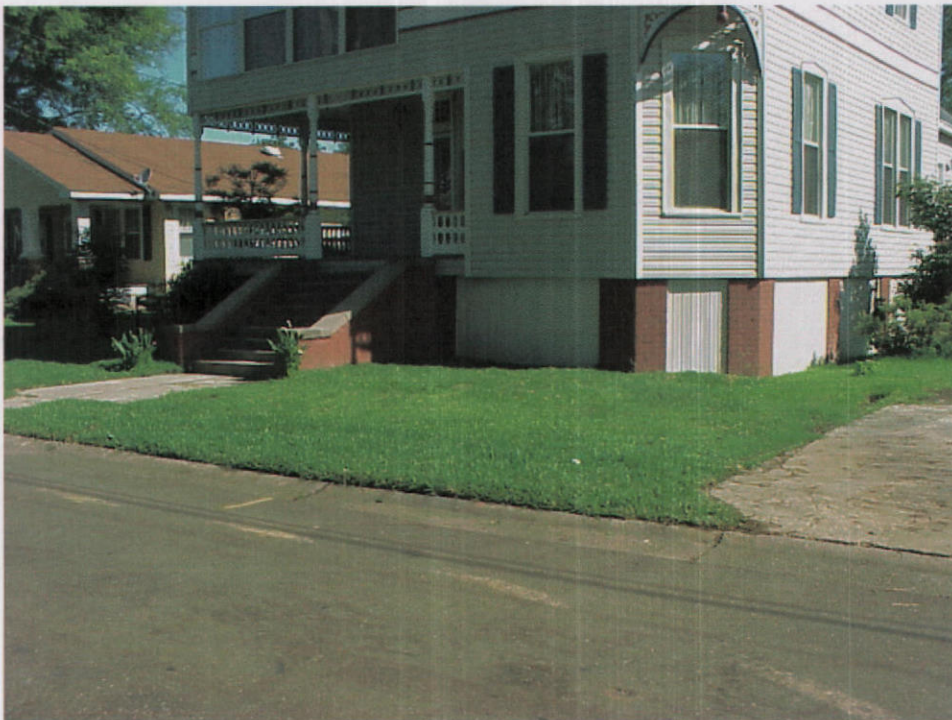
Photo 10 – The front yard of the Frazier house with finished sod in place.
