## PHASE I ENVIRONMENTAL SITE ASSESSMENT

FORMER MISSISSIPPI SCHOOL OF THE BLIND 1254 EASTOVER DRIVE JACKSON, MISSISSIPPI 39211

> EARTH CONSULTING GROUP, INC. PROJECT NO. 210391.22 JANUARY 20, 2011

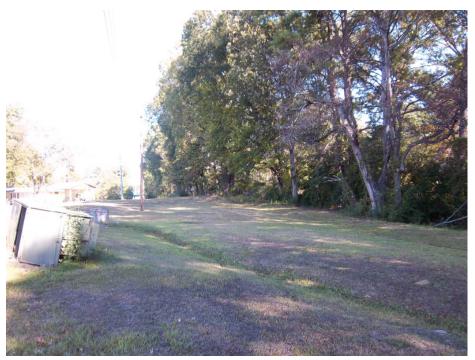
Photograph 3: View of the eastern property boundary looking north. Note the drainage swale for stormwater runoff and the electrical transformer housing in photo left.

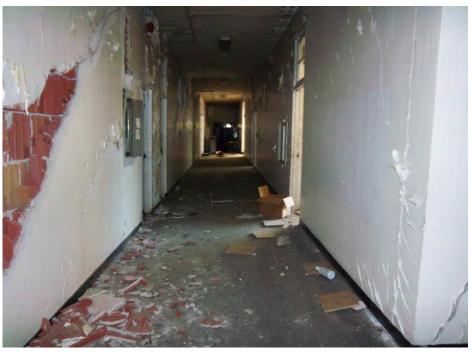
Photograph 10: Typical view of the interior of the school building structures on the subject property showing deterioration of the building materials.

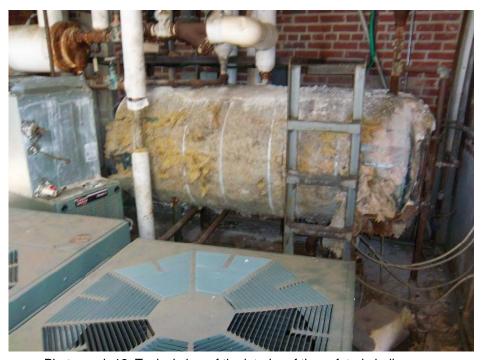
Photograph 12: Typical view of the interior of the cafeteria boiler room.

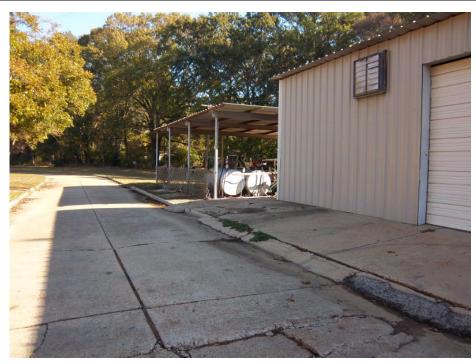
EarthCon observed three (3) ASTs in use at the Property. These tanks included one (1) steel, skid mounted, 500-gallon AST for diesel fuel, one steel skid mounted, 500-gallon AST for unleaded gasoline, and one (1) 250-gallon steel, skid-mounted AST for storage of used oil. The ASTs were stored on the north side of the vehicle maintenance shop under a metal canopy shed. The fuel ASTs were stored on an unpaved surface with the fuel nozzles located on the south side of the ASTs facing the vehicle maintenance shop where vehicles could be refueled on the paved surface of the northwest corner of the shop building. The used oil AST was stored in an approximately 6.0-foot by 6.0-foot by 1.0-foot high concrete containment area. Soil within the containment area appeared soaked with oil, and oil-stained soil was observed surrounding the exterior of the containment area. The oil stained soil is considered a REC in connection with the Property.

Photograph 15: View of the northwest corner of the vehicle maintenance shop showing the adjacent metal canopy and the diesel and unleaded gasoline ASTs where vehicles are fueled.

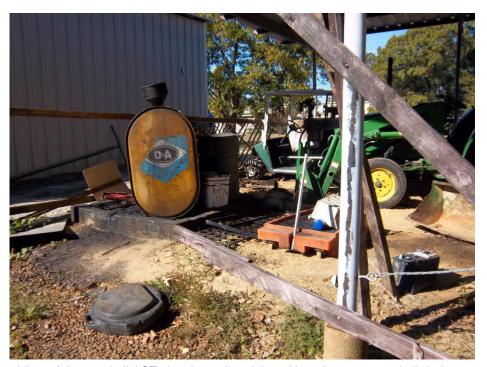
- The vehicle maintenance shop utilizes an area covered by a metal canopy adjacent to the north side of shop to store and dispense unleaded gasoline and diesel fuel, and to store used motor oil on an unpaved surface. Staining was observed on the unpaved ground surface adjacent to the used oil AST. This staining is considered a REC in connection with the Property

- A damaged lead-acid automotive battery was observed improperly stored on the unpaved ground surface beneath the metal canopy shed adjacent to the used oil AST.

The potential for spillage from this damaged battery is considered a REC in connection with the Property.

EarthCon observed one (1) approximately 5-quart plastic, used motor oil drain pan and one (1) approximately 5-gallon wheeled, grated, portable, motor oil drain pan stored under the metal canopy on the north side of the vehicle maintenance shop. The small, plastic used motor oil drain pan was observed to be overturned on the unpaved ground surface. Other open, oil-stained plastic containers (pails, approximately 5-gallon capacity) were observed stored adjacent to the used oil AST and on the wheeled used oil drain pain. One (1) oil filter was observed on the grate of the wheeled used oil drain pan. Due to the observed improper storage of oil containers and the dark stained soil adjacent to these containers, this area is considered a REC.

EarthCon observed one (1) damaged lead-acid automotive battery stored on the unpaved ground surface approximately 15 feet north of the used oil AST. The battery casing was observed to be broken on the top exposing the interior battery components and lead acid liquid contents. No obvious visual evidence of spillage or leakage from the battery was observed on the adjacent ground surface other than the lack of vegetation in the immediate vicinity of the damaged battery. Due to the observed improper storage of a damaged lead acid battery on the unpaved surface, this area is considered a REC.

The used oil AST area was observed to have dark staining in multiple areas including staining covering the tank itself, the soil within the AST containment area, and the ground surface adjacent to the AST. The most significant area of staining was observed on the east side of the used oil AST area with an approximately 5-foot square area of black stained soil. This staining is considered a REC in connection with the Property.

EarthCon observed stained soil and stained pavement as described in Section 6.10. Stressed vegetation was observed associated with the staining on the east side of the used oil AST. The staining and stressed vegetation is considered a REC in connection with the Property.

Photograph 16: View of the used oil AST showing soil staining. Note the overturned oil drain pan on the ground surface, the portable oil drain catch pan, and the damaged automotive battery stored on the ground surface.

EarthCon recommends a limited subsurface investigation at the Property to assess the potential impacts to soil and groundwater from the above-reference RECs.

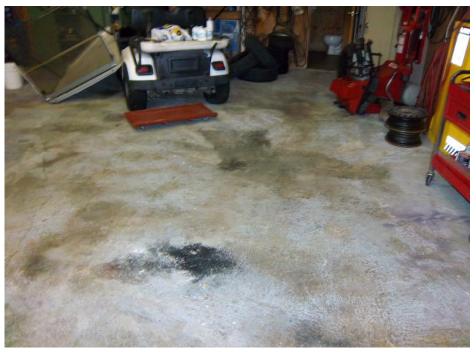
- The vehicle maintenance shop was observed to have an operational floor drain that reportedly discharges to the sanitary sewer system. The floor drain was observed to have dark staining on the concrete surface surrounding the drain. Discharge of chemicals into the drain could provide a pathway for impacts to the soil and groundwater through breaches in the drain line and is therefore a REC in connection with the Property.

EarthCon observed staining in multiple locations on the Property. The concrete floor of the vehicle maintenance shop was observed to have an approximately 3.5-foot by 2.0-foot area of dark staining surrounding the floor drain. Other dark stained patches were observed on the vehicle maintenance building floor in scattered locations. The presence of dark staining surrounding the operational floor drain is considered a REC.

EarthCon observed one (1) approximately 4.0-inch diameter, round, grated floor drain in the northern portion of the vehicle maintenance shop interior. This drain reportedly discharges to the municipal sanitary sewer system serving the Property. Staining associated with this drain is discussed above in Section 6.10. Mr. Pace reported that the school bathrooms and cafeteria contained floor drains that also drained to the sanitary sewer. No staining was observed in connection with these drains.

Photograph 18: View of the interior of the vehicle maintenance shop looking north at the floor drain and dark staining on the concrete floor.

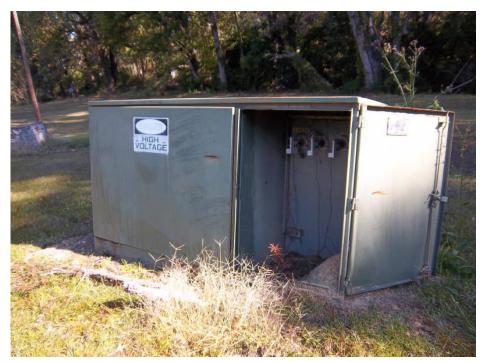
EarthCon observed one (1) approximately 6.0-foot by 3.0-foot by 4.0-foot high pad-mounted transformer housing stored on the unpaved ground approximately 20 feet east of the used oil AST. The transformer was reportedly transported from the adjacent Mississippi School of the Deaf campus and stored at this location in 1996 as it was no longer needed. The transformer appeared to have been removed from the right side of the steel housing. The enclosed left side of the transformer housing was observed to have an approximately 1.5-foot long horizontal gash in the back left corner approximately four to five (4-5) inches above the ground surface. Based on the metal tag attached to the interior door of the transformer housing, the transformer was a 225 KVA distribution transformer. The tag indicated that 700 pounds of liquid was stored in the transformer. No indication of the PCB content of the liquid was noted on the tag. Stressed vegetation and bare ground were observed in the immediate vicinity of the transformer housing. The presence of this transformer housing with a damaged exterior and the presence of stressed vegetation in the immediate vicinity is considered a REC.

Photograph 19: View of the electrical transformer housing stored on the ground surface east of the used oil AST.

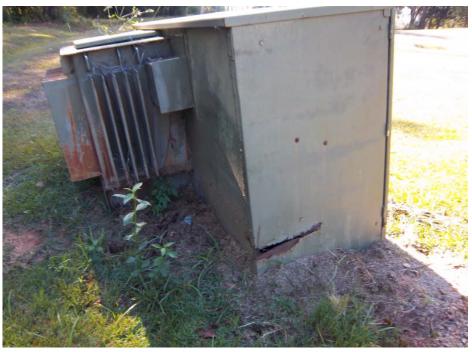
- The damaged housing of a pad-mounted electrical transformer was observed stored on the unpaved ground surface east of the metal canopy shed. The transformer label indicated the unit contained 700 pounds of liquid when operational. No indication of the PCB content of the liquid was noted on the transformer housing. The housing appeared damaged by a lawnmower blade or similar equipment causing a gash near the bottom of the transformer housing. The potential for spillage from the transformer at the time damage occurred to the housing is considered a REC in connection with the Property.

Photograph 20: View of the north side of the electrical transformer showing the gash in the housing approximately 4-5 inches above the ground surface.
