MISSISSIPPI DEPARTMENT OF ENVIRONMENTAL QUALITY

**TO:** Gulf States Creosote Site File  
Hattiesburg, MS

**SUBJECT:** Site Inspection of Fill Area Well Vaults Conducted

**SUBJECT:** Fill Area – Product Removal Event August 2010

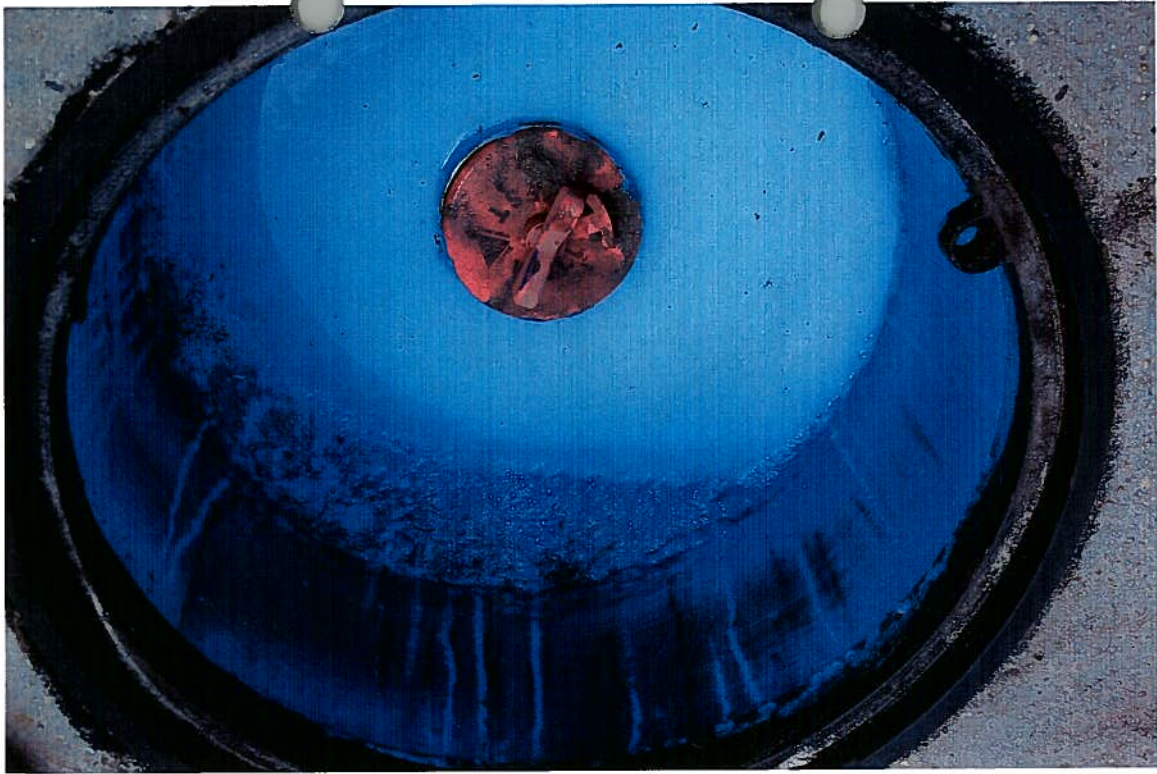
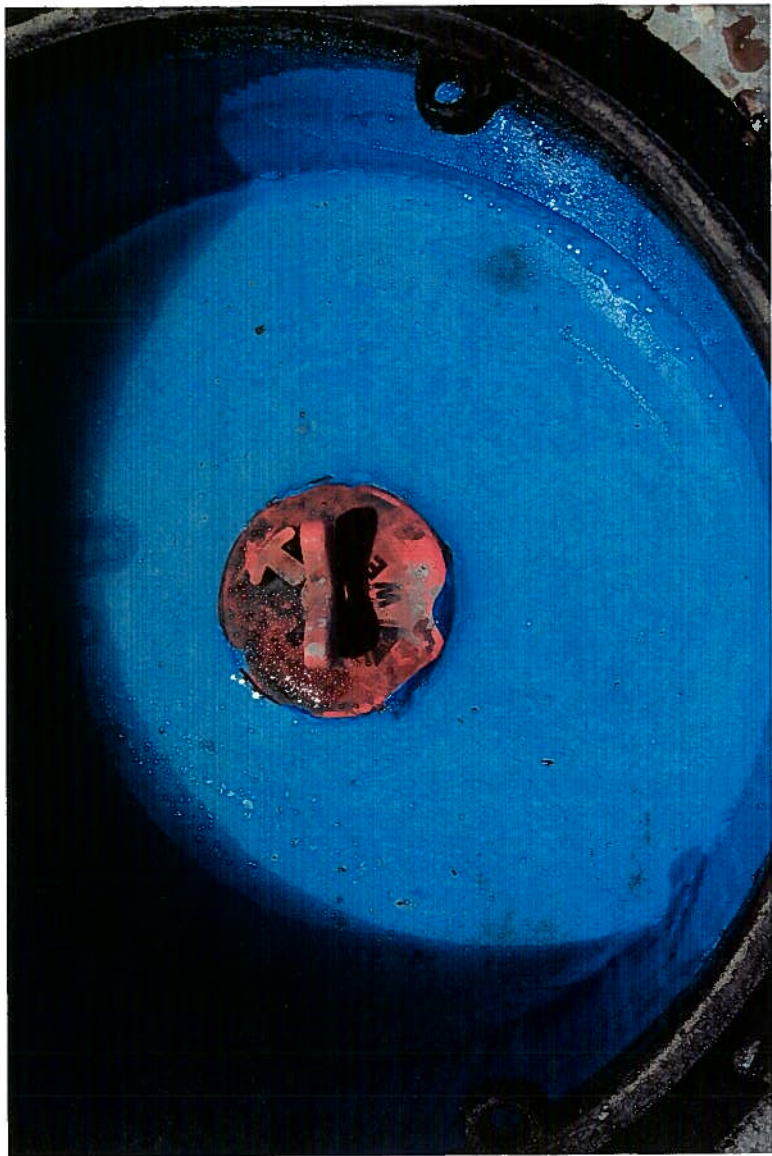
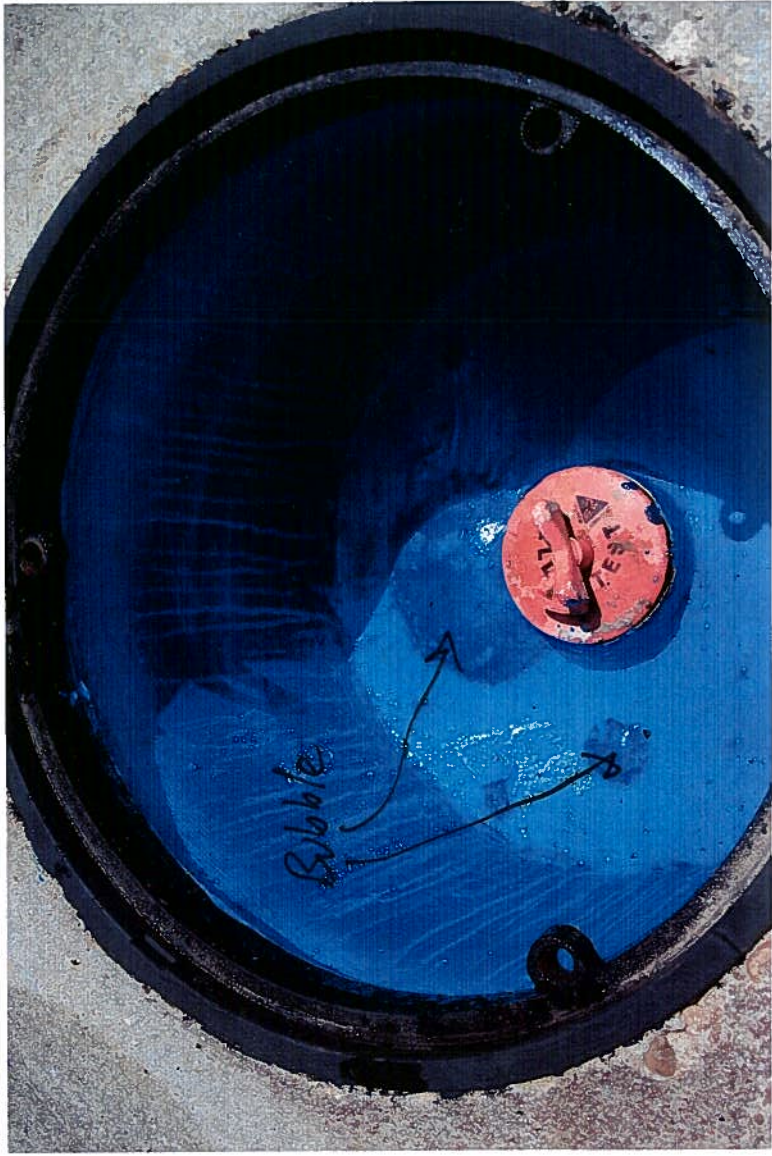
GSC- Fill Area Site  
Hattiesburg, Ms.  
9/2/10

I conducted a site visit at the Fill Area on September 2, 2010 to observe the work conducted on August 24 on the recovery well vaults. The vaults were painted with a rubber sealant. Upon investigation of the previous work, it was noted that the sealant did not adhere to the concrete grout. The moisture present in the well from either rain or permeation through the concrete had caused the sealant to not adhere to the concrete. Several wells were checked and observed to be in this condition; therefore, it is assumed that all the wells will have to be reworked.

Photos of rubber sealant used on  
recovery well vaults. Light blue  
color indicates sealant failed

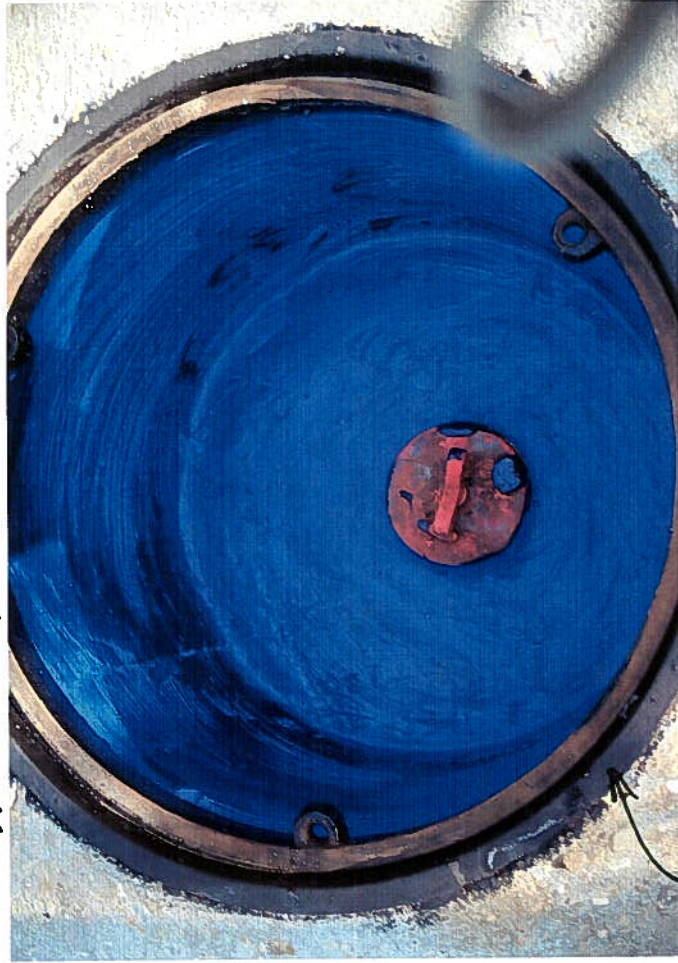
GSC - Hill Area 8-23-2020  
Hattiesburg, MS,

All the recovery well vaults and grout were painted with a rubber sealant in an attempt to create a non-permeable seal within the vaults except for the wells that were re-grouted and RW-11. The grout in RW-11 was damp so it was not painted during this event. The following 6 wells were re-grouted with quik-crete to give the sealant a better surface to adhere to: RW-10, RW-9, RW-7, RW-16, RW-1 and RW-15.

Well vaults after sealant applied

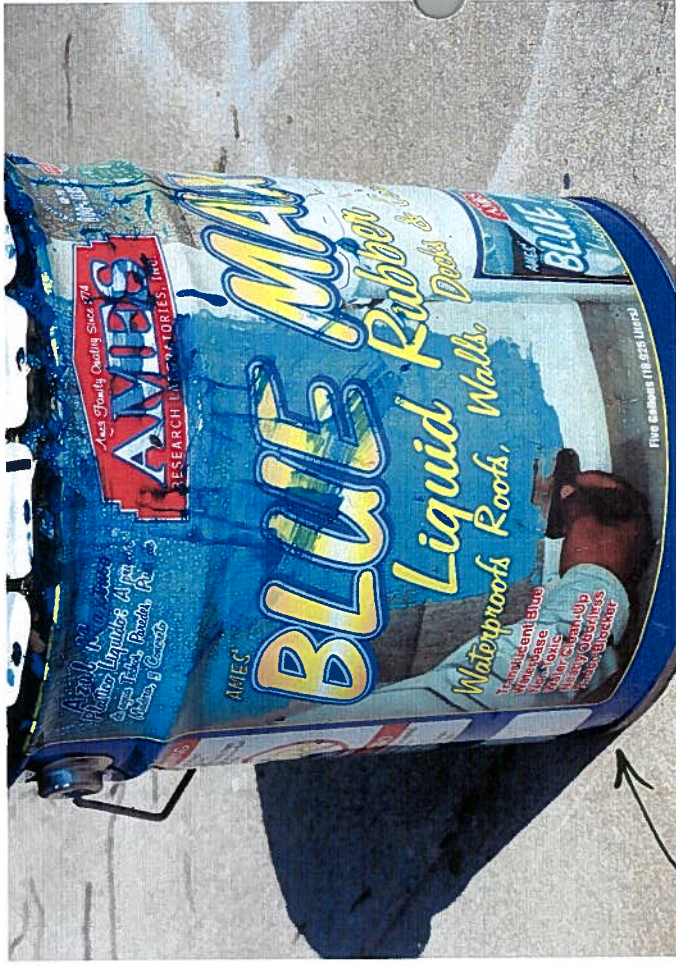
Material used to seal concrete, in vaults

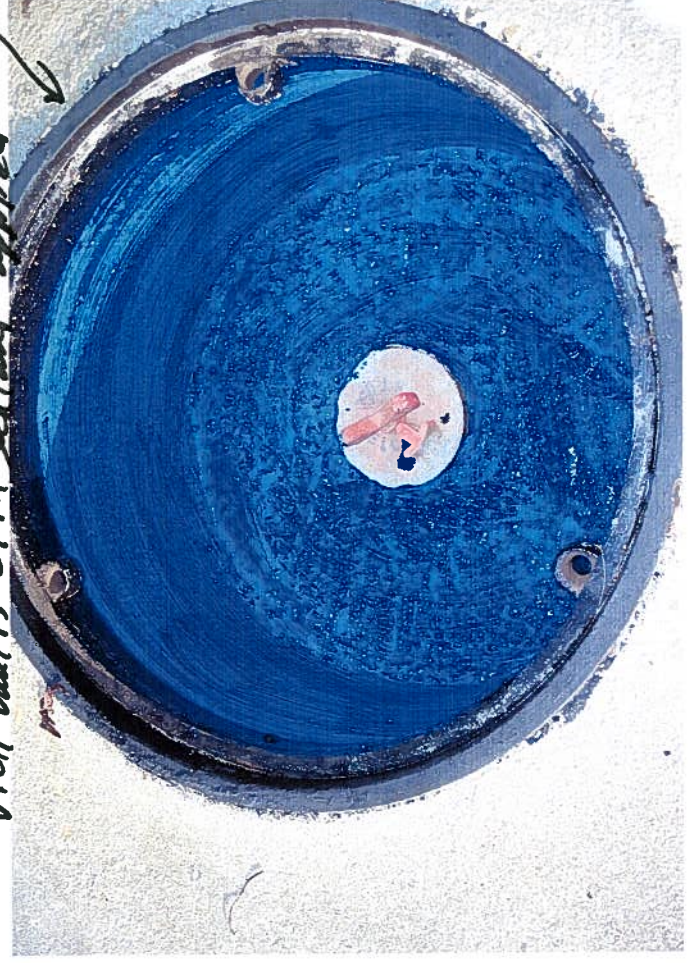
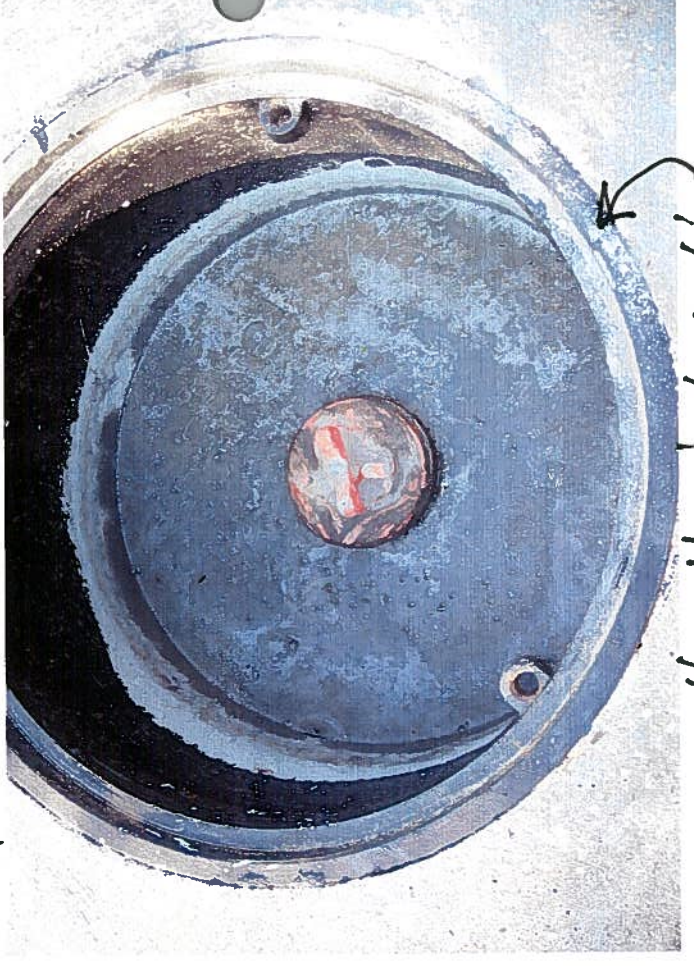
well vault prior to sealing

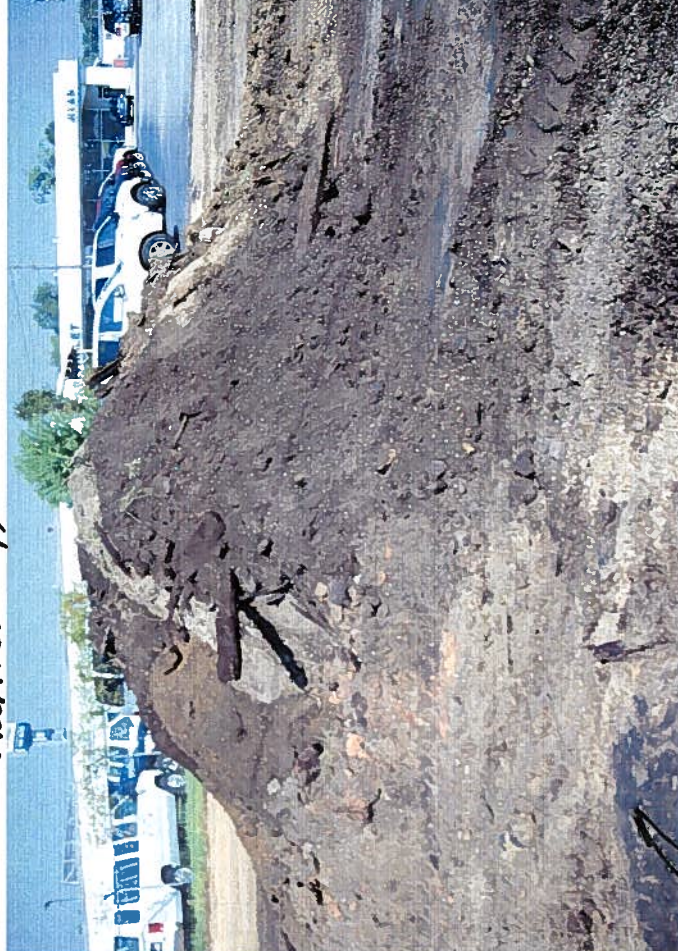
Courtsey Ford Dealership  
Abilene, Mo.  
8/24/10

Soil w/ creosote timbers (old ties)

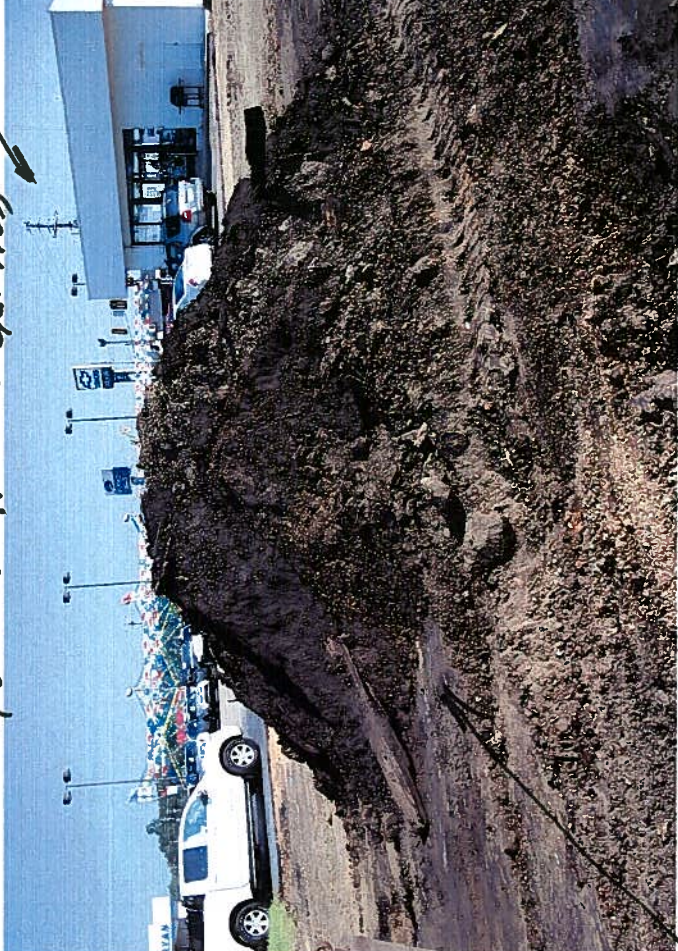
At approximately 1015 hrs, Mike Bonner arrived to pull the sample. He collected a composite sample from the soil pile into a stainless steel bowl. He then thoroughly mixed the sample and then evenly distributed the sample into two sample containers. The sample will be delivered to OPC lab in Pearl for semi-volatile analysis by Method 8270.

Soil sample collected from soil pile to determine disposal options

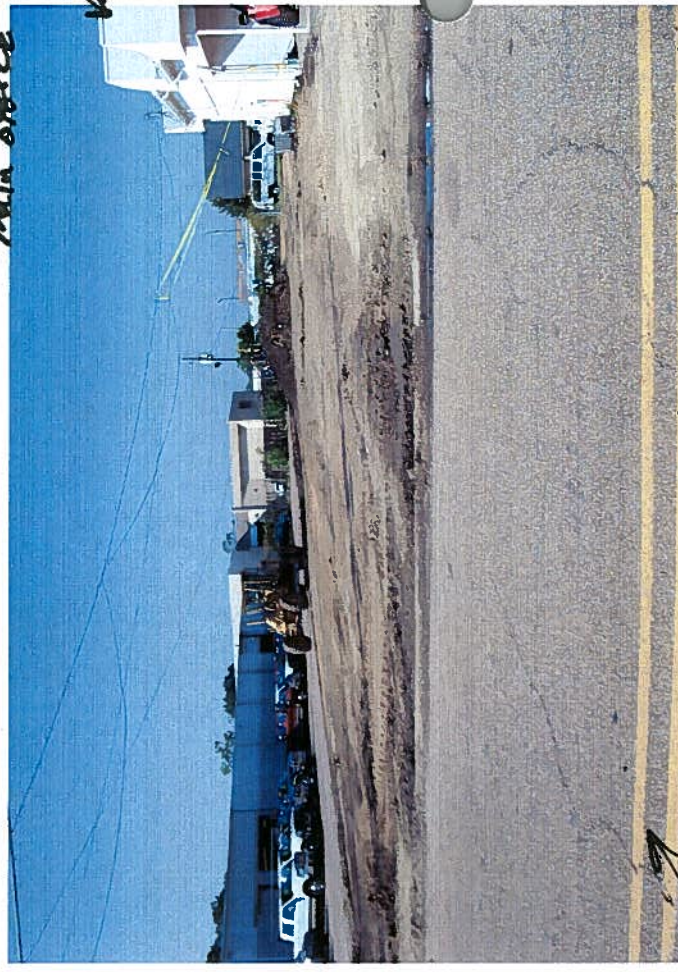
Courtsey Ford Used Car  
Main Office

Over-all view of Area being Scrapped

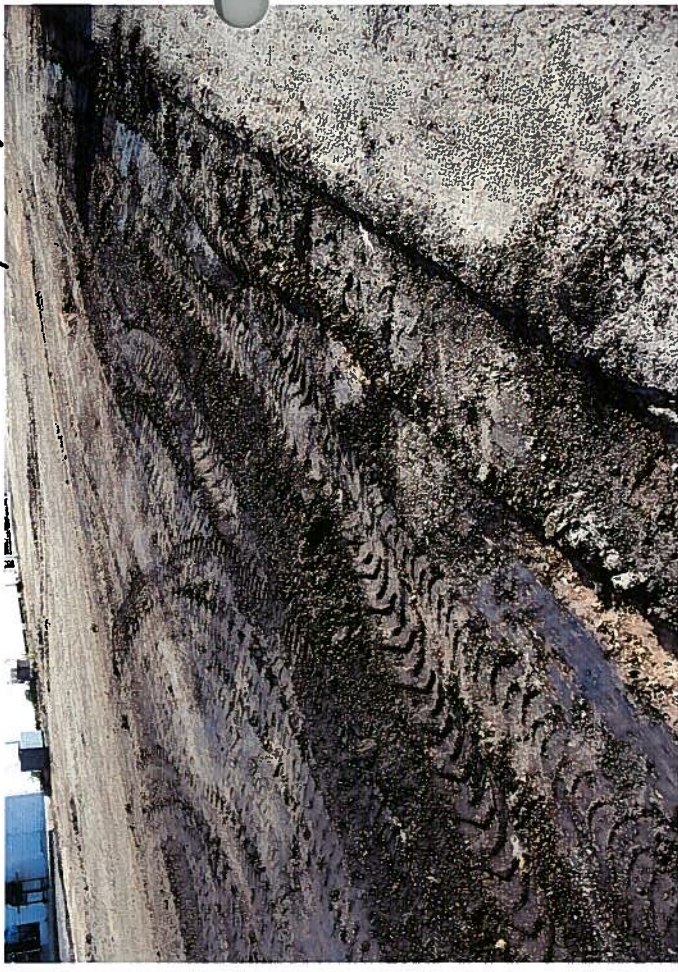
I met with Courtesy Ford's General Manager (Mr. Mixon) on August 24, 2010 after observing a pile of soil behind the used vehicle sales office. Warren Paving had workers on site scrapping the soil up so that the area could be paved with asphalt. The inspection was conducted due to a complaint from the local activist group – FCEST.

Area being scrapped so it can be paved with asphalt
