WASTE MATERIAL REMOVAL COMPLETION REPORT FOR  
ARVINMERITOR

Former Moose Lodge Road Disposal Area  
Grenada, MS

January 12, 2006  
220T.11530.00.00016

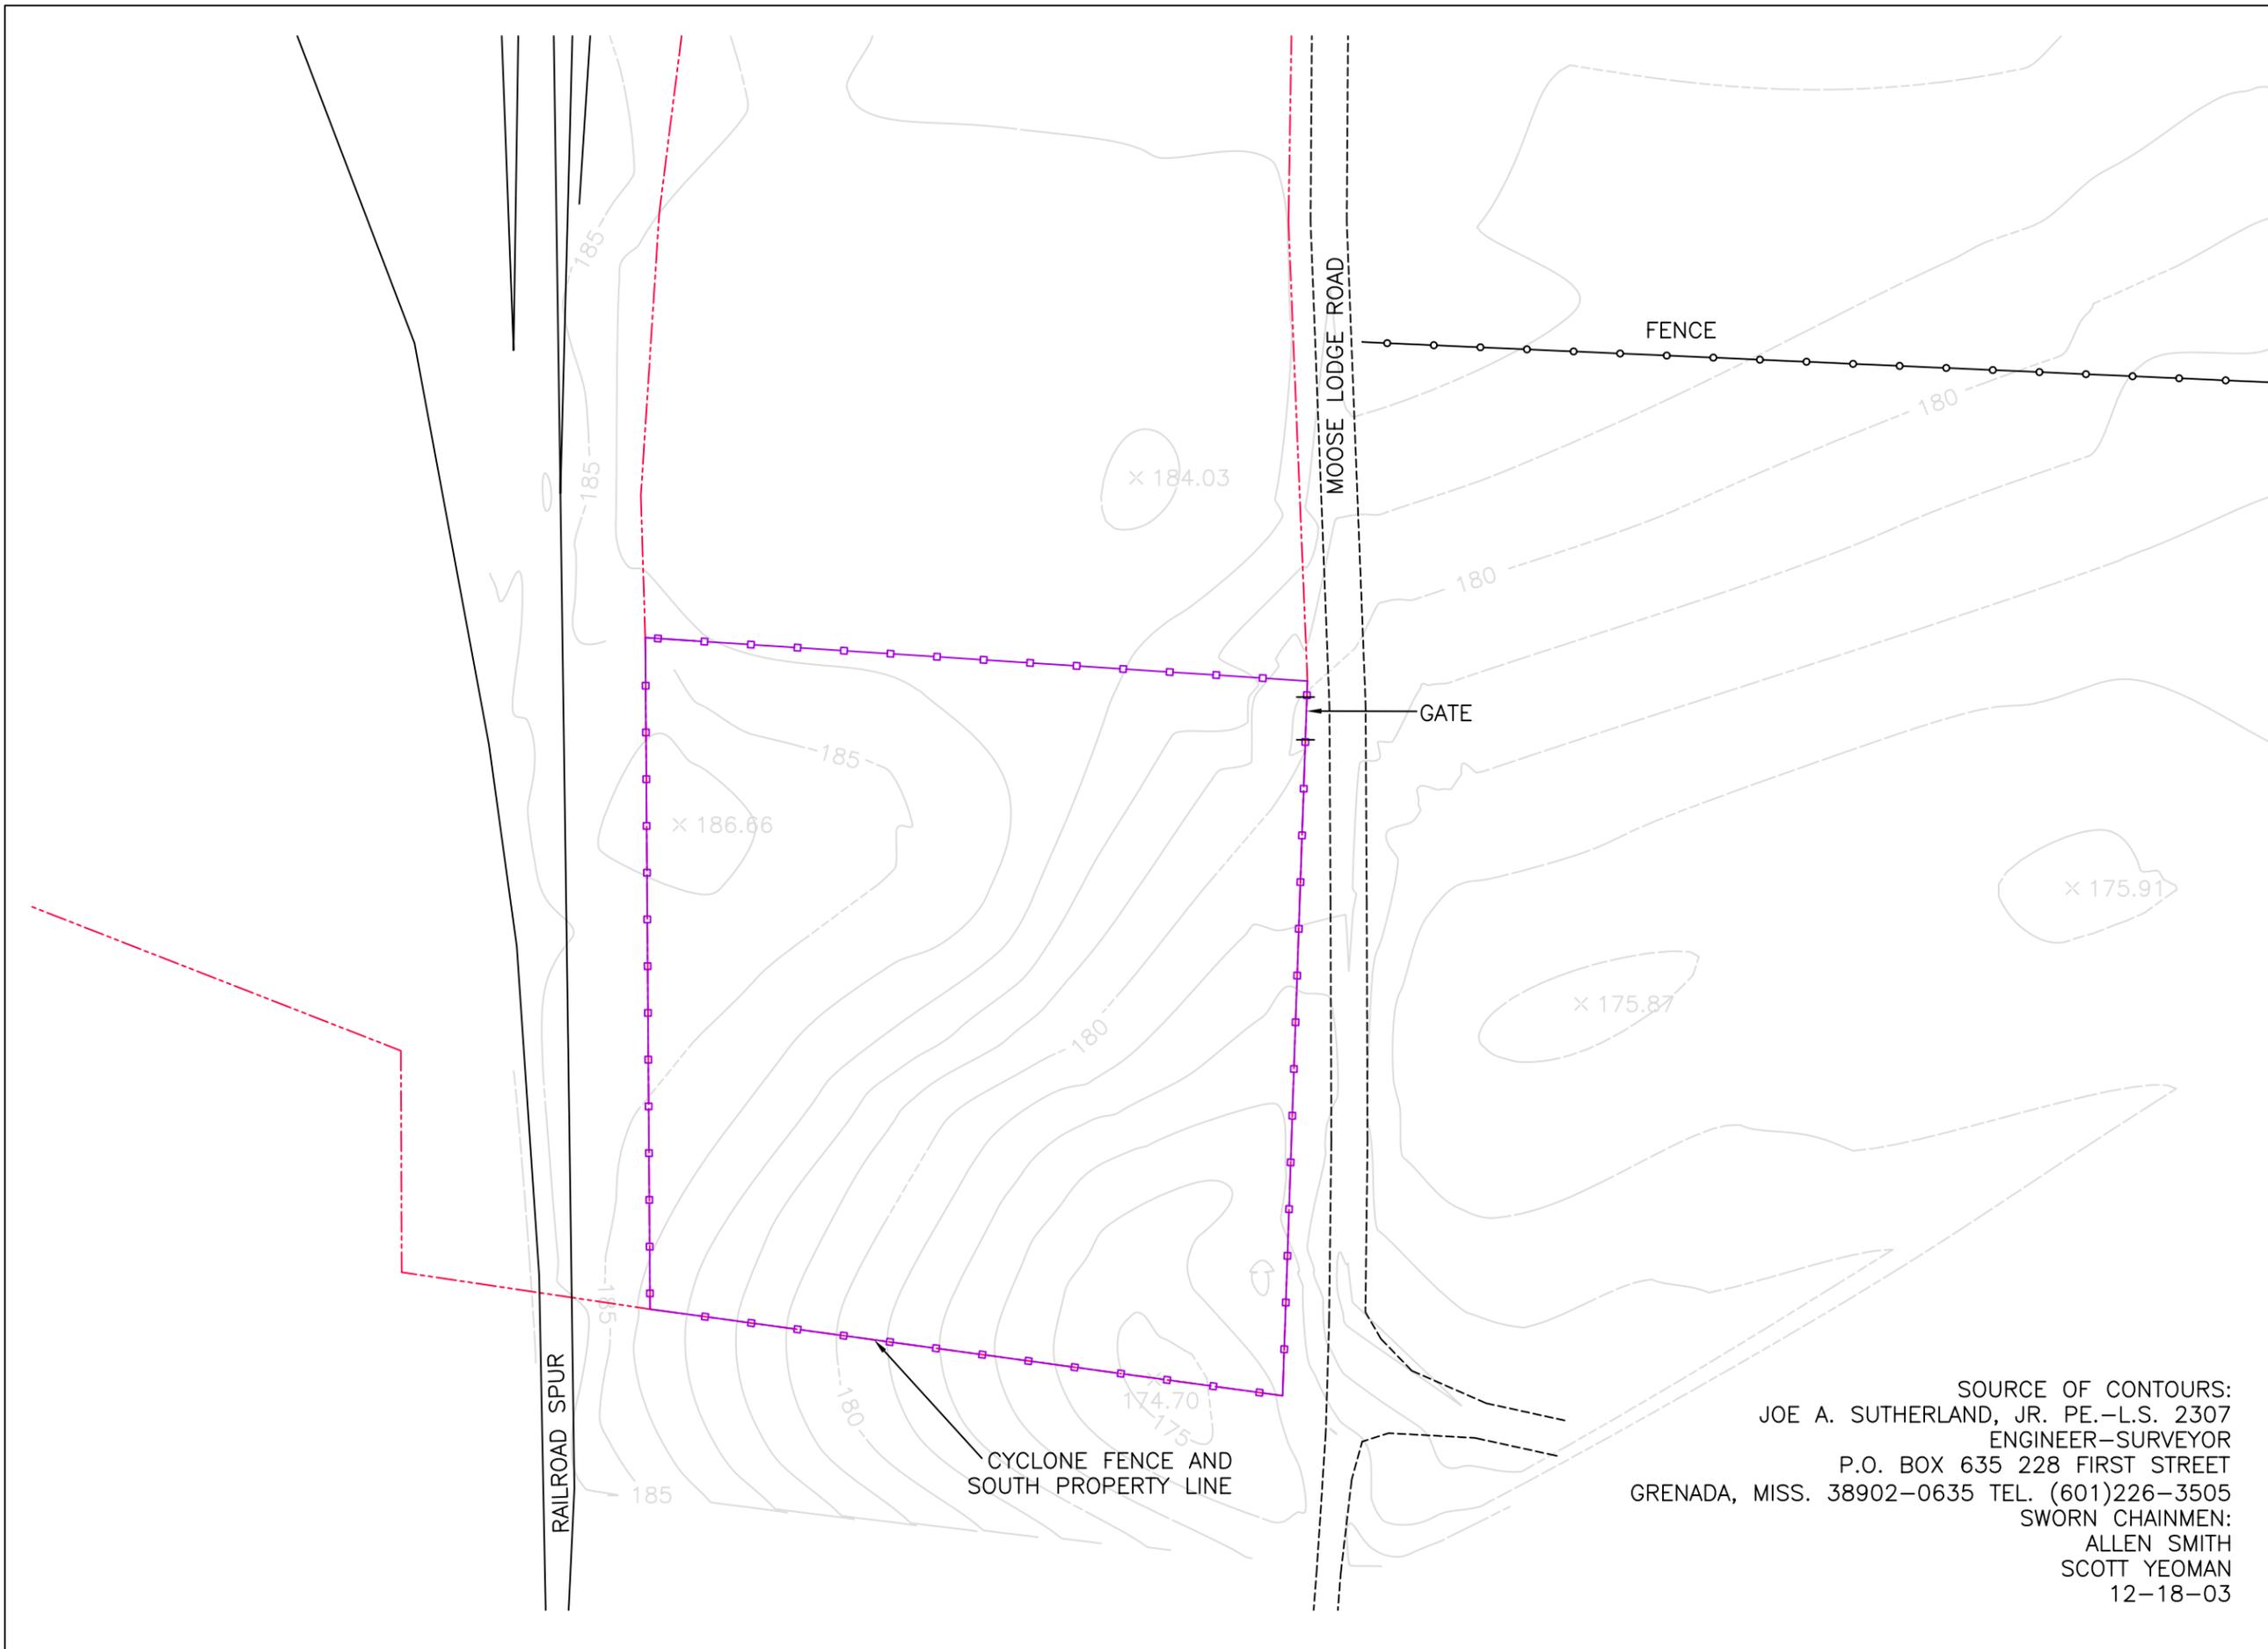
**FIGURE 2**

During the week of January 30, 2006, clearing and grubbing was initiated to remove trees, snags, logs, stumps, rubbish and garbage from the area illustrated on Figure 2 and in Appendix B – Photographs 1 and 2. Clearing and grubbing was necessary to remove vegetation and allow access to the waste material. Trees and underbrush were cut above ground level and chipped on-site. The root systems were left in place until the Site was cleared. The root systems with visible waste material were removed and staged for disposal. Larger trees were cut above ground surface and staged for off site transportation. The clearing and grubbing concluded during the week of February 13, 2006.
